Self Mitigating Protection for Pipeline Crossings in Degraded Streams:
A Case Study from Woodward Creek, Washington

Tim Abbe, Ph.D., PEG, PHG Natural Systems Design, Inc.
tim@naturaldes.com, 206-681-8697
Charley Miller, PE Incline Village, NV
Michael Aubele Williams Northwest Pipeline

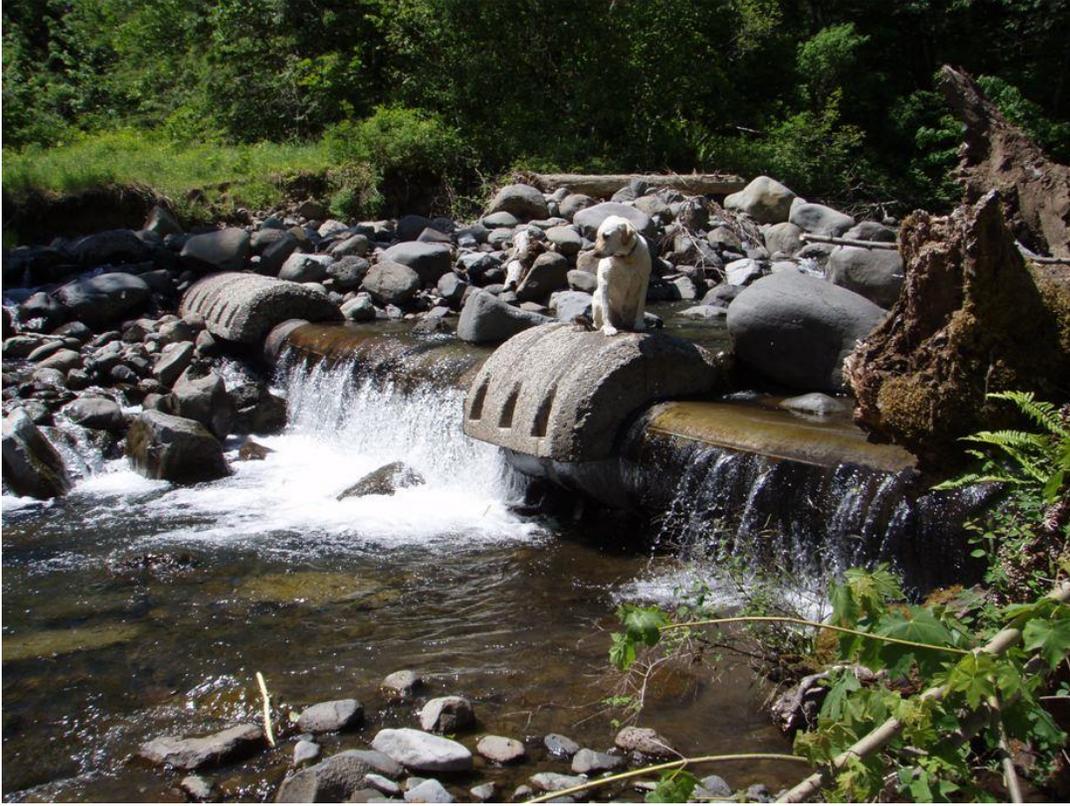
In the winter of 2006-2007 a 2 m headcut moved upstream through the project site and exposed the pipeline (Figure 2). The exposed pipeline created an emergency situation and an initial response in the summer of 2007 involved placing a large rock (1–2 m median diameter) weir immediately down stream of the pipeline. The weir extended across the bankfull channel and

Figure 2. Exposure of pipeline in summer of 2007 after over 2 m of channel incision. Note coarse boulder substrate. Initial treatment was to construct large rock weir immediately downstream of pipeline crossing.

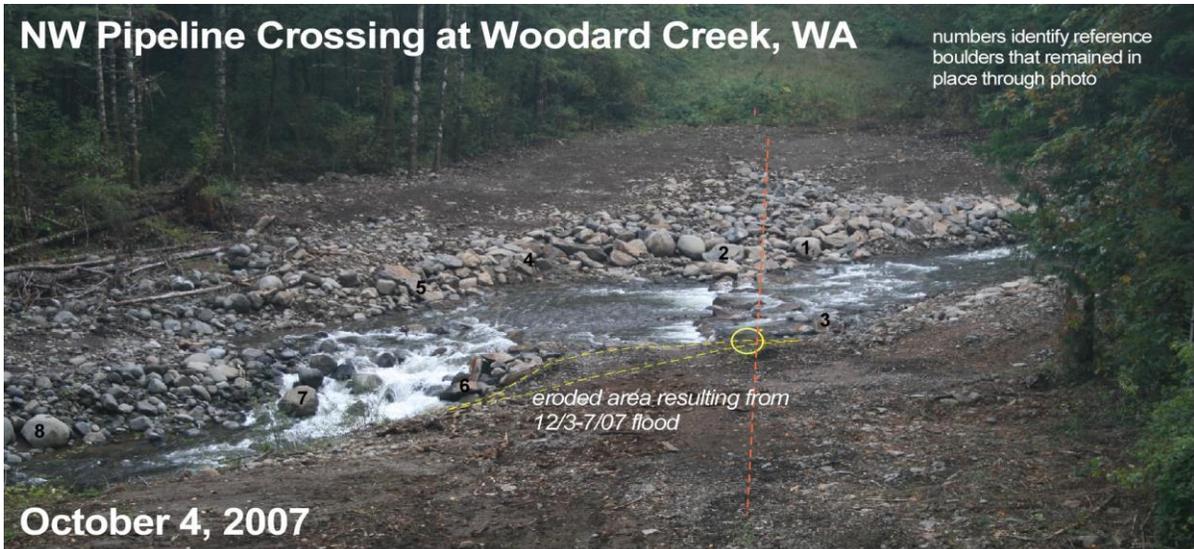
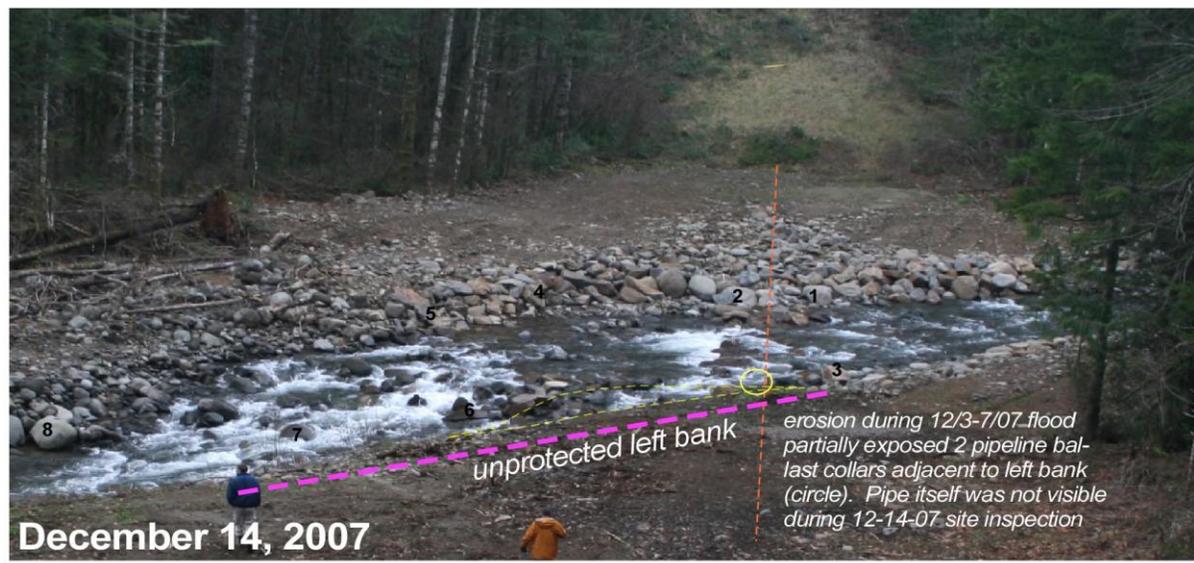
created a fish passage barrier. To improve fish passage an unplanned boulder cascade was constructed out of native alluvial from the site that raised the creek bed about 1.6 m and allowed for partially burial of the rock weir (Figures 3 and 4). The construction contractor came up with the boulder cascade based on a natural one located about 60 m upstream of the pipeline crossing. But the slope of constructed cascade was more than twice that of the natural one and the constructed channel over the cascade was only about half the width. After only one peak flow event in December 2007 the constructed boulder cascade was eroded, reducing its slope all the way up to the rock weir (Figures 3 and 4). The channel also widened in response to the peak flow, particularly along the left bank (looking downstream, Figures 3 and 4). Bed degradation after only one peak flow event raised concerns that the rock weir would become fully exposed and reform a fish barrier. Channel widening had already re-exposed one of the ballast collars along the left bank which threatened to recreate the same conditions that occurred in 2007. The senior author was contacted after construction of the emergency project had been completed in the fall of 2007 to assist with a mitigation plan to place large woody debris in the channel, required by regulatory agencies for construction of the rock weir. After the channel alterations the following winter, the mitigation project became more structurally focused to stabilize the downstream cascade to ensure the rock weir and pipeline remained buried and fish passage improved.

Figure 3. Project site in October 2007 after construction of rock weir (right center) and boulder riffle (left). Boulder riffle was built to raise creek bed so rock weir would not create fish barrier. Site less than 3 months later showed major deformation of boulder riffle, exposure of rock weir and erosion of left bank threatening to circumvent weir.

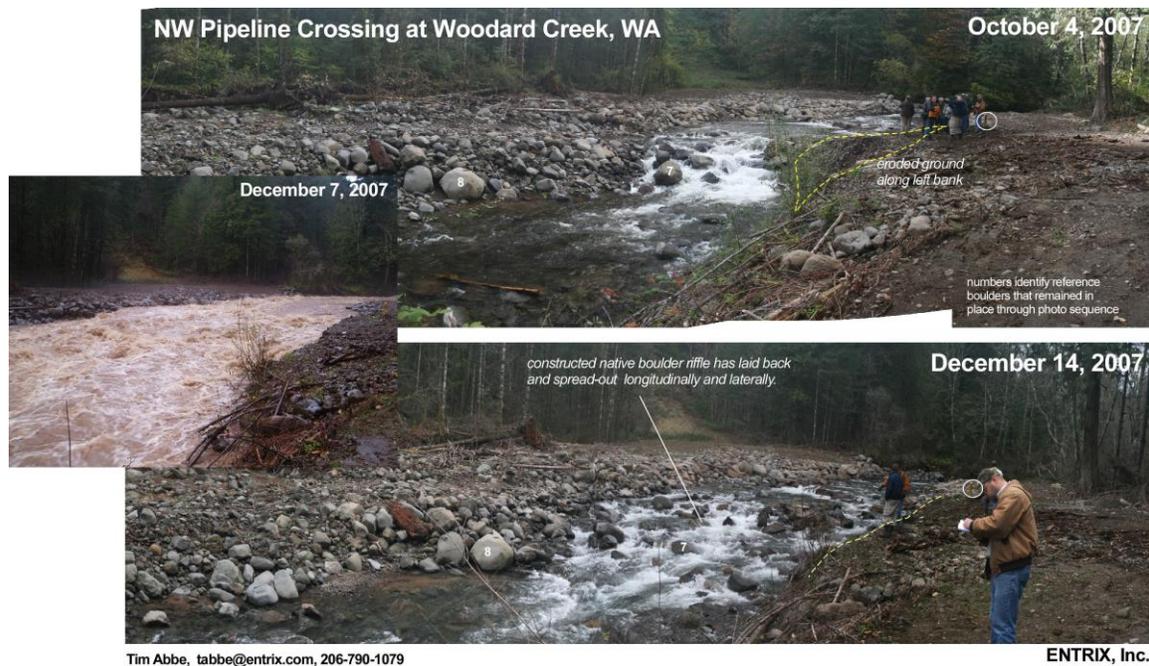
Figure 4. Post construction view looking upstream and again after peak flow on December 7, 2007 (approximately a 1 yr recurrence event, inset photo). December 14 photo shows channel width over boulder riffle almost doubled, eroding into left bank (on right of photo), threatening to cut around weir and re-expose pipeline. Boulder riffle has also laid back its slope and resulted in more exposure of rock weir.

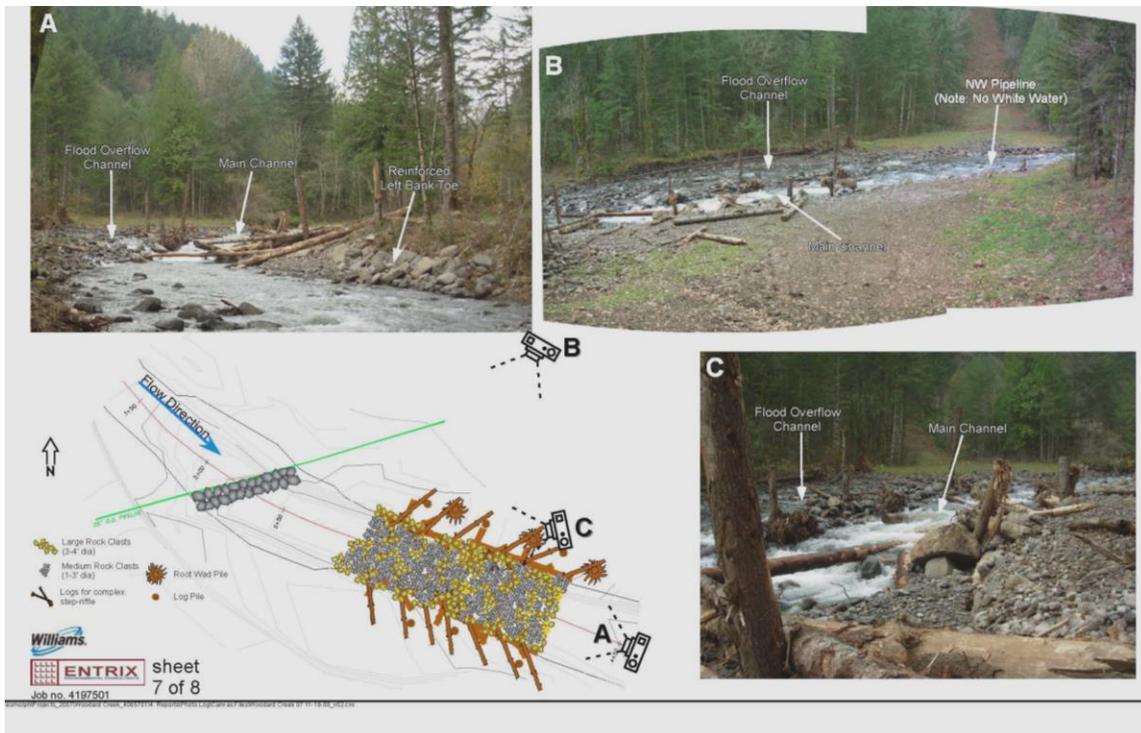
The completed timber grade control structure was tested within short order, experiencing an estimated 5 yr peak flood recurrence event in November 2008. During an inspection after the flood event the structure was performing as intended with a series of alternating steps from side to side over the length of the cascade and no deformation was observed (Figure 9). The overflow area along the right bank was partially engaged during the inspection.

Figure 9 Woodward Creek grade control structure on November 18, 2008 after a 5 yr recurrence flow. Structure is completely intact with overflow area on right bank activated (left of photos A and C). Peak flows were contained within channel and right bank overflow area.

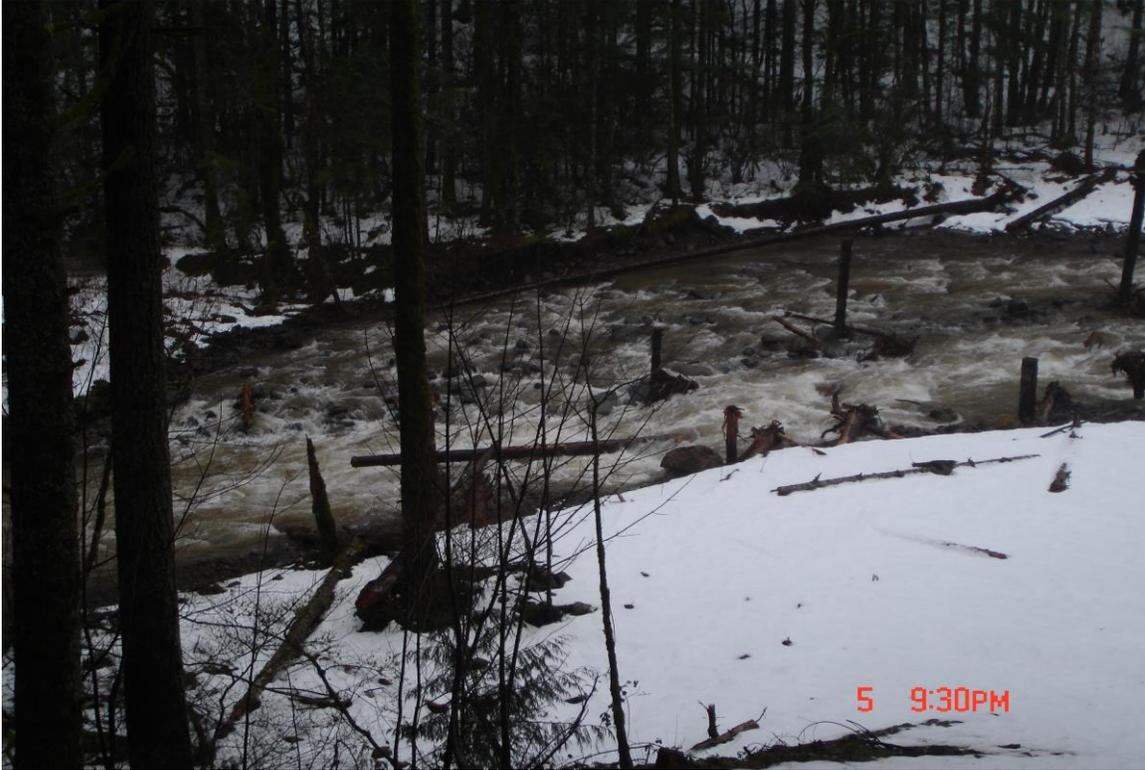
In January of 2009 Western Washington experienced a major storm event that resulted in record flooding from the Lower Columbia to Seattle. Based on nearby gages we estimated that flow in Woodward Creek was approximately $25 \text{ m}^3/\text{s}$, corresponding to a 50 yr flood. An inspection of the site shortly after the peak flow showed the creek channel and its overflow area completely inundated (Figure 10). After the flood it was clear that bedload transport occurred within the creek and through the reinforced cascade (Figure 11). The structure was completely intact with no observed changes in channel geometry and no bank erosion.

Figure 10. January flood showing inundation of low right bank floodplain. Fine sediment deposition indicated water just barely inundated left bank floodplain but was not sufficient to move any of unanchored wood on ground surface.

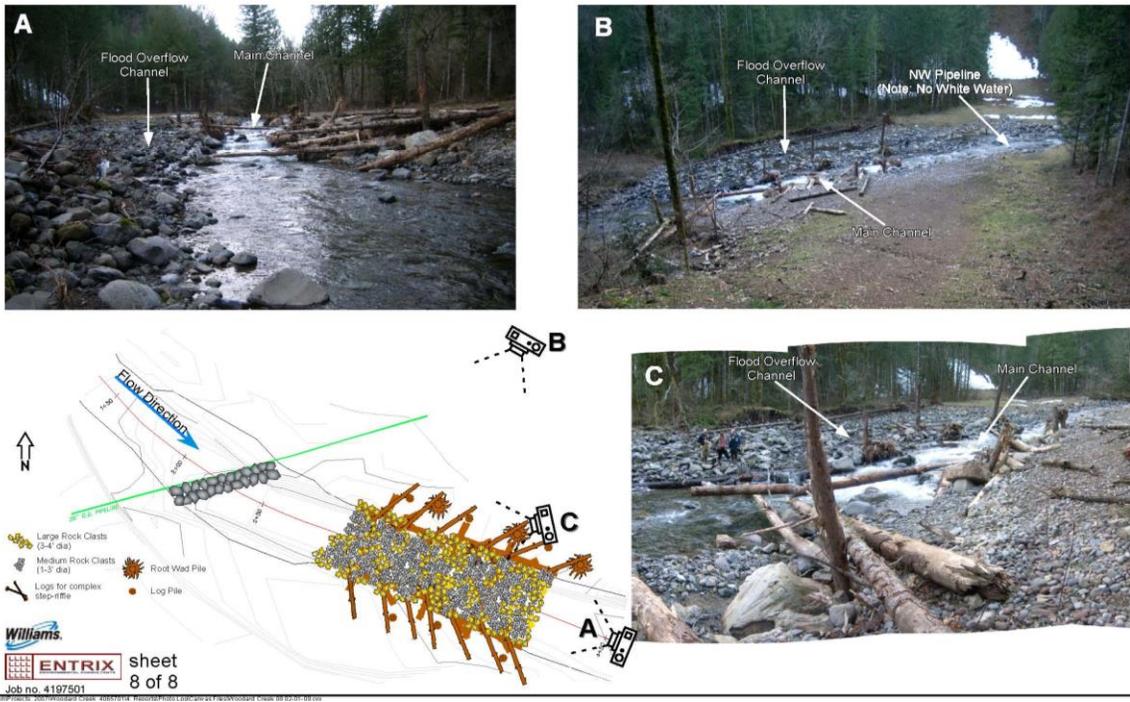
Figure 11. Project site on February 1, 2009 after January flood which was estimated to be have a recurrence interval of approximately 50 years. Structure completely intact with no signs of significant deformation. Flow remained concentrated in the channel and right bank overflow area.
