Chico Creek Watershed Assessment for the Identification of Protection and Restoration Actions

Kitsap County, Washington

July 31, 2014

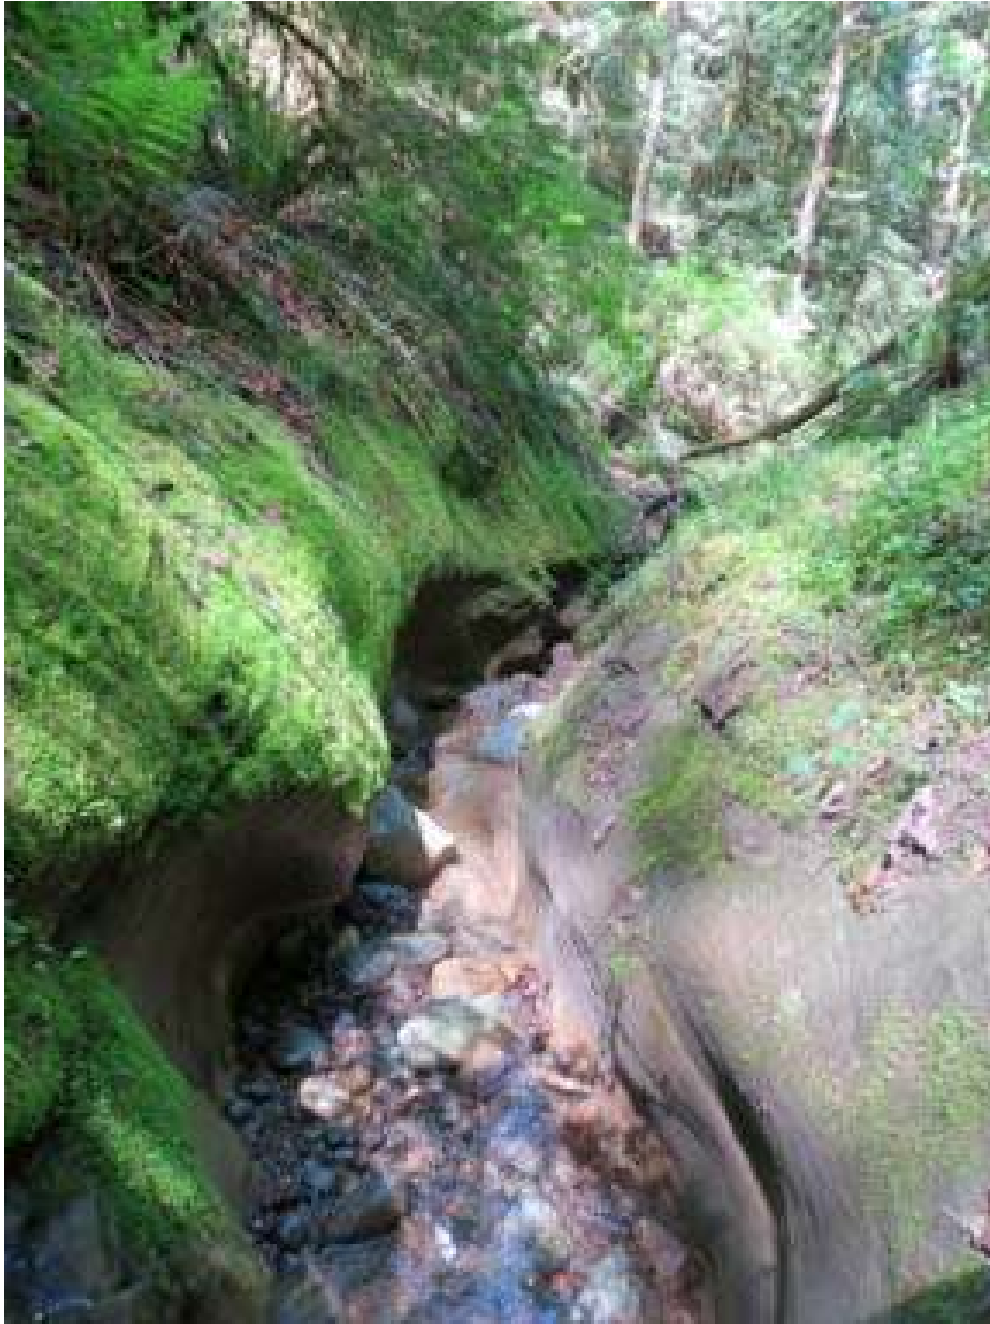
Figure 30. Photo of moderately steep, forested channel segment that has incised a narrow ravine in response to accelerated surface runoff. Much of the small watershed of this right bank tributary to Lost Creek was clearcut and had road construction in the 1990s and in about 2004. In 2009 the Ueland Tree Farm donated a conservation easement for part of the subbasin to the Mountaineers Foundation to protect this riparian corridor and stream into the future. The parcel was purchased by the Mountaineers Foundation in 2012 with a donation from the Suquamish Tribe under EPA's National Estuary Program. Photo taken May 2013 by Steve Todd

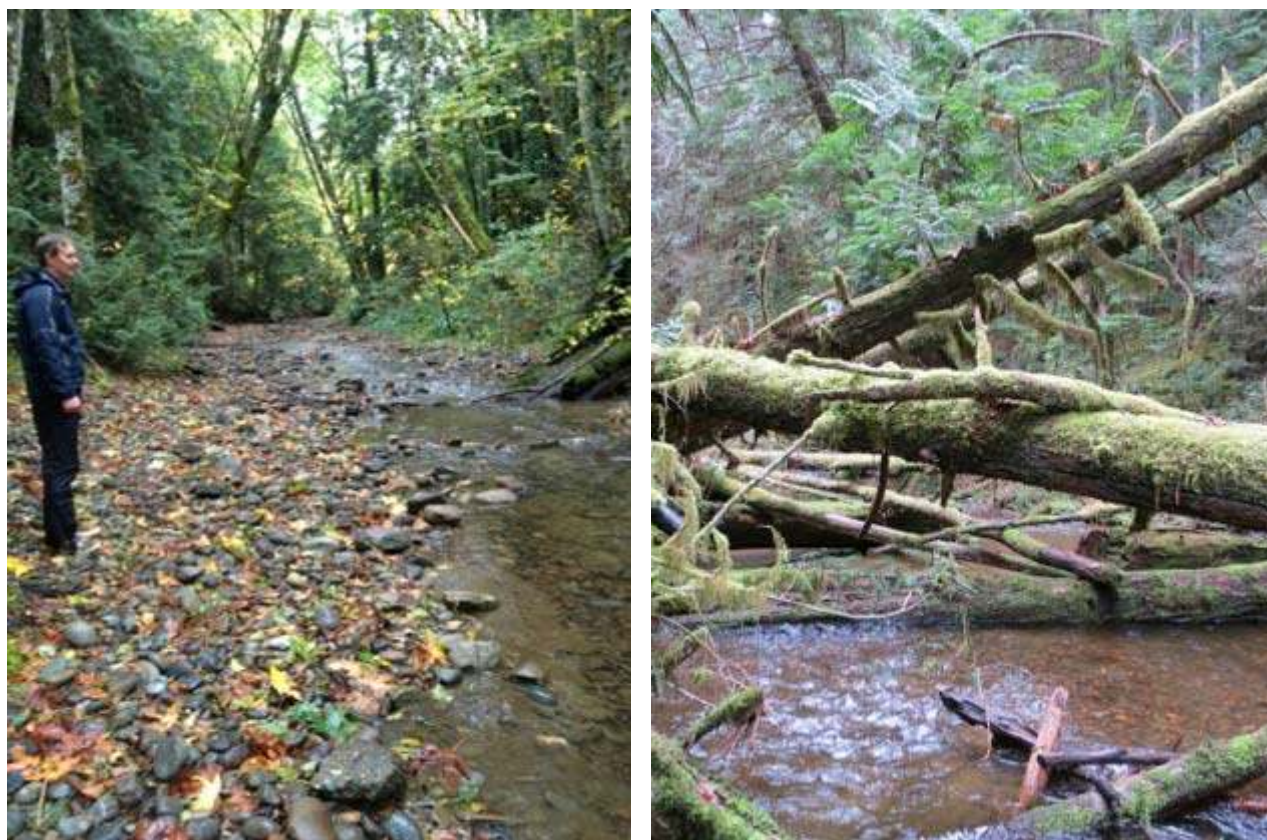
Figure 32. Photograph comparison of a reach lacking channel complexity due to deficiency of wood in Chico Creek upstream of Taylor Road (left) and a reach with active wood recruitment and increased channel complexity in Wildcat Creek (right). Photos by Shawn Higgins, NSD (left) and Steve Todd, Suquamish Tribe (right).

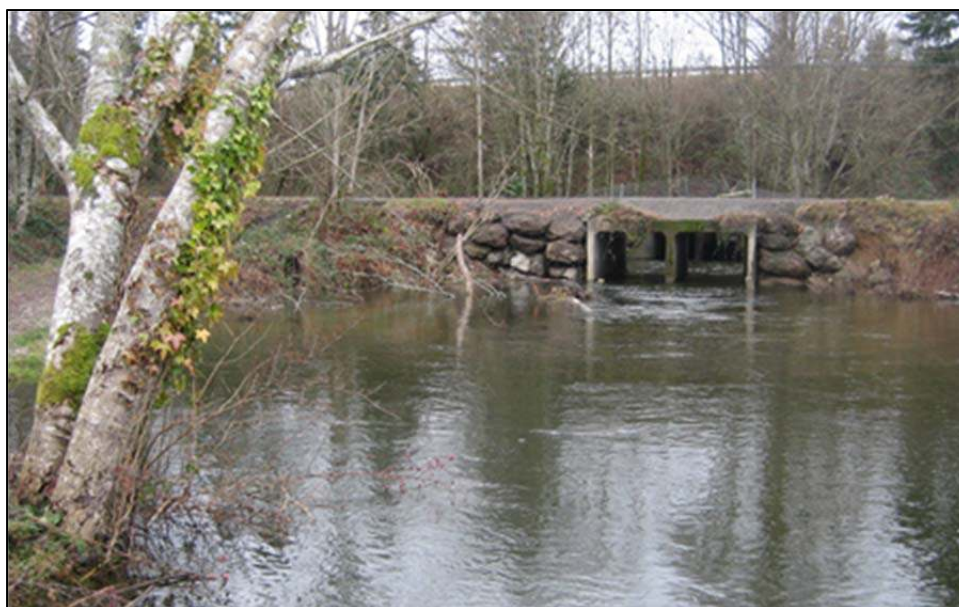
The double box culverts at SR 3, located immediately upstream of the Kittyhawk Drive culvert, constrain floodplain/upper estuarine habitat-forming processes in the reach and are also a partial barrier to fish passage. Much of the habitat benefit gained from removal of the Kittyhawk Drive culvert is dependent upon future action to address constraints at the SR 3 stream crossing.

Figure 46. Photo of double box culvert at Kittyhawk Drive (view upstream). Photo taken from Habitat Work Schedule, credit unknown.

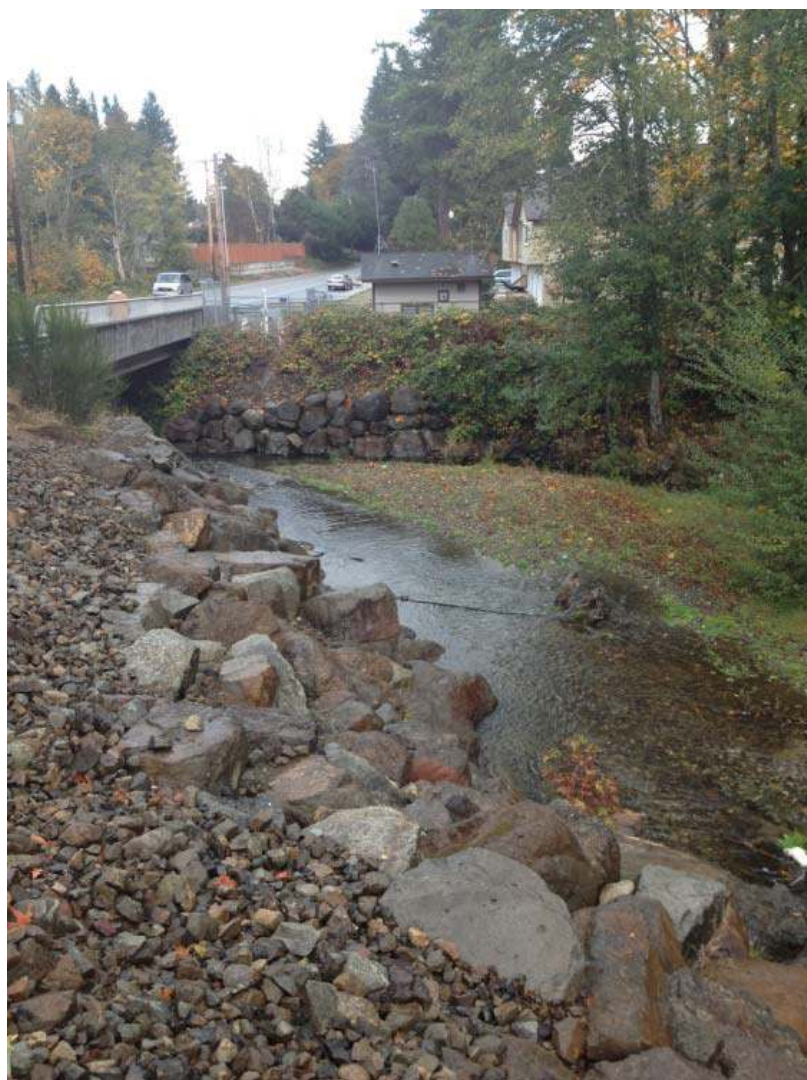
Figure 48. Bridge crossing at Erlands Point Road. View is looking downstream. Photo by Shawn Higgins (NSD), October 23, 2012.

Approach: The action will replace Erlands Point Road bridge with a wider span and reduce floodplain constriction. Fill material composing the existing road embankment would be removed. The property immediately upstream includes residential development on artificial fill that encroaches into the stream corridor and impairs natural processes. The bridge project should be coordinated as part of a more comprehensive project that includes channel and floodplain constraints created by residential development along Shadden Lane NW.

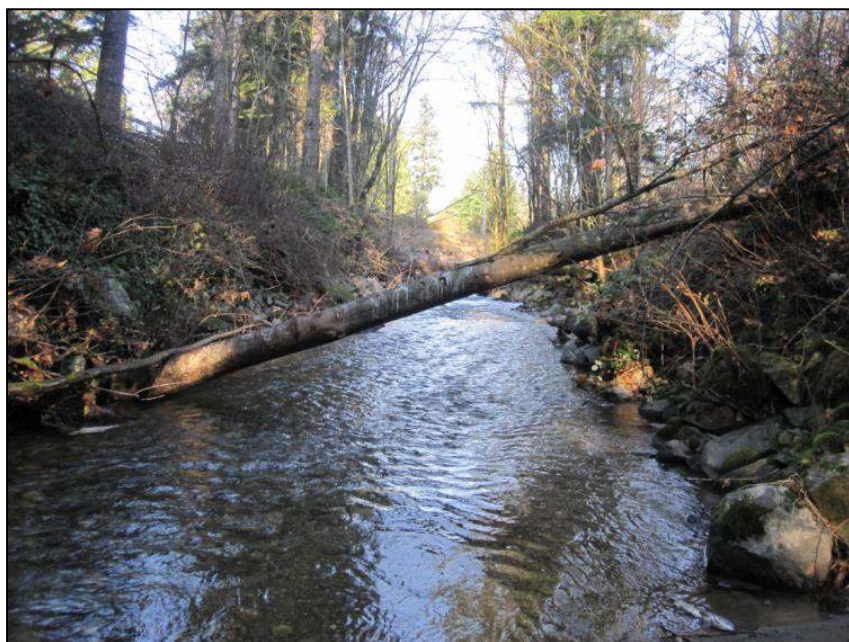
Figure 53. Photo of incised channel conditions, armored banks, and road fill (at left) in Chico Creek upstream of Chico Way NW (view upstream). Photo taken December 2011 by Steve Todd, Suquamish Tribe.

Approach: This action will restore instream habitat conditions and floodplain connectivity with strategic wood placements designed to increase channel complexity and restore natural stream grade control. Limited wood placements to increase channel complexity could be implemented in the short term; however, such an approach would not restore habitat-forming processes. Short term efforts to enhance habitat conditions should focus on localized areas where the channel has eroded into the terrace surface and a small inset floodplain is developing. A more holistic approach to process-based restoration will require substantial volumes of wood to reverse the effects of past incision and restore floodplain connectivity. Multiple houses are located within the stream corridor along the left bank and pose constraints to restoration of reach-scale processes through this segment. Restoration of riparian processes will require removal of bank armor and revegetation of the riparian forest. The long term approach to restoration of the stream corridor through this segment will require coordination with willing landowners in negotiating conservation easements and/or acquisition of 12-15 properties between Chico Way NW and Northlake Way NW. Land acquisition will be complicated by the need to coordinate with numerous landowners. Acquisition of key parcels to facilitate restoration is estimated at approximately \$1.5 M based on 2012 tax records.

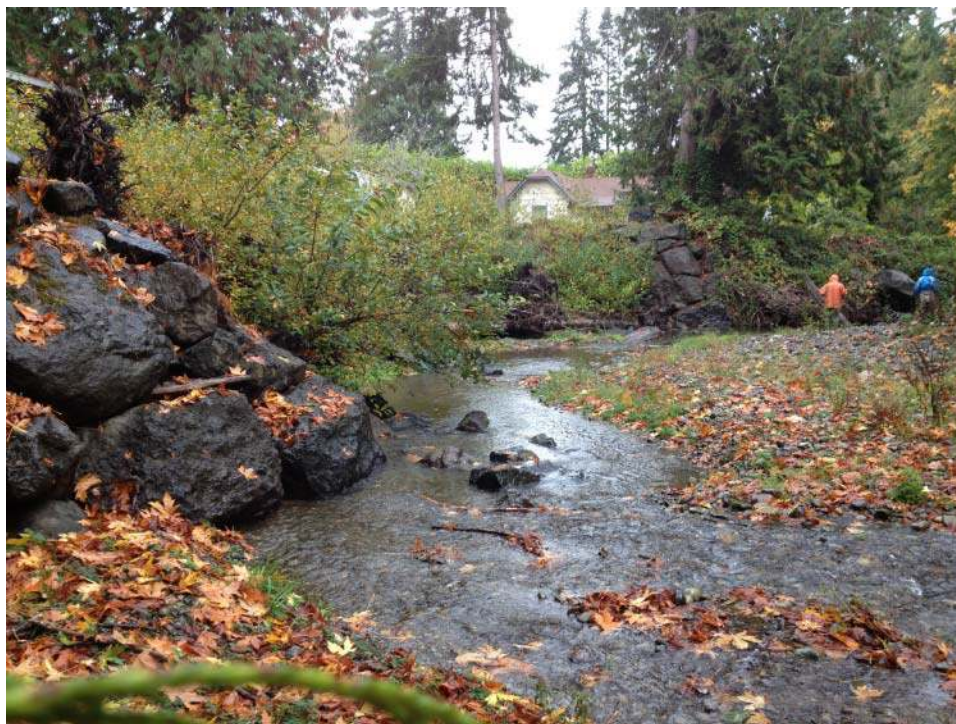
Figure 54. Photo of incised channel and riprap bank protection along the left bank downstream of Northlake Way. Photo taken in Oct. 2012 by Shawn Higgins (NSD).

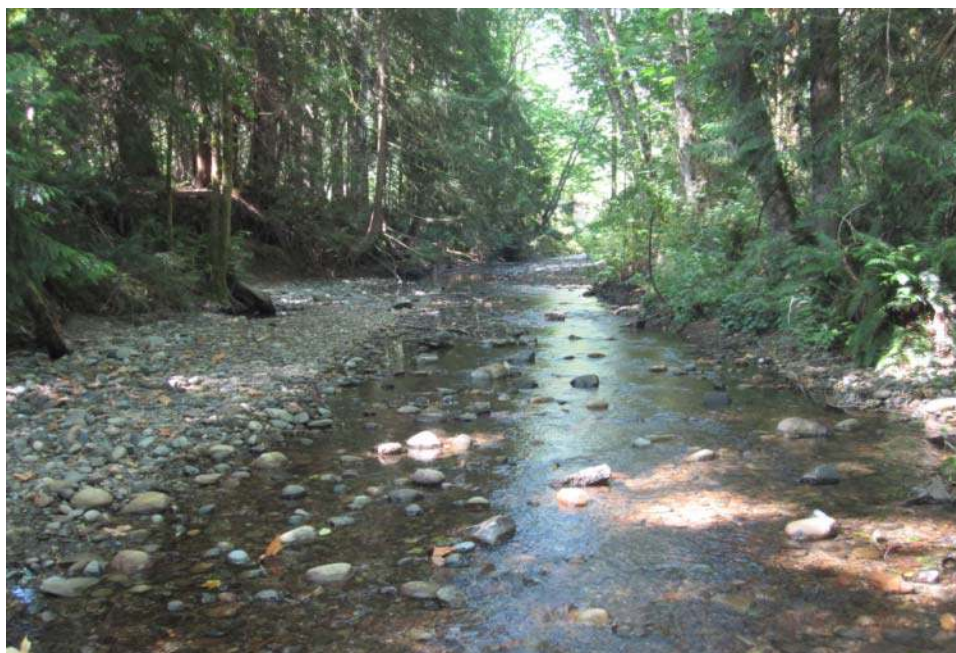
Figure 56. Photo of channel and riparian conditions in Chico Creek between Taylor Road NW and the Navy RR Trestle (view upstream). Photo taken August 2012 by Steve Todd, Suquamish Tribe.

Approach: This action will aim to restore floodplain connectivity, riparian processes, and instream habitat conditions. The primary mechanism for past channel incision has been removal of instream roughness due to loss of instream wood and impairment to riparian processes. Restoration actions should focus on restoring the riparian forest conditions and include targeted wood placements to increase channel complexity and restore natural stream grade. Properties within the stream corridor should be dedicated to maintenance and provision of habitat-forming processes. Landowner negotiations should consider opportunities to establish conservation easements and/or land acquisition to facilitate restoration in the stream corridor. Key parcels intersecting the preliminary corridor boundary in this segment include 10 parcels totaling 6.5 acres (5 along David Road and 5 along Taylor Road) with an assessed value of \$1.6 M per 2012 tax records. Additional negotiation should focus on opportunities to provide alternative access to property on the north side of the creek and removing the existing driveway crossing. The property along the south side of the channel (right bank) includes low-lying areas on the south side of David Road that could provide opportunities for floodplain connectivity and off-channel habitat.

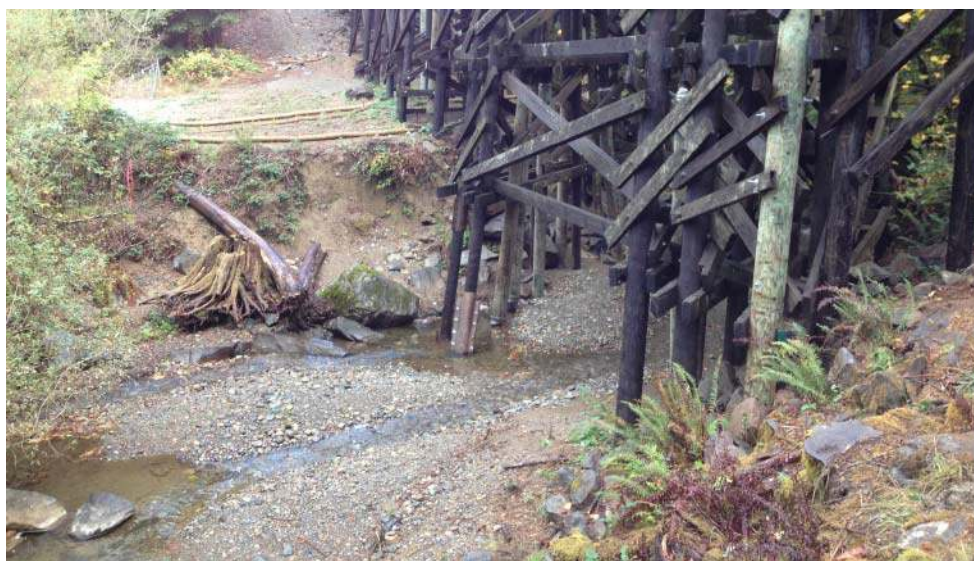
Figure 57. U.S. Navy RR trestle crossing at Chico Creek.

Approach: The trestle should be replaced with a longer span that accommodates channel migration and establishment of a wider stream corridor through this incised channel segment.

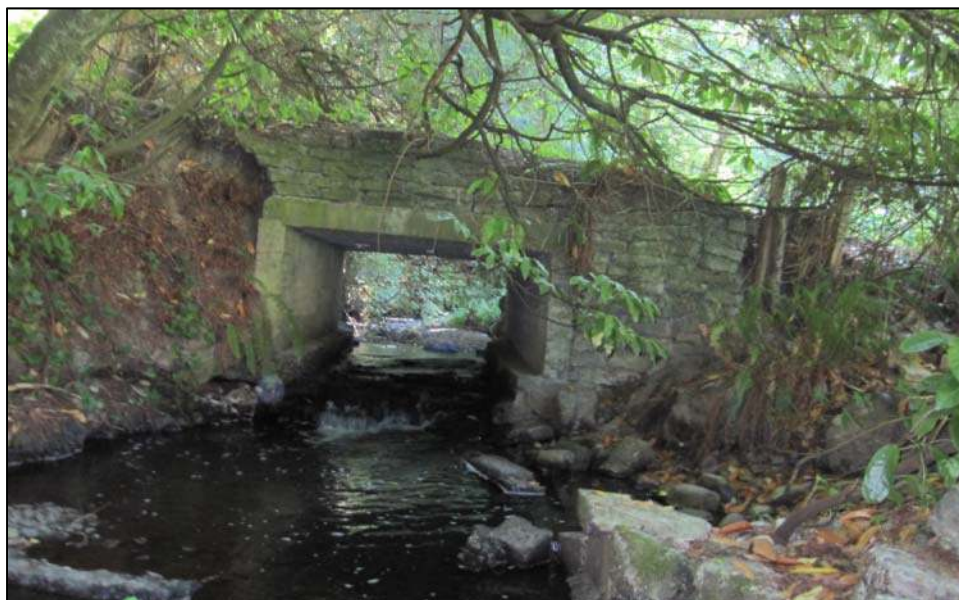
Figure 58. Photo of partial barrier to fish passage in Kitsap Creek at RS 2400 (view upstream). Photo taken August 2012 by Steve Todd, Suquamish Tribe.

Approach: Replace the crossing with a wider culvert or bridge span, or remove road crossing from the floodplain.

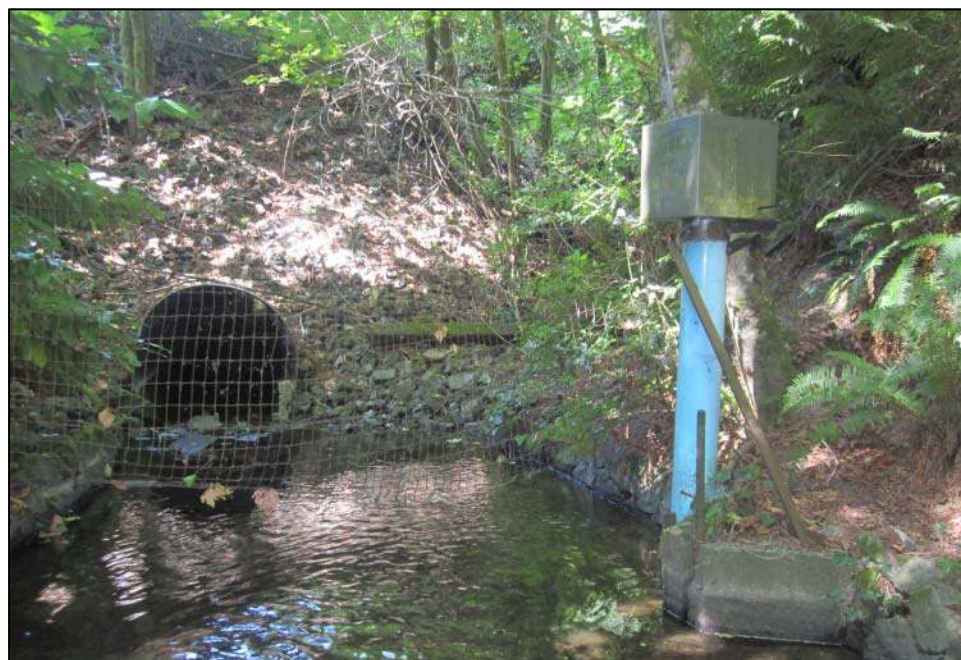
Figure 59. Photo of partial barrier to fish passage in Kitsap Creek at Northlake Way NW (view downstream). Photo taken August 2012 by Steve Todd, Suquamish Tribe.

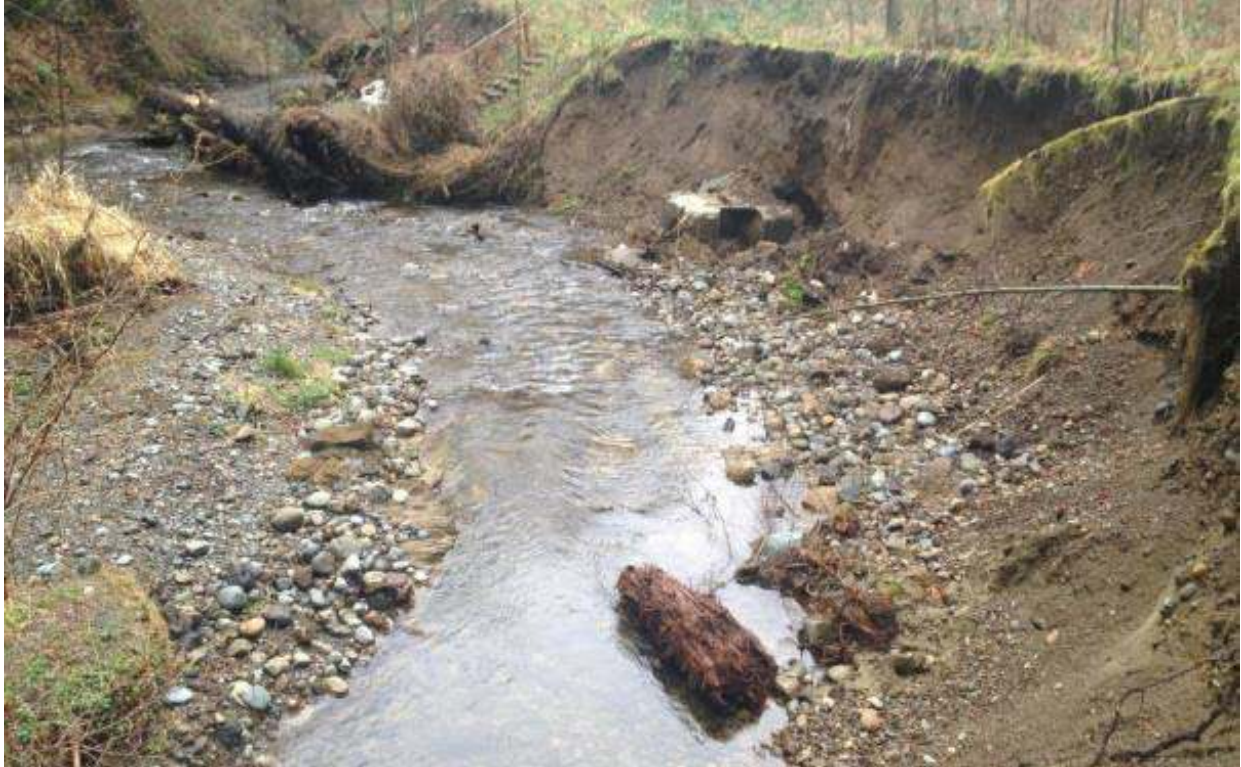
Figure 61. Photo of incised channel segment on Dickerson Creek downstream of failed log weirs (view downstream). Note box at toe of right bank is exposed septic basin. Photo by Tim Abbe, NSD (2/12/2013).

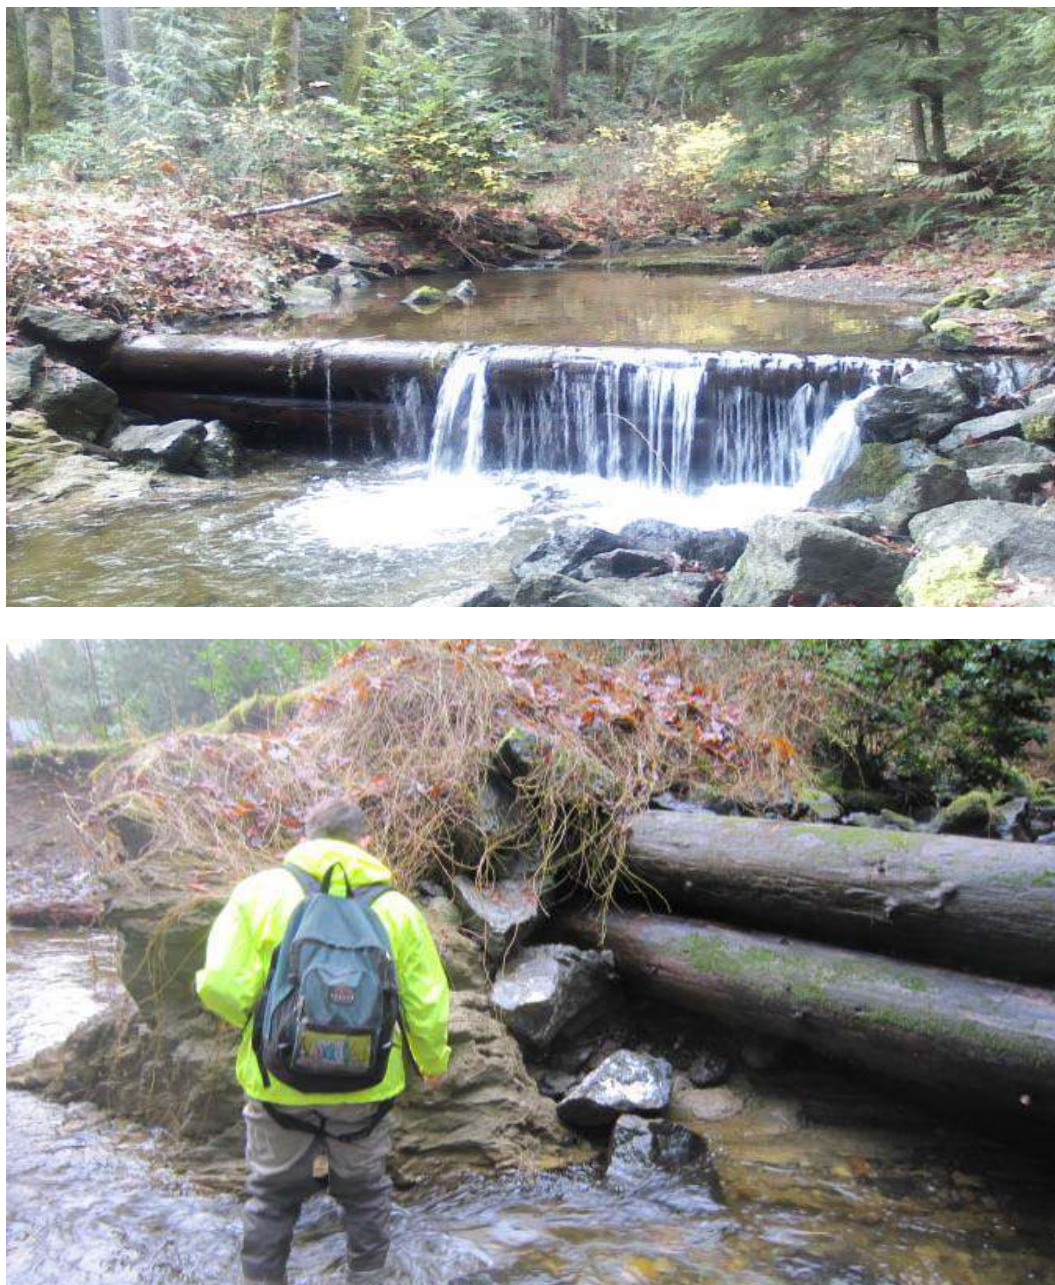
Figure 62. Photos of log weirs on Dickerson Creek downstream of Navy railroad in 2007 (Upper; photo by Jon Oleyar, Suquamish Tribe) and in February 2013 (Lower; photo by Paul Dorn, Suquamish Tribe). Note erosion around failing weir in 2013.

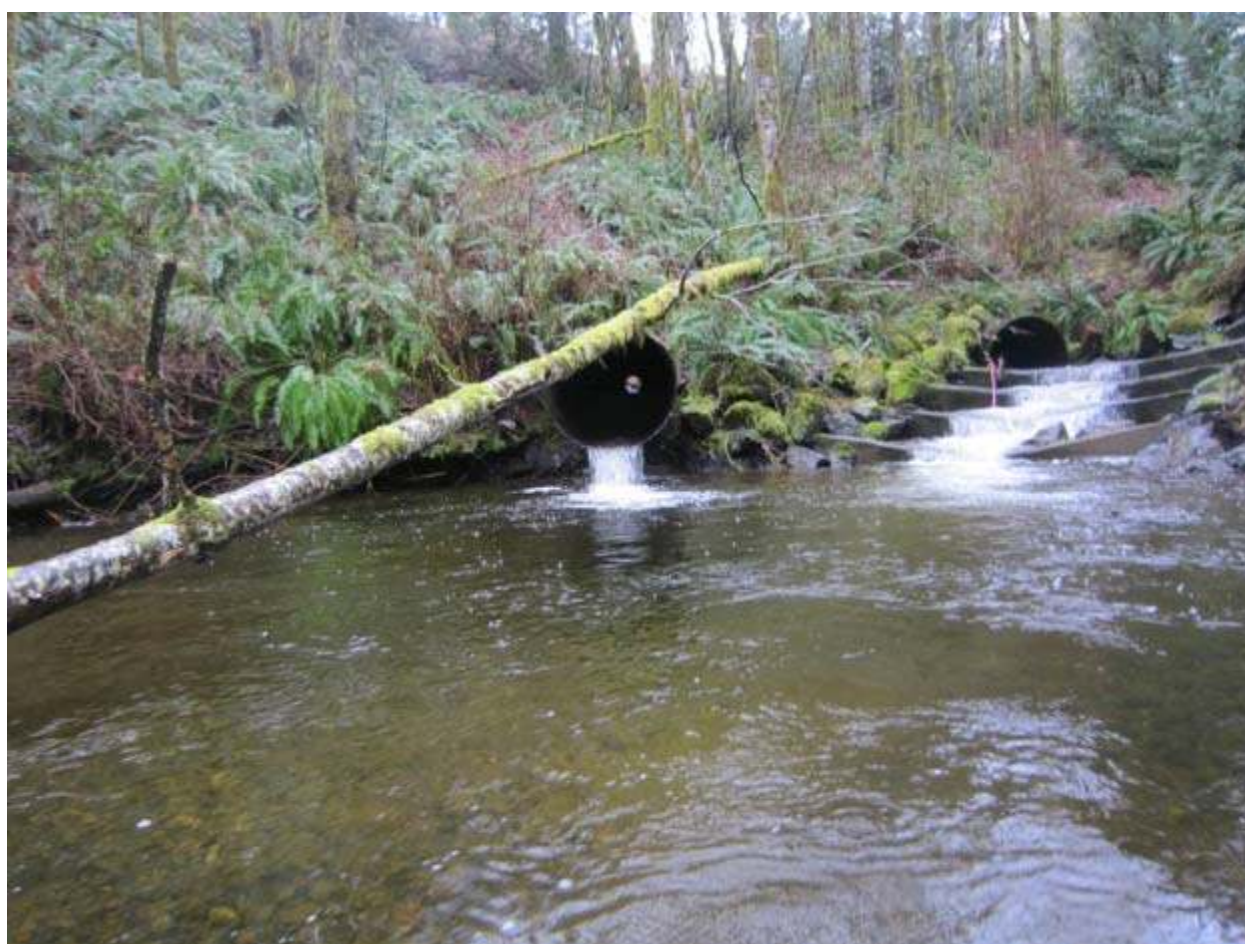
Figure 63. Photo of Dickerson Creek at the Navy railroad culverts. View upstream; February 2013 (photo by Paul Dorn, Suquamish Tribe).
