# Flood Erosion Hazard Mitigation Evaluation

## Upper Sandy River

Clackamas County, Oregon

March 24, 2015

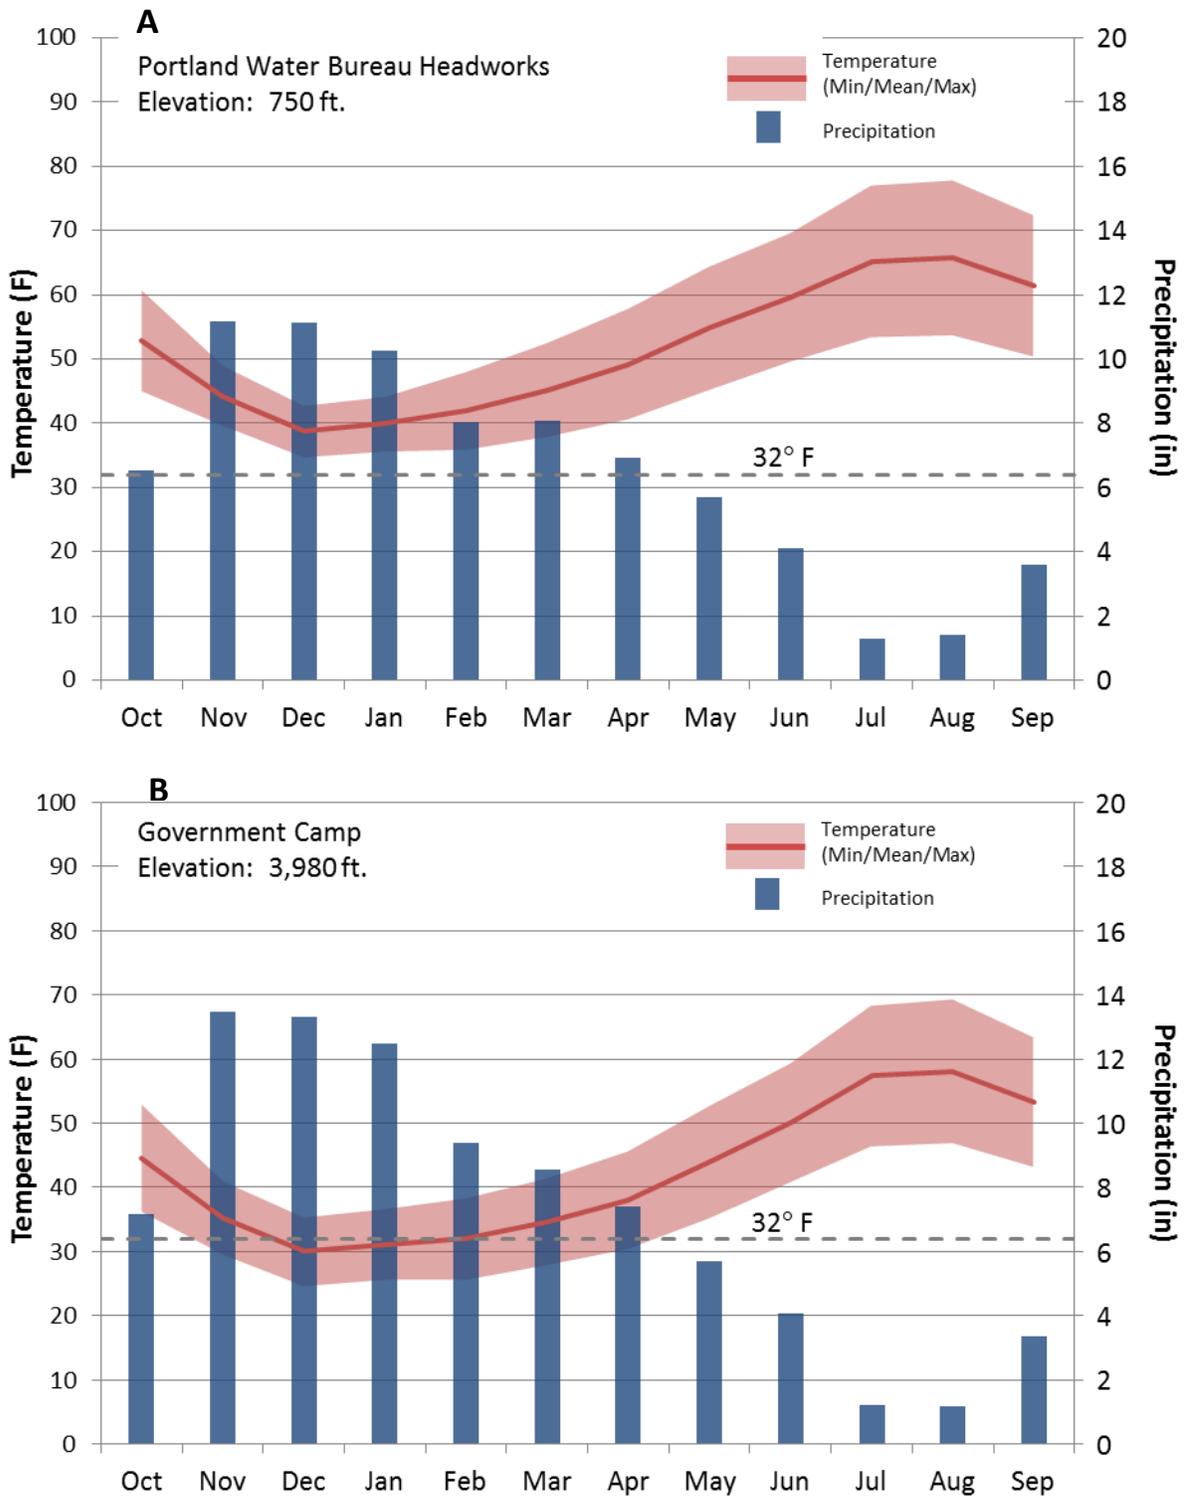
**Figure 4A/B. Monthly average temperature and precipitation at the Portland Water Bureau’s Headworks site (elev. 750 feet) and Government Camp (elev. 3,980 feet). Data source: NCDC climatic normals (1981-2010).**

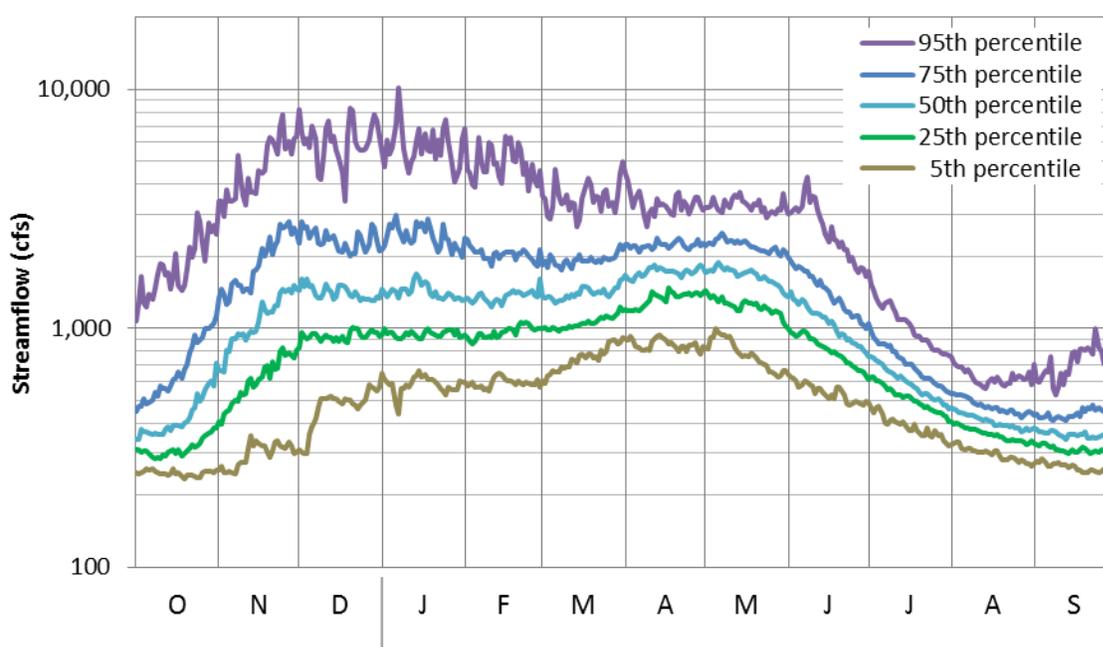
**Figure 5. Daily streamflow statistics for the USGS gaging station at Marmot (#14137000); WY 1912-2013.**

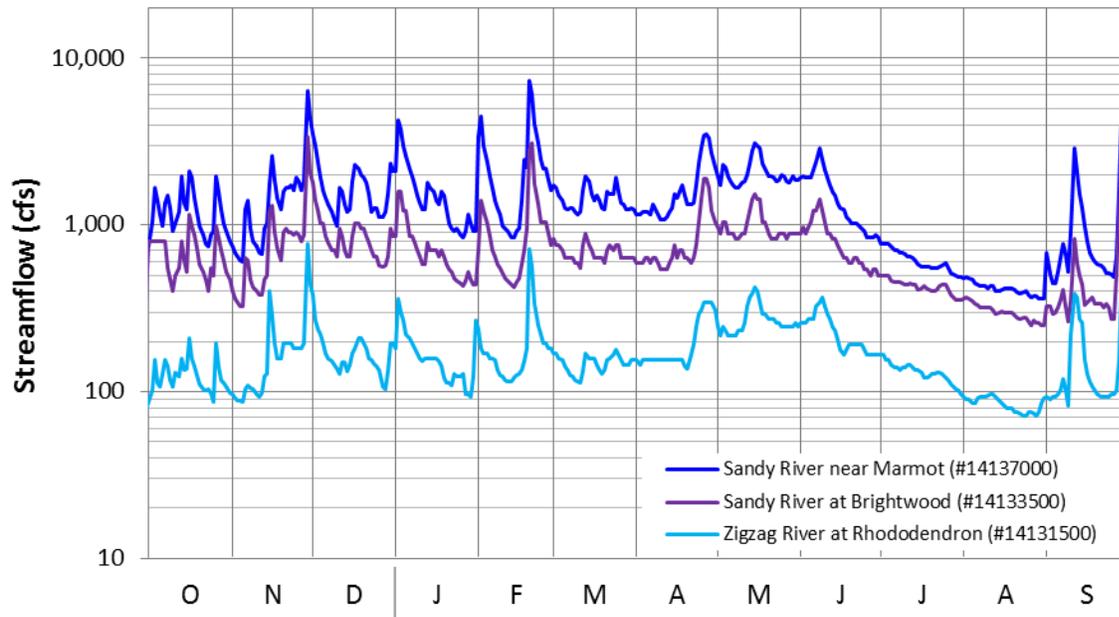
**Figure 6. Comparison of three concurrent hydrographs in the Sandy River Watershed for WY 1927. The contributing drainage area is 31 mi<sup>2</sup> for the Zigzag River at Rhododendron (#14131500), increases to 117 mi<sup>2</sup> for the Sandy River above the Salmon River confluence at Brightwood (#14133500), and to 264 mi<sup>2</sup> above the Sandy River at Marmot (#14137000).**

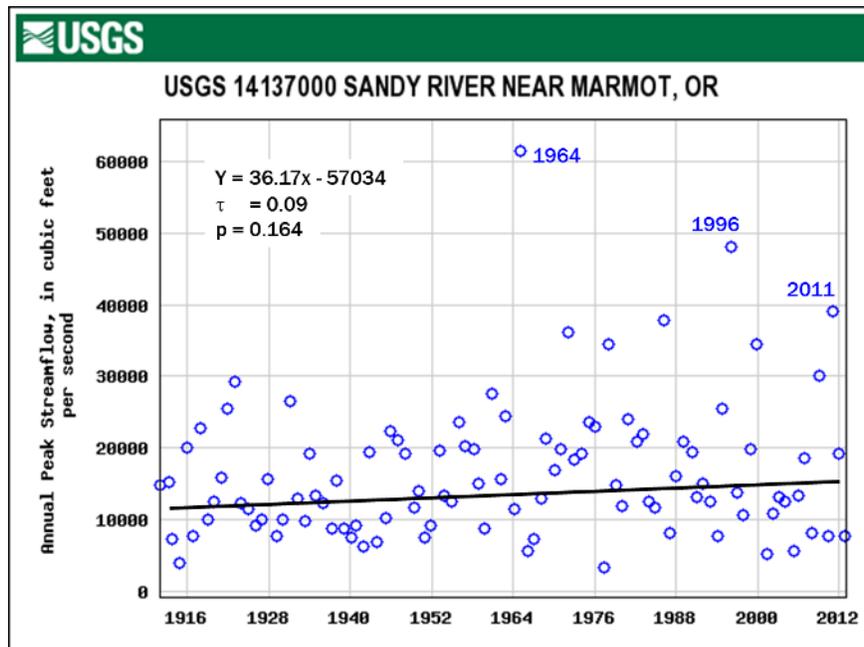
Figure 7A. Annual maximum time series for peak streamflow in the Sandy River at Marmot (WY 1912-2013). The trend line shows an increase in peak flow over the historical period; however the trend is not statistically significant at a 90% ( $p < 0.1$ ) confidence level.

Streamflow trends in the Sandy River display historical changes in response to the observed 20th century warming. Jefferson (2011) evaluated the sensitivity of 29 watersheds to recent warming in the Pacific Northwest, including the Sandy River at Marmot. This study noted a statistically significant increase in winter flows, with a concurrent decreasing trend in spring streamflow. NSD analyzed streamflow trends with the Mann-Kendall test; a non-parametric statistical measure of the strength of the relationship between two selected variables. Kendall's rank correlation coefficient ( $\tau$ ) is well suited to this application because it is not sensitive to the effect of skewness, or extreme values, which are typical of hydrological data (Helsel and Hirsch, 2002). Values of  $\tau$  range between -1 and +1, where the negative or positive sign of  $\tau$  indicates the direction of the observed trend. When no trend exists, the expected value of  $\tau$  is zero. The observed trend for peak flow at Marmot has a  $\tau$  value of 0.07 indicating a slight increasing trend; however the observed trend is not statistically significant at a 90% confidence level (Figure 7A).

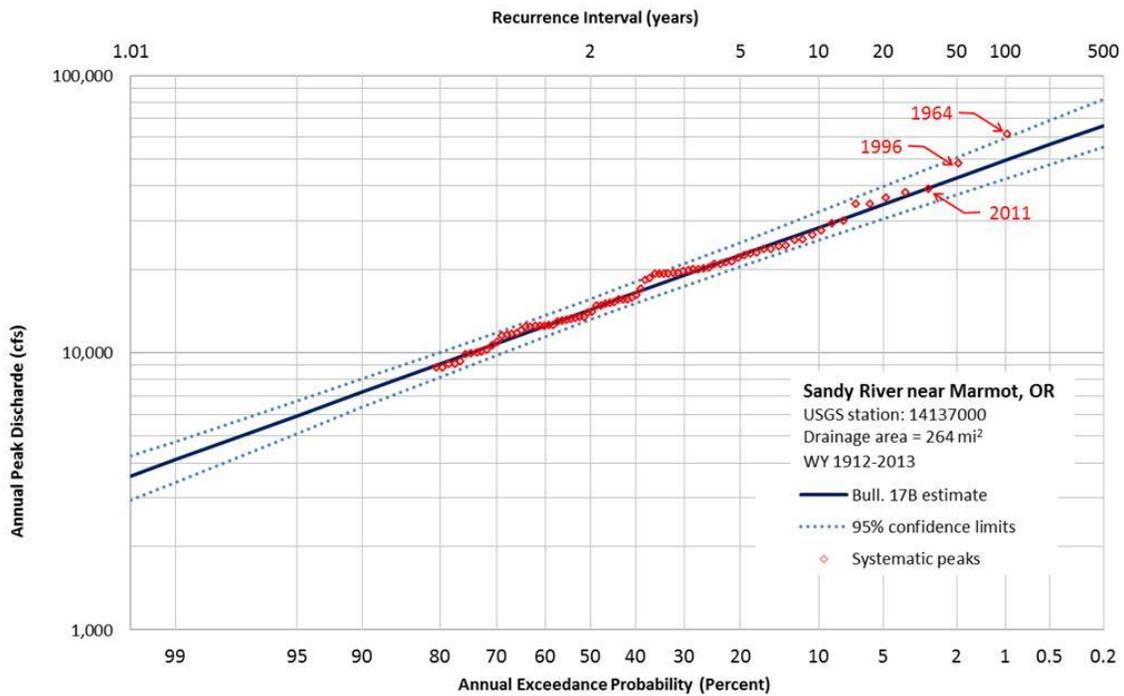
Figure 7B. Flood frequency plot for Sandy River. To determine a flood of a particular recurrence year interval, T, take the reciprocal of the annual exceedance probability (AEP). For example if AEP = 0.01 (1%), then  $T = 1/.01 = 100$ , so an AEP of 1% corresponds to a 100 year flood (1964 flood). An AEP of 2 (1996 flood) corresponds to a 50 year flood. The 2011 flood was about a 30 year flood.

The Christmas Flood of December 1964 was the largest flood recorded in the historical period (~250 yr flood, Figure 7B) and caused widespread damage to property and infrastructure in the Sandy River Watershed. The event began with a blast of cold arctic air from British Columbia interacting with a maritime air mass moving in from the Pacific resulting in new snowfall over the watershed including 10 inches of snow in the valley at Brightwood and 18 inches of snow at Government Camp. Temperatures began to rise on December 19th and 20th and snow turned to rain. The weather station at Government Camp (elevation 3,980 feet) reported a daily high temperature of 48° F at on December 22nd. Following 9 inches of rain over two days, the formerly 55 inch deep snowpack at Government Camp, was reduced to only 6 inches in three days (from December 20th - 23rd). Observations of frozen ground suggest that infiltration would have been limited, and likely increased runoff. Snowmelt totaling 4 inches of water equivalent, enhanced the rainfall runoff to produce a total of 13 inches of runoff. Snow pillow measurements from an elevation of 5,500 feet showed that slopes at higher elevation with deeper snowpacks were more effective at absorbing the initial rainfall and yielded less than 5 inches of total runoff despite receiving over 9 inches of precipitation (Waananen et al., 1971). Streamflow in the Sandy River began to rise rapidly on December 21st and reached a peak discharge of 61,400 cfs on the afternoon of December 22nd. This magnitude has an estimated recurrence interval of greater than 200 years and is more than double the previous flood of record in 1923, 55 years prior to the Christmas Flood. During this flood, large quantities of sediment were mobilized and transported; however, no sediment data are available.

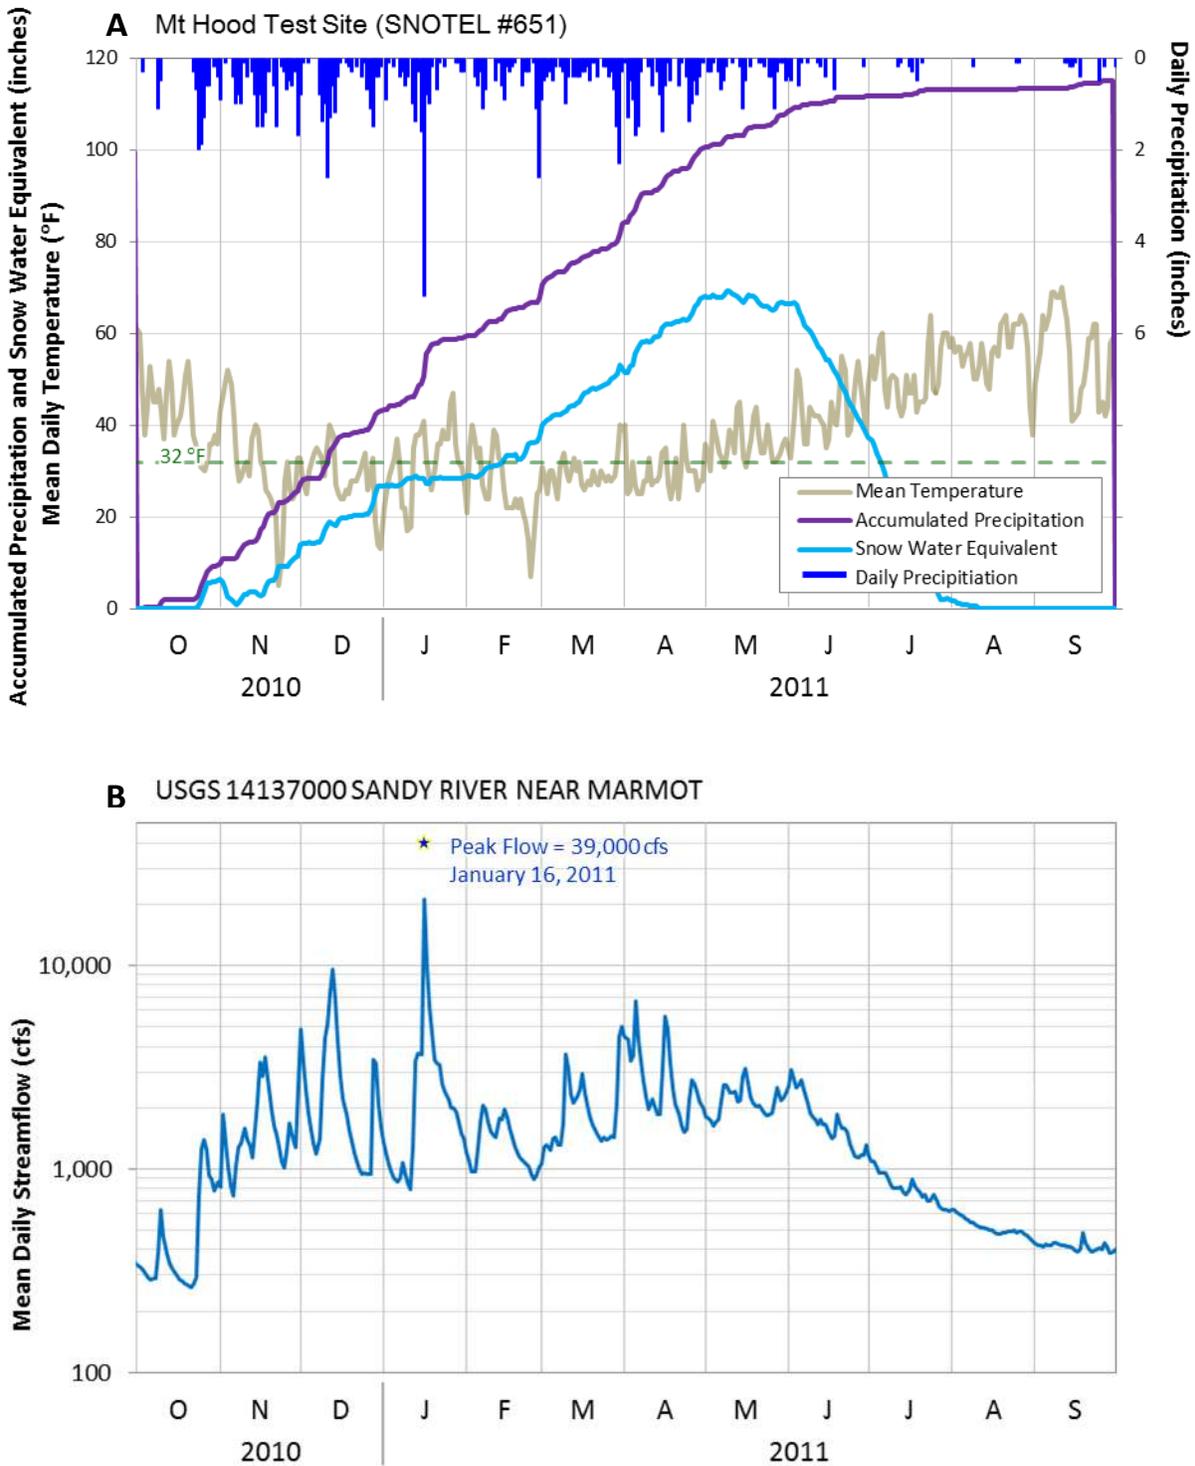
Figure 8A/B. Annual time series of temperature, precipitation, snow water equivalent and streamflow for WY 2011. Temperature and precipitation data from Mt. Hood Test Site (SNOTEL; elevation 5,370 ft). Streamflow data from USGS gaging station #14137000 on the Sandy River near Marmot.

The most recent flood event to cause widespread damage on the Sandy River occurred in January 2011. The two day precipitation total at Government Camp was 6 inches on January 16. The maximum temperature reached 44 degrees F at both Government Camp and the Mt. Hood Test Site SNOTEL station despite the nearly 1,400 foot rise in elevation. The snowpack at Government Camp was 34 inches on January 12 and reduced to 19 inches following 2.5 inches of rain on January 13-14, then further reduced to 12 inches following heavy rainfall on the 16th. At the Mt. Hood Test Site SNOTEL station, 7 inches of precipitation fell in the two day period on January 15th and 16th, the snowpack compressed from 78 inches to 70 inches (net change of -8 inches) and the snow water equivalent remained nearly constant resulting in 7 inches of runoff (Figure 8a,b).

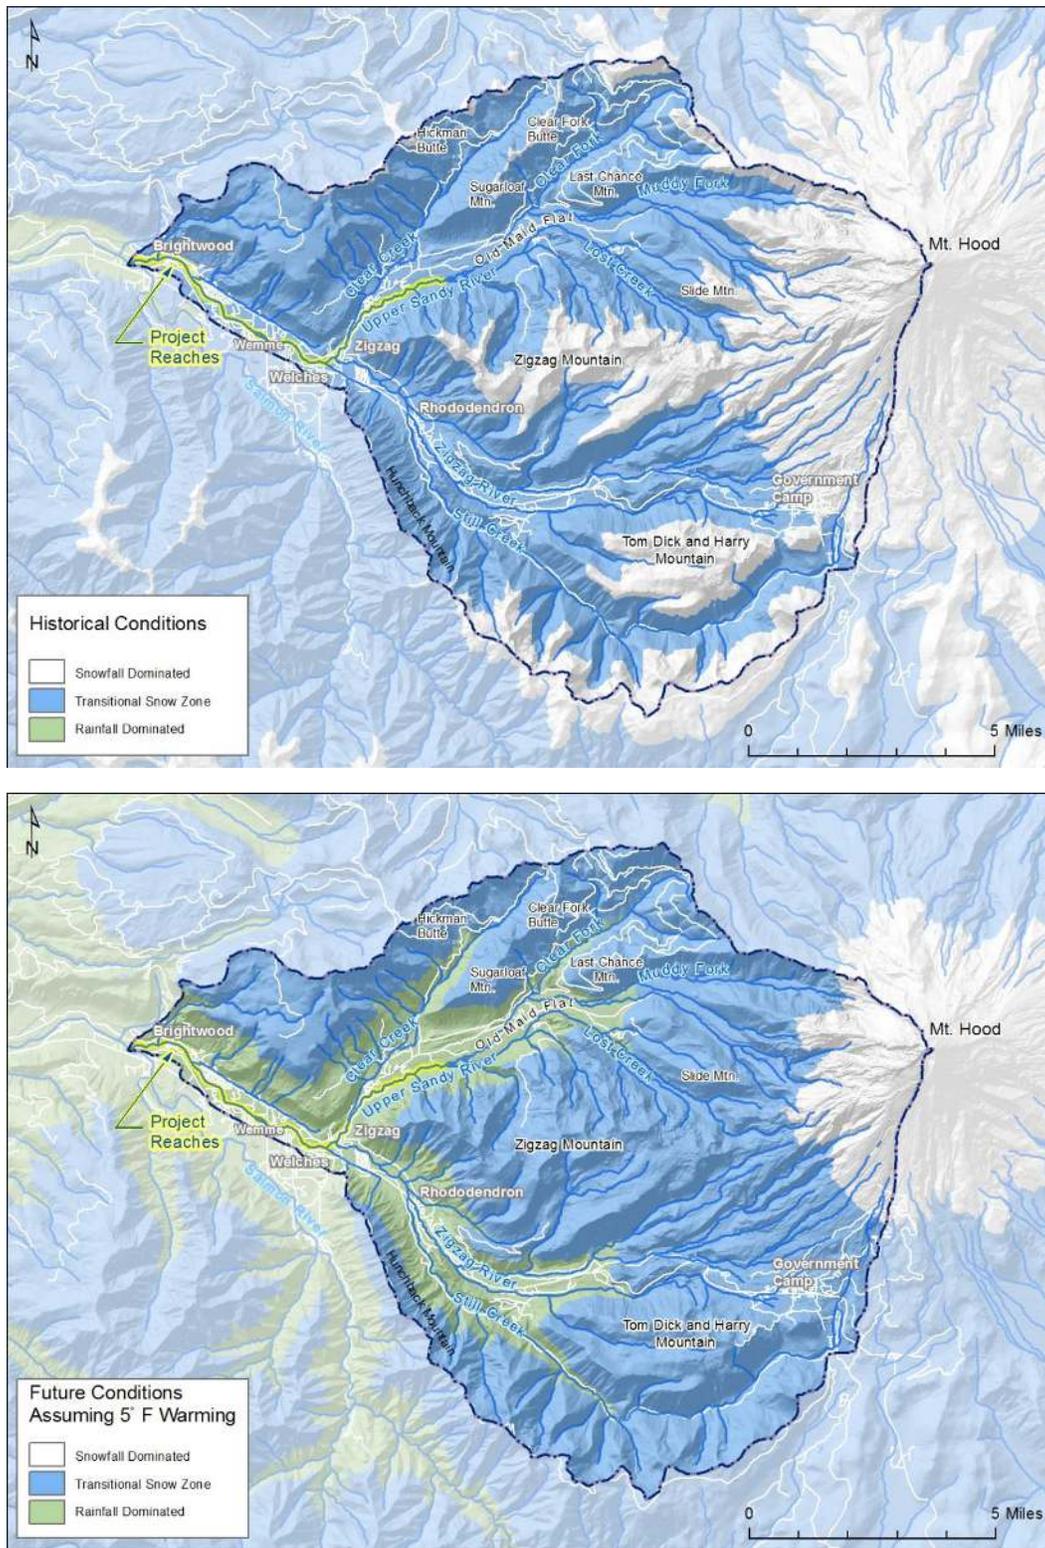
Figure 9. Map of hydrologic zones in the Upper Sandy River Watershed based on the dominant form of winter precipitation and the projected change in elevation thresholds by the end of the 21st century under the A1B emissions scenario.

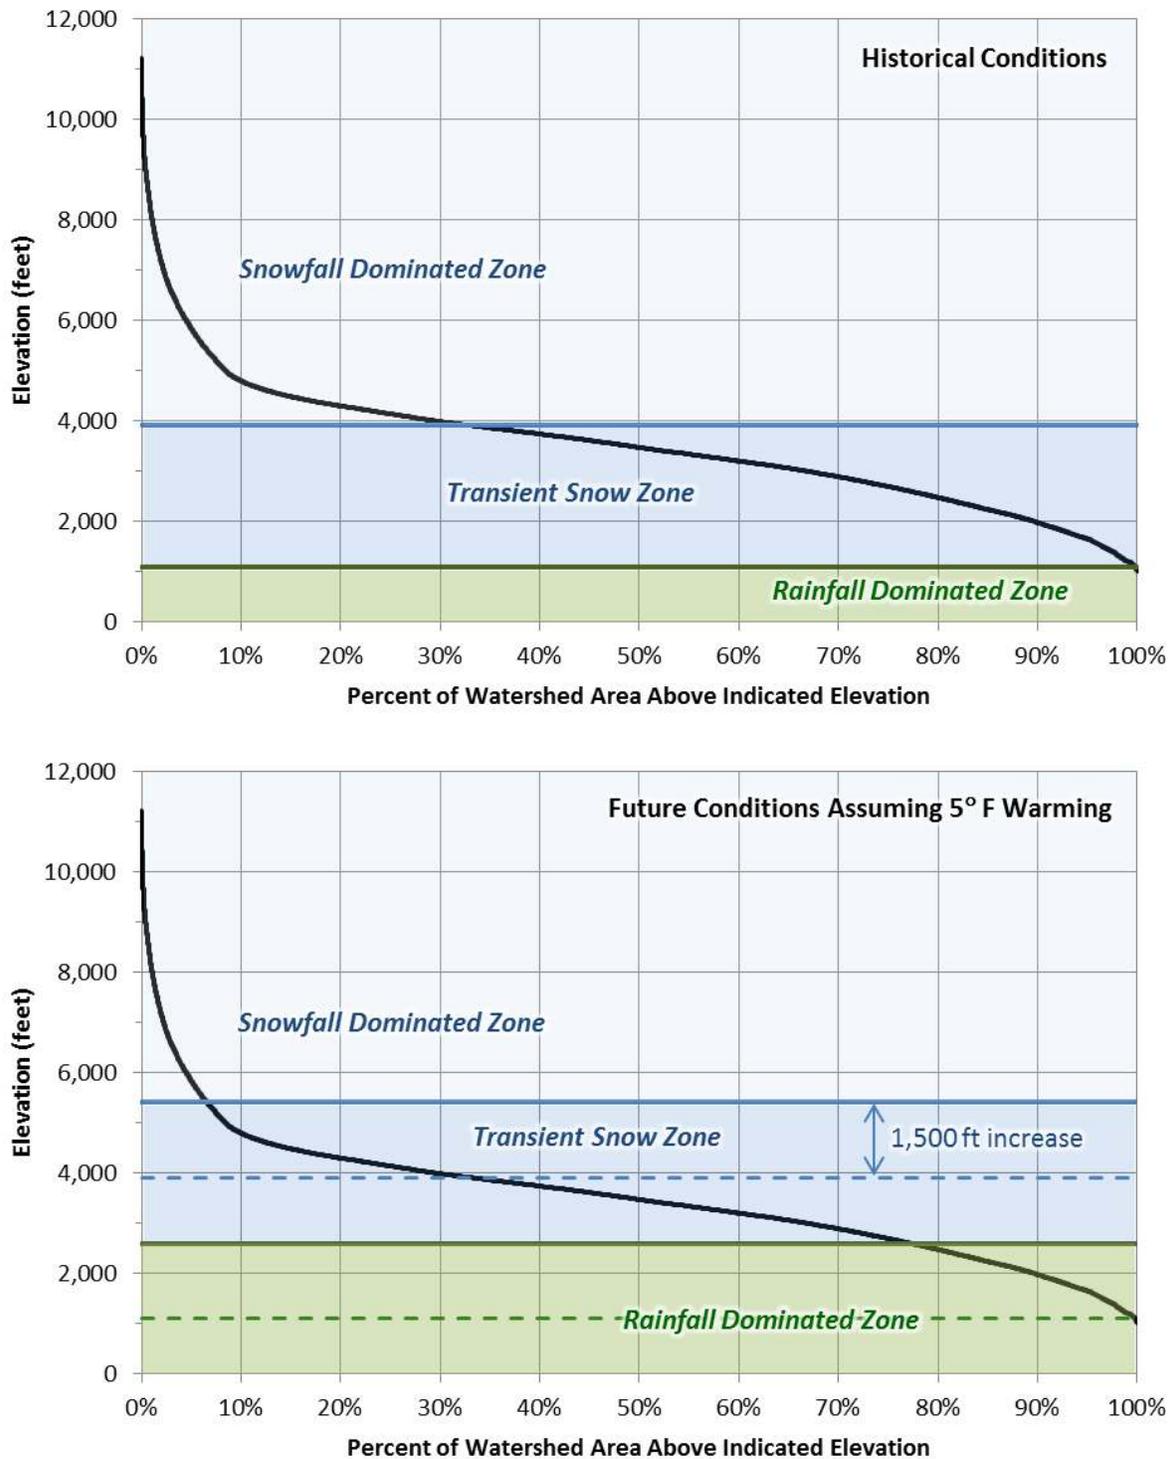
Figure 10. Hypsometric curve showing the range of elevations in the Upper Sandy River Watershed. Elevation thresholds delineate the relative land areas in hydrologic zones characterized by dominant winter precipitation and the projected increase in the contributing watershed area for rainfall, and rain-on-snow, generated floods under future conditions assuming a 5° F increase in temperature.

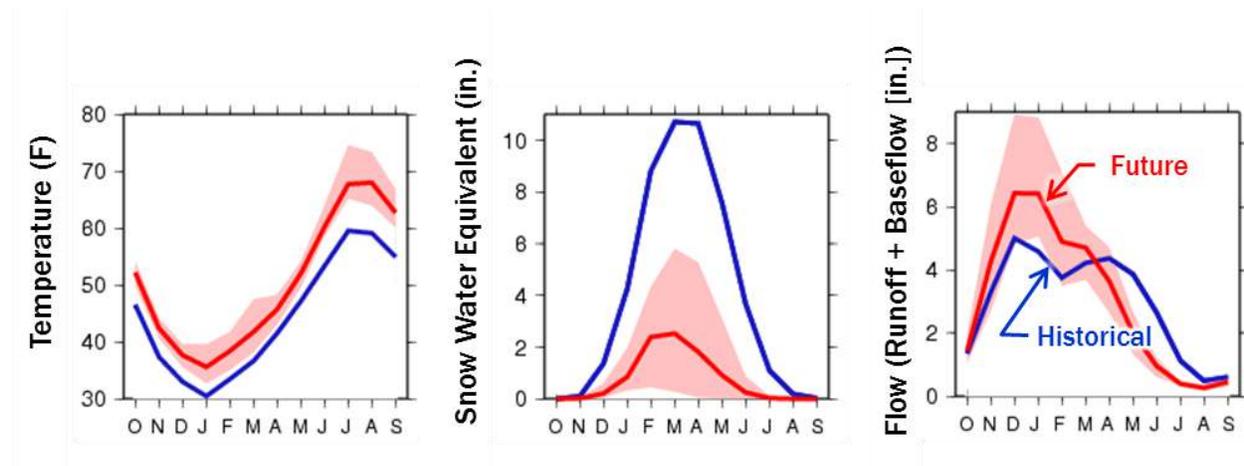
**Figure 11. Simulated changes in temperature (left), snowpack (center), and runoff (right) for the Sandy River Watershed. The blue line shows the historical average and the red line shows the ensemble average from 10 climate models. The pink shading shows the range of estimated future conditions derived from the 10 climate models. Figures were downloaded from the Columbia Basin Climate Change Scenarios Project website at <http://warm.atmos.washington.edu/2860/>.**

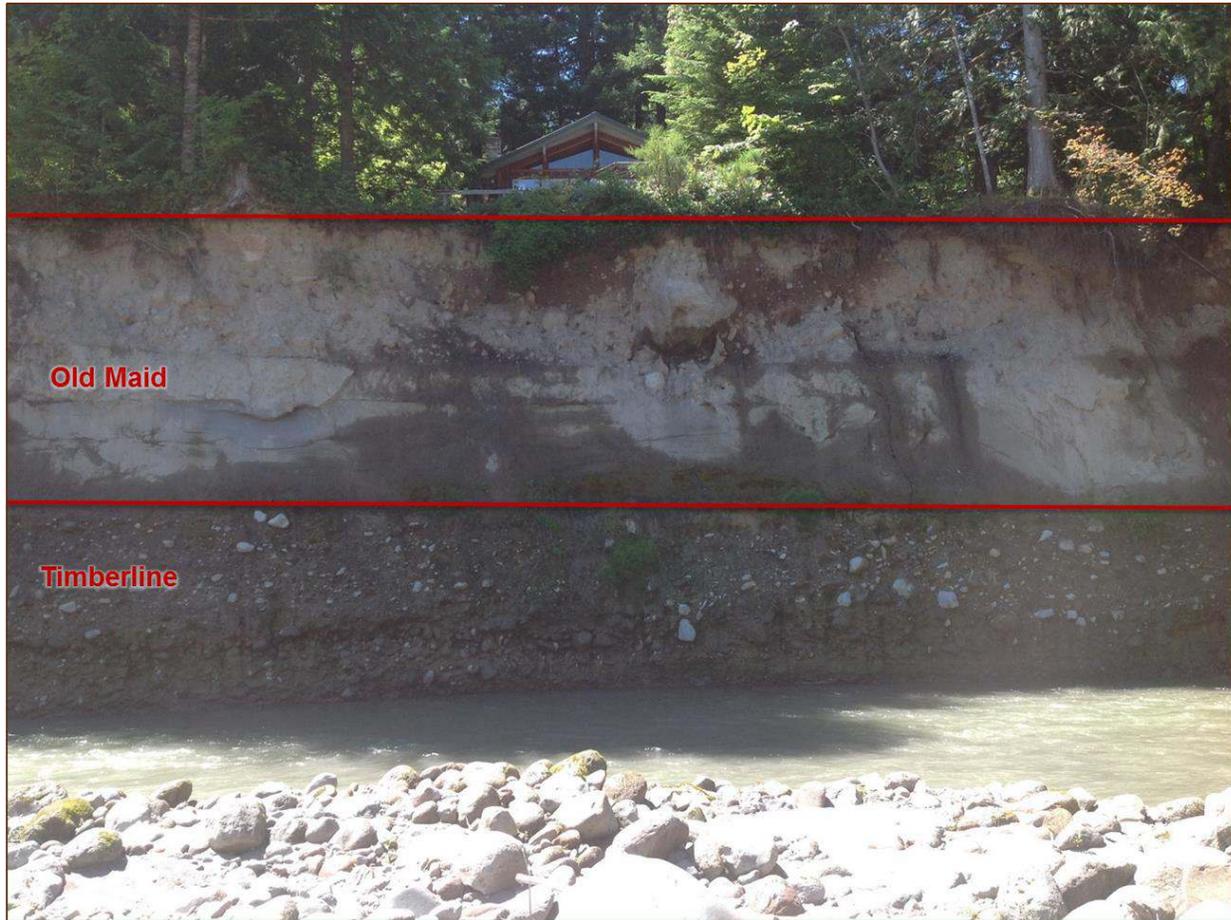
**Figure 12. Old Maid and Timberline Lahar Deposits. The cut bank is located on the left bank downstream of the Zigzag confluence at RM 42.3. This site is one of only a few where the river has exposed and is currently eroding the Timberline lahar deposit. As the Timberline erodes, the Old Maid lahar is undermined and fails.**

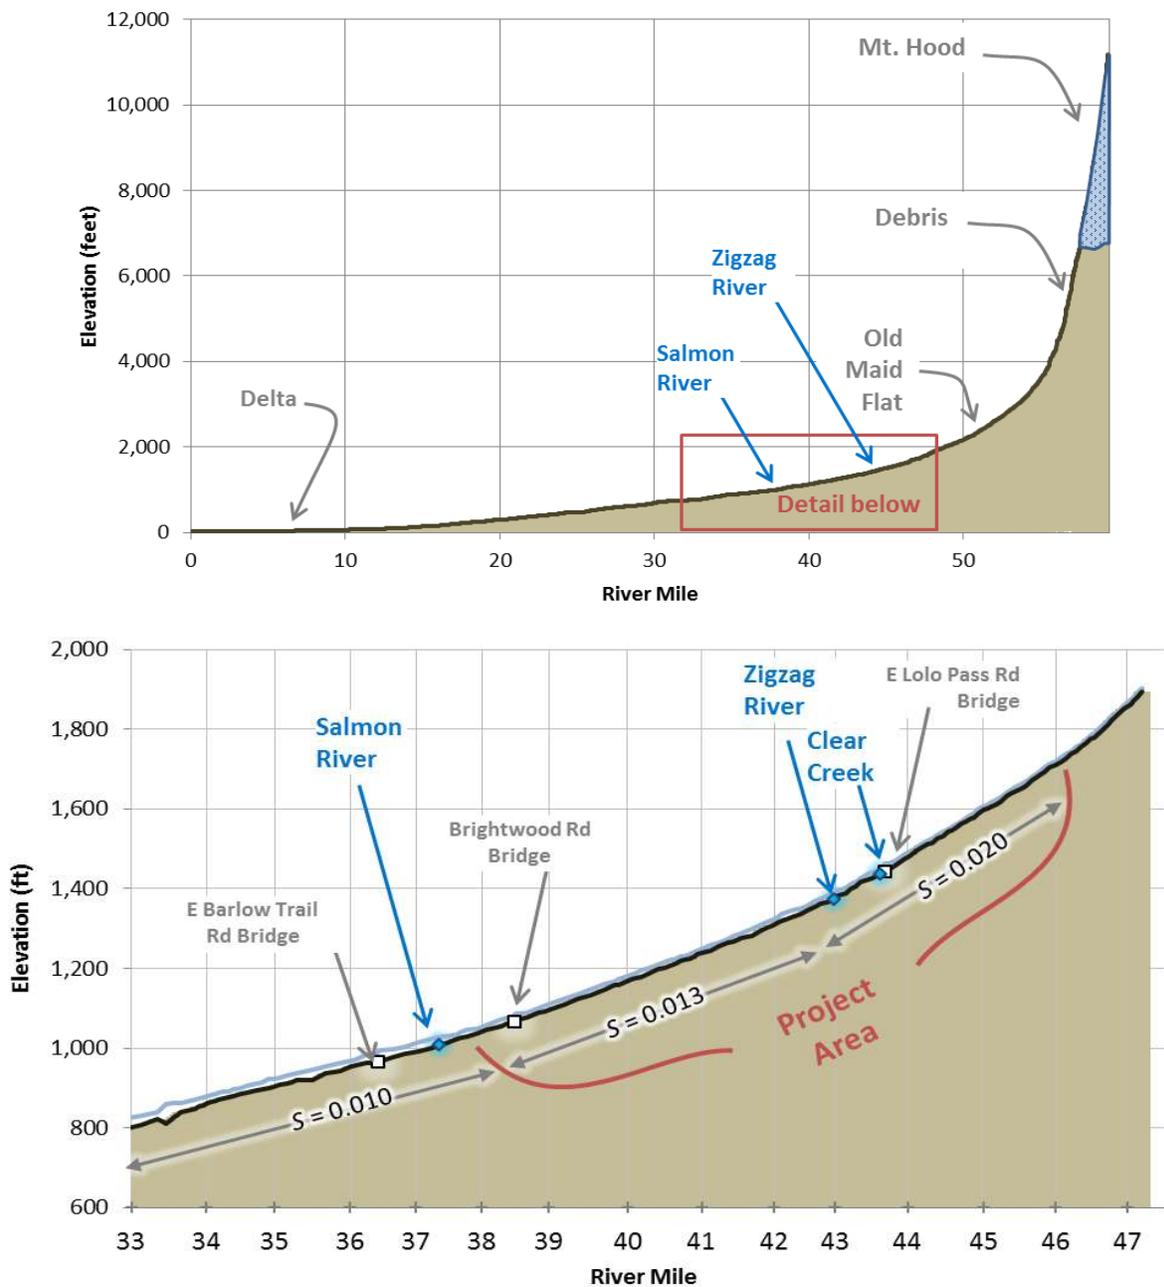
**Figure 13. Valley Profile - The project area is situated roughly 10 miles from the Sandy River source area on Mt Hood. Average valley gradients through the project area range from 2 percent above the Zigzag River to 1 percent. at the Salmon River confluence.**

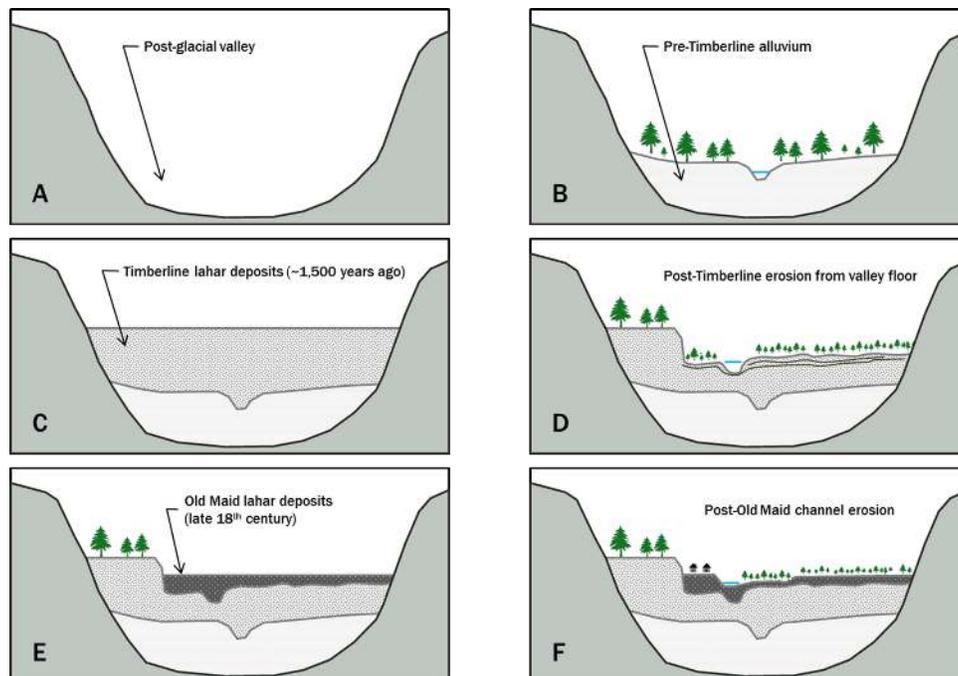
**Figure 15. Watershed Scale Valley Responses to Lahars - The effects of Timberline and Old Maid lahars on the Upper Sandy River valley begin with sketch C, which depicts how the mudflow buried the valley floor to depths up to 100 feet. Over the course of next 1,500 years, the river channel cut downward and widened the floodplain, creating terraces composed of Timberline lahar (D). The Old Maid lahar buried the active channel and floodplain, but not the high Timberline terraces about 200 years ago, forcing the process of incision and channel/floodplain widening to start over again.**

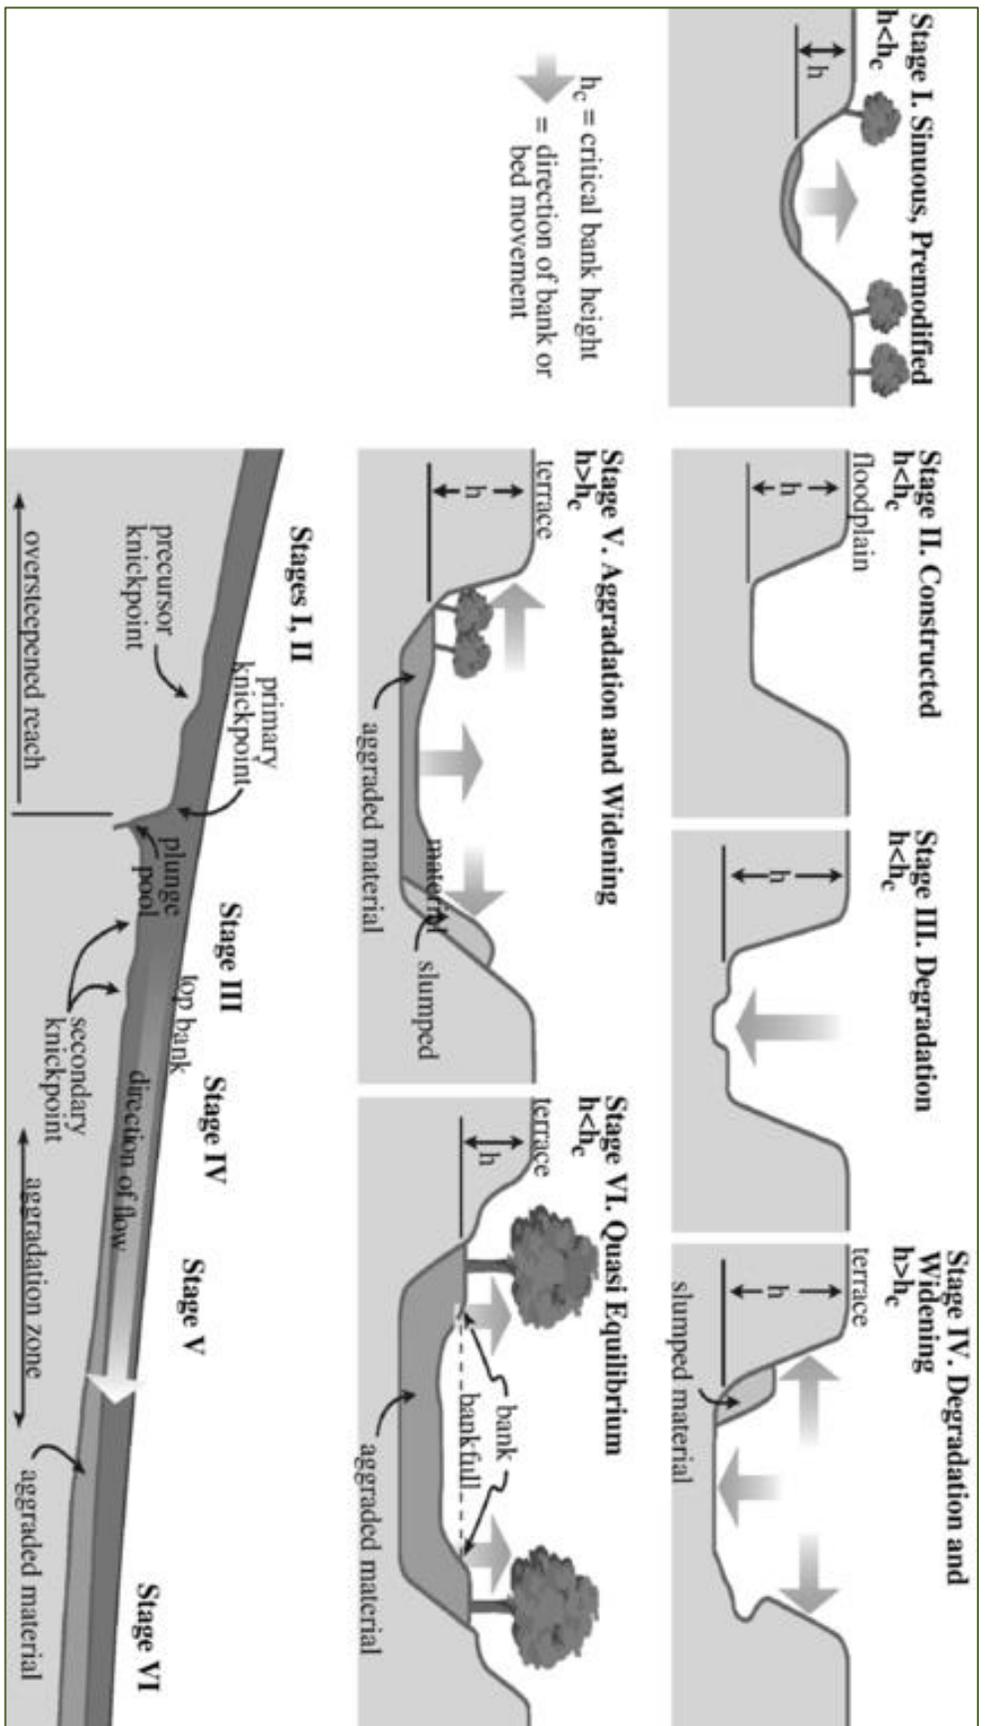
Figure 17. General sequence of stages associated with channel incision (from Simon and Rinaldi 2006).

Channel form has evolved in response to changes in local/reach scale valley gradients and the amount of loose sediment the stream has to work through. Changes in channel dimensions and function generally follow the succession of evolutionary phases shown on Figure 17.

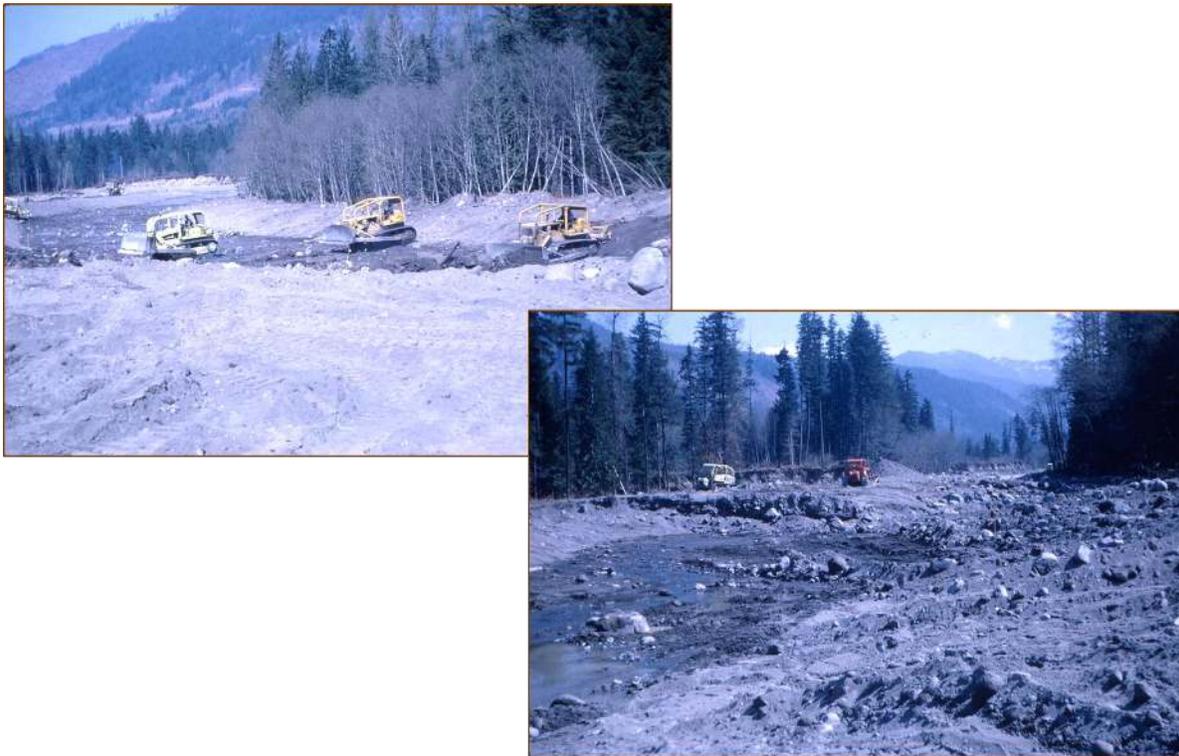
**Figure 19. Army Corps of Engineers Bull Dozers Re-Grading the 1964 Channel. Following the 1964 flood the ACOE mechanically graded over the active channel to recover the pre-'64 single stem channel. The re-grading straightened and shortened the 1964 channel, increasing the channel gradient in the process. Note the large proportion of fine grained materials comprising the flood deposits. Photos courtesy of Raymond Arrigotti.**

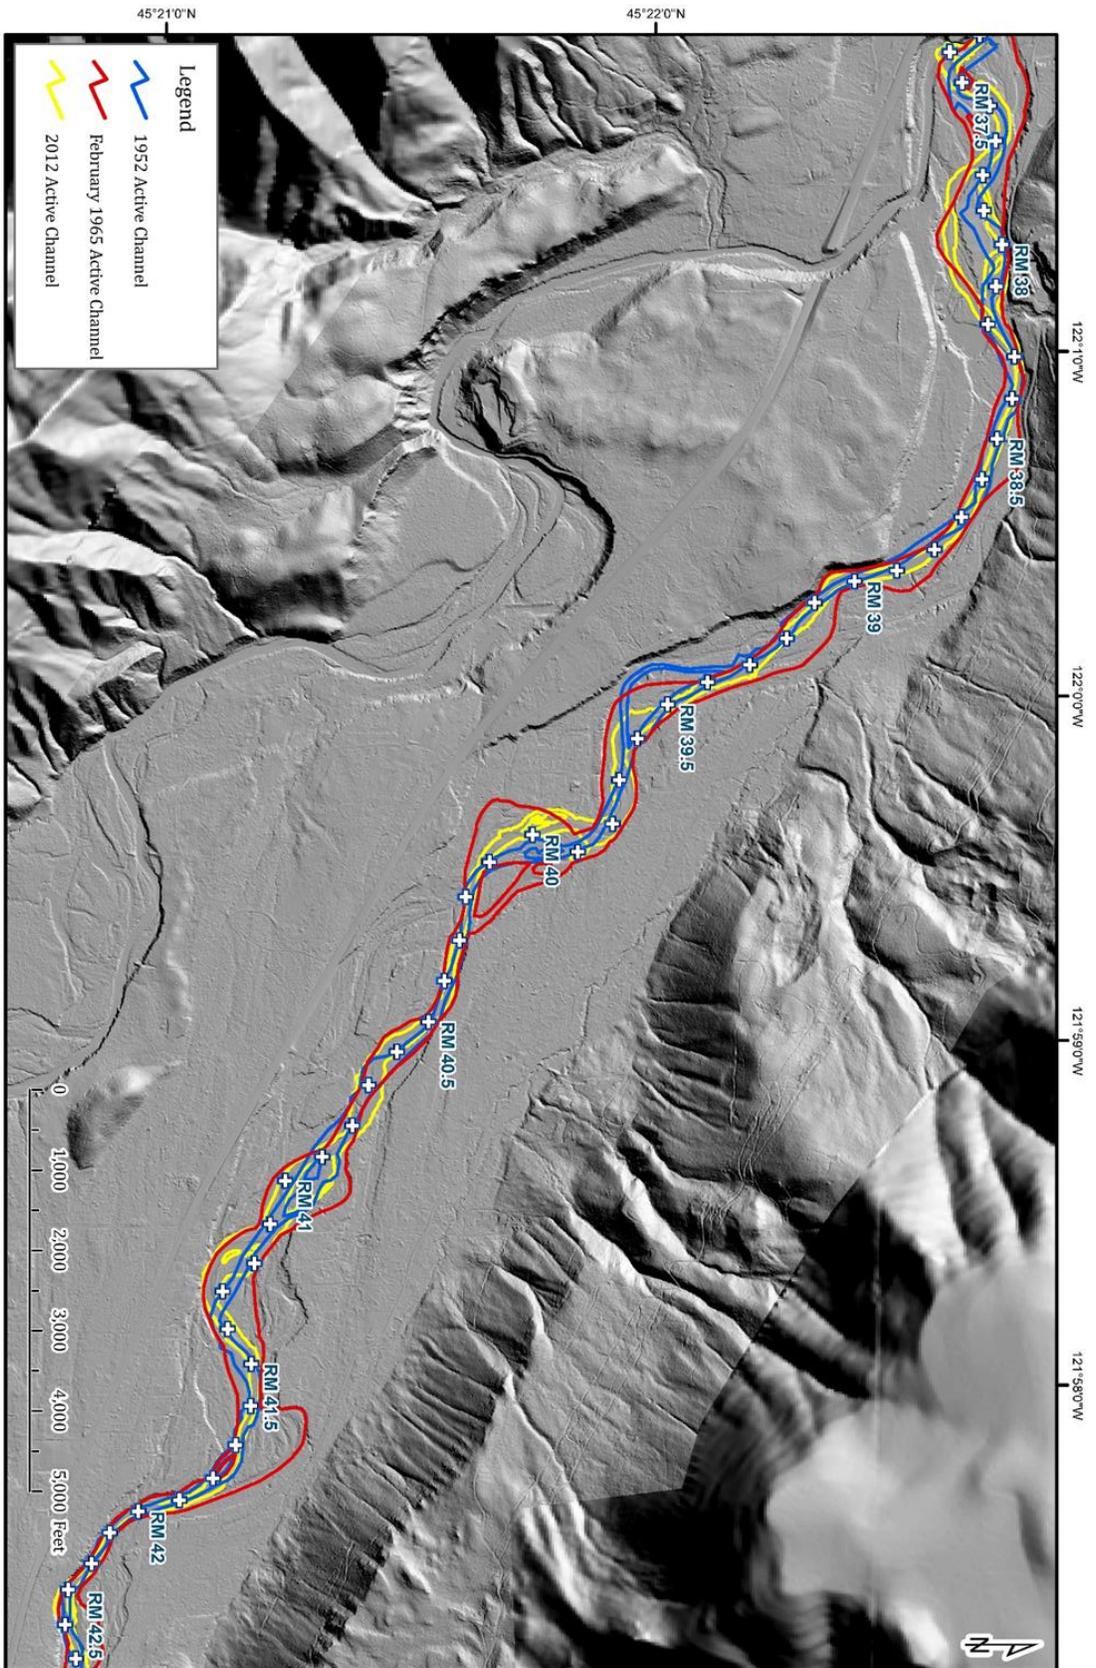
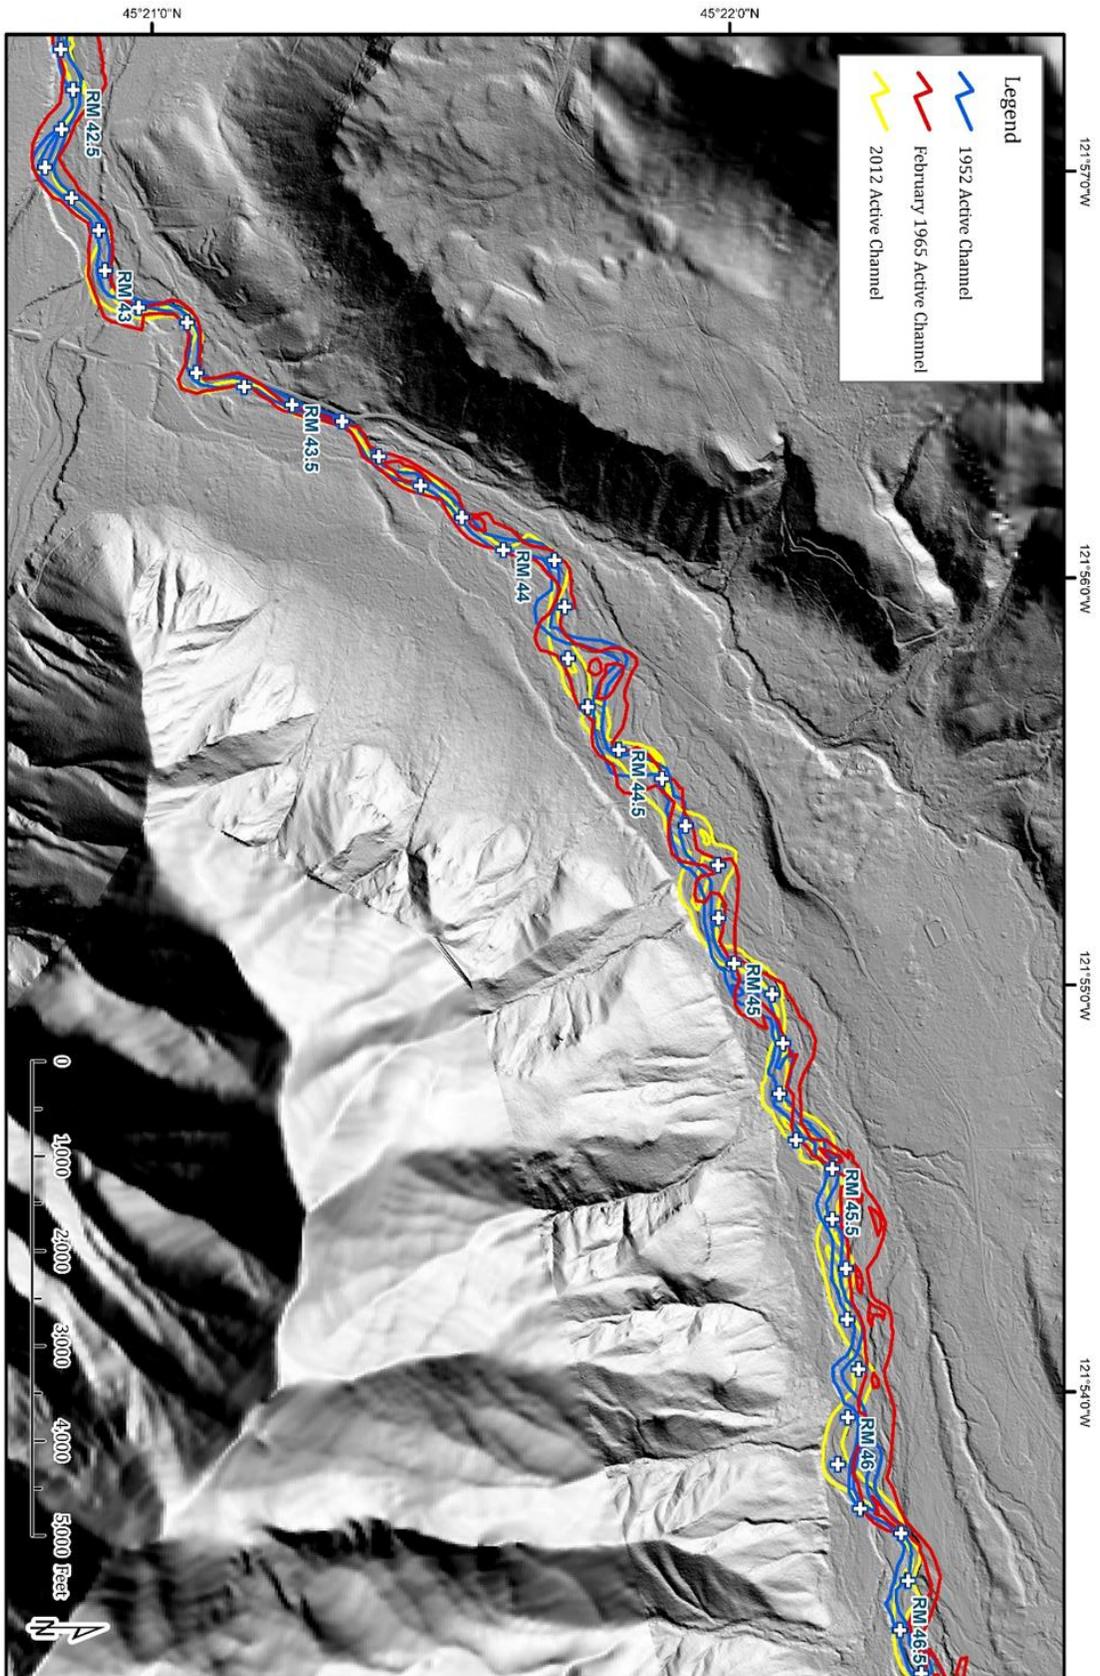
Figure 20A. 1952, February 1965, and 2012 Channel Traces. Channel traces digitized from aerial photographs show how the channel width expanded in response to the 1964 storm. The 1952 channel is representative of the pre-1964 channel. Note that the 1964 channel width increased 2 to 3 times the 1952 width. The 2012 channel reflects channel responses to ACOE channel re-grading since 1965. Data sources: USGS 10m DEM, DOGAMI LIDAR (2013), NSD 2014.

Figure 20B. 1952, February 1965, and 2012 Channel Traces. The digitized channel traces display channel responses to the 1964 storm event, and to sediment deposition generated by large storms and debris flows since 1964. Note the avulsion between RM 44.3 and RM 44.4. Data sources: USGS 10m DEM, DOGAMI LIDAR (2013), NSD 2014.

The channel continued to evolve from 2008 to 2012 (2012 Appendix Mapbook 16) with the most significant areas of change occurring in response to the 2011 storm event. This storm caused substantial erosional damage along channel banks and, in some areas, threatened the total loss of several residential structures. It is worth noting that the evolution of the channel followed in suit with the changes observed after the 1964 and 1996 storms, based on 1970 and 2005 aerial photographs, respectively. The channel sections subject to the greatest changes in active channel width are the areas most affected by the Corps actions following the 1964 event (see channel traces in Figures 20a/b and 21a/b).
