# Flood Erosion Hazard Mitigation Evaluation

## Upper Sandy River

Clackamas County, Oregon

March 24, 2015

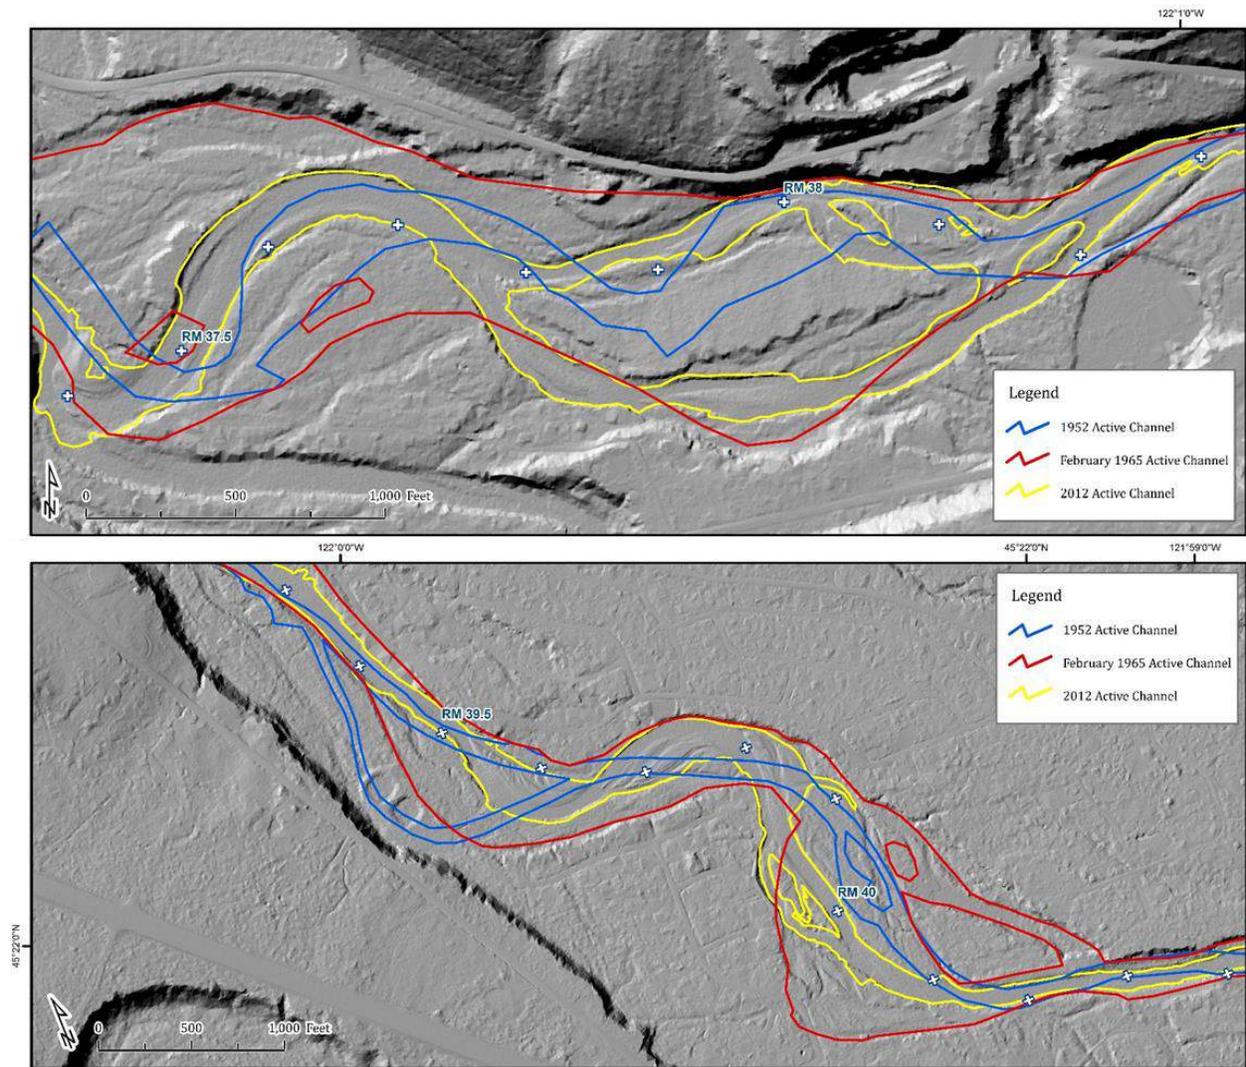
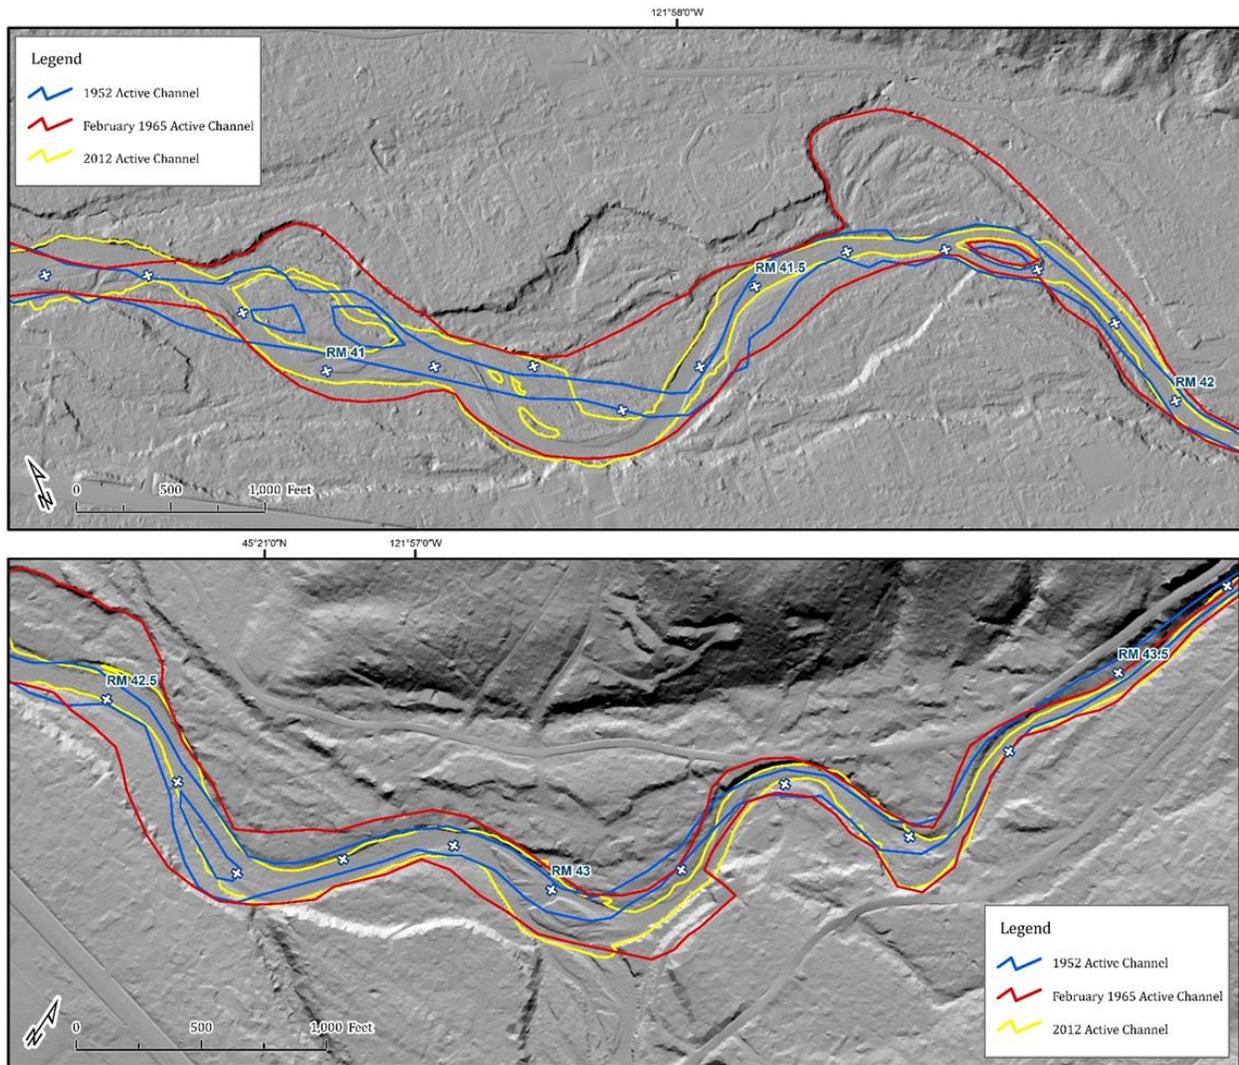
**Figure 21A. 1952, February 1965 and 2012 Channel Traces. Digitized channels show how the pre-1964 channel widened in response to the 1964 storm event. At each location the ACOE re-graded the 1964 channel area and moved the river back into the 1952 alignment and location. Both sites have experienced substantial migration as the river moves to reclaim the re-graded portions of the 1964 channel some of which are now developed, and recover some of the sinuosity lost to the Corp actions. Data sources: DOGAMI LiDAR (2013), NSD 2014.**

**Figure 21B. 1952, February 1965 and 2012 Channel Traces. Digitized channels show how the pre-1964 channel widened in response to the 1964 storm event. At each location the ACOE re-graded the 1964 channel area and moved the river back into the 1952 alignment and location. Both sites have experienced substantial migration as the river moves to reclaim the re-graded portions of the 1964 channel some of which are now developed, and recover some of the sinuosity lost to the Corp actions. Data sources: DOGAMI LiDAR (2013), NSD 2014.**

The channel continued to evolve from 2008 to 2012 (2012 Appendix Mapbook 16) with the most significant areas of change occurring in response to the 2011 storm event. This storm caused substantial erosional damage along channel banks and, in some areas, threatened the total loss of several residential structures. It is worth noting that the evolution of the channel followed in suit with the changes observed after the 1964 and 1996 storms, based on 1970 and 2005 aerial photographs, respectively. The channel sections subject to the greatest changes in active channel width are the areas most affected by the Corps actions following the 1964 event (see channel traces in Figures 20a/b and 21a/b).

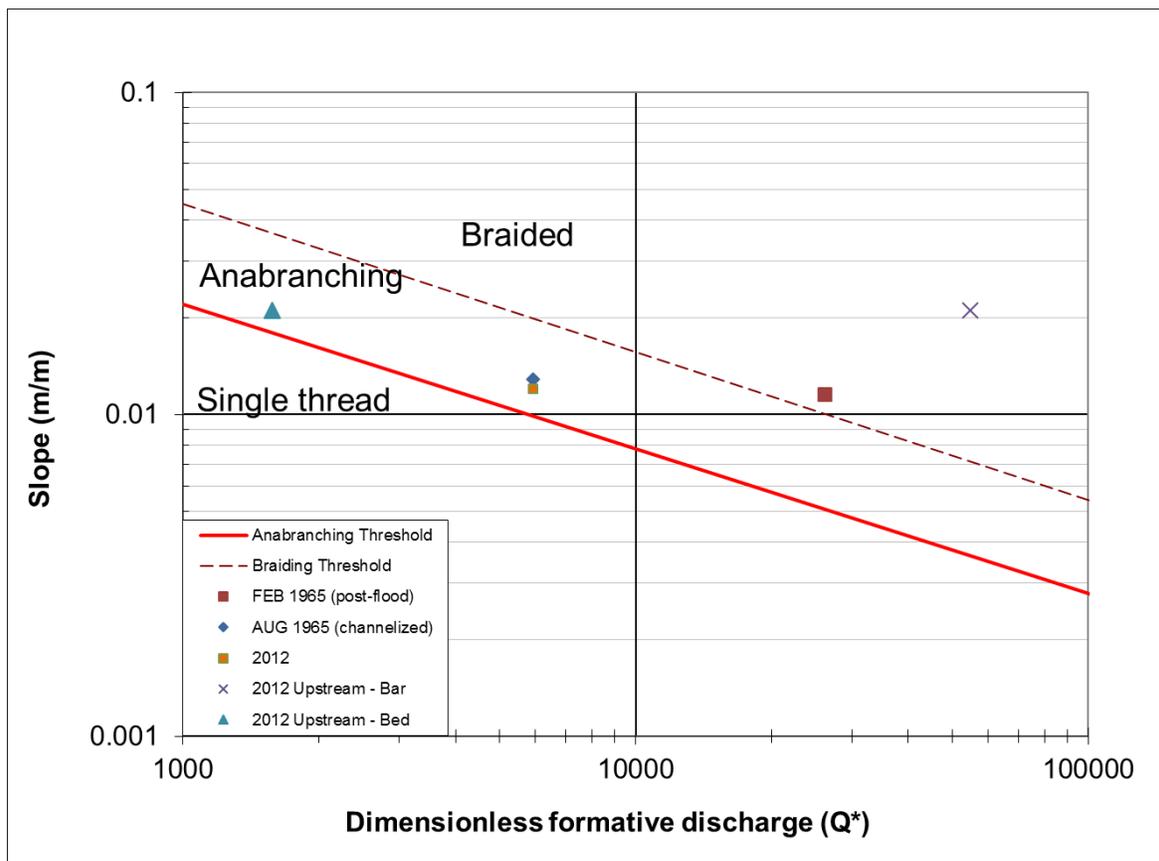
Figure 22. Anabranching Threshold for Sandy River. After Eaton et al. 2010.

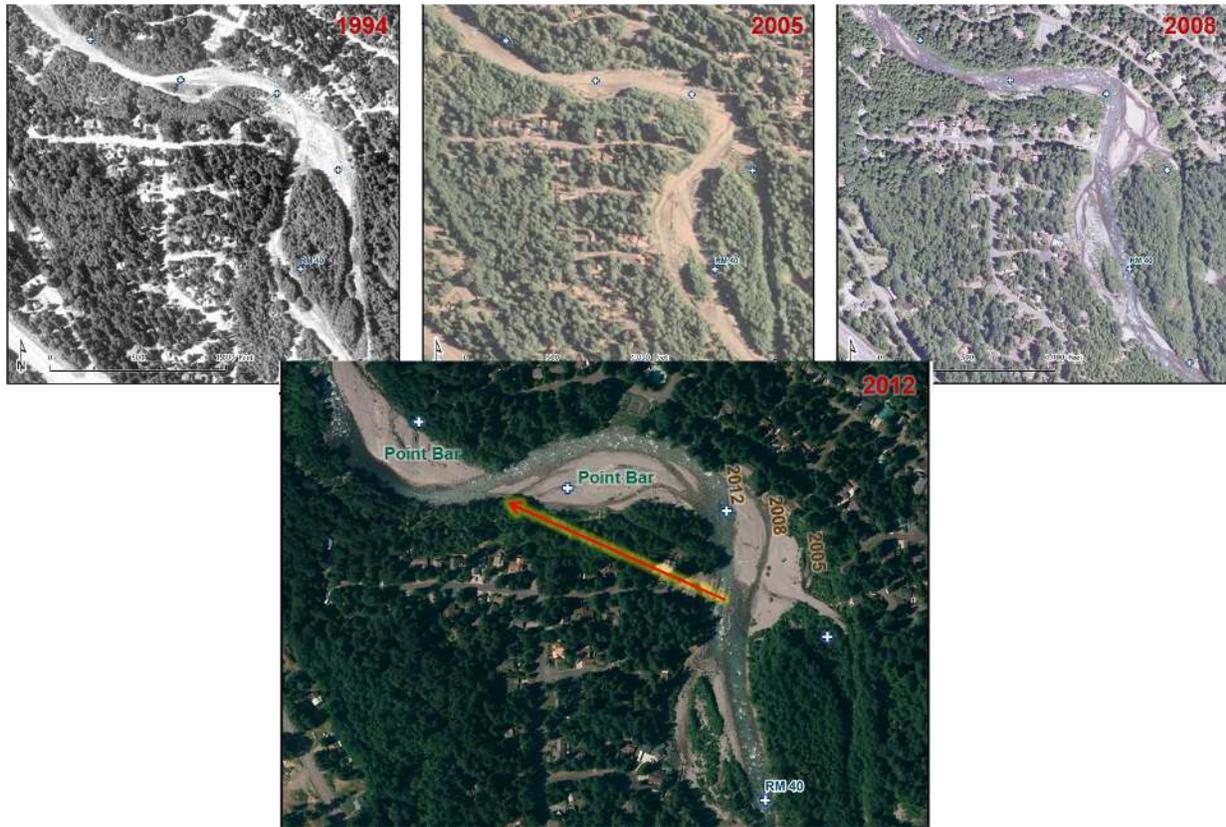
**Figure 23. Timberline Rim Channel Migration.** This group of air photos shows the lateral and downstream migration of the large bend adjacent to the Timberline Rim community. Note the remnant channel traces showing the distance of migration from 2005 to 2008 to 2012. Note also the size of the bend relative to property plats. Data sources: University of Oregon Libraries, USDA NAIP.

For the purposes of this project, it is important to understand the mechanics of migration and, more importantly, the length scales of migrating bends. Throughout the project area, channel widening and migration can be initiated wherever sediment is deposited as bars on the river bed during a large storm event. The resulting topography causes small to large changes in local flow patterns. As the bar grows, it deflects or steers increasing portions of the flow around the bar towards the adjacent river bank. The growing bar extends into the channel and compresses flow against the outside bank of the bend, where flow velocity is also fastest, causing bank erosion. This hydraulic condition results in slower velocity along the inside bank of the bend, promoting the deposition of sediment on the bar. As the point bar grows both the bend radius and the channel length (circumference around the bend) increase. Channel lengths comprising the erosional portions of migrating meander bends vary roughly from 700 feet (upstream of the Zigzag confluence) to 1,250 feet at the downstream end of the project area. Keeping in mind that the erosion prone channel length of any bend is in constant flux, changing as the bend it develops over time and with changes in upstream and downstream channel form, the eroding portion of the bend at Timberline Rim (Timberline bend) is about 1,060 feet long. The 'Timberline bend', (shown in lower image of Figure 21A and Figure 23), has been the most active bend in the project area.

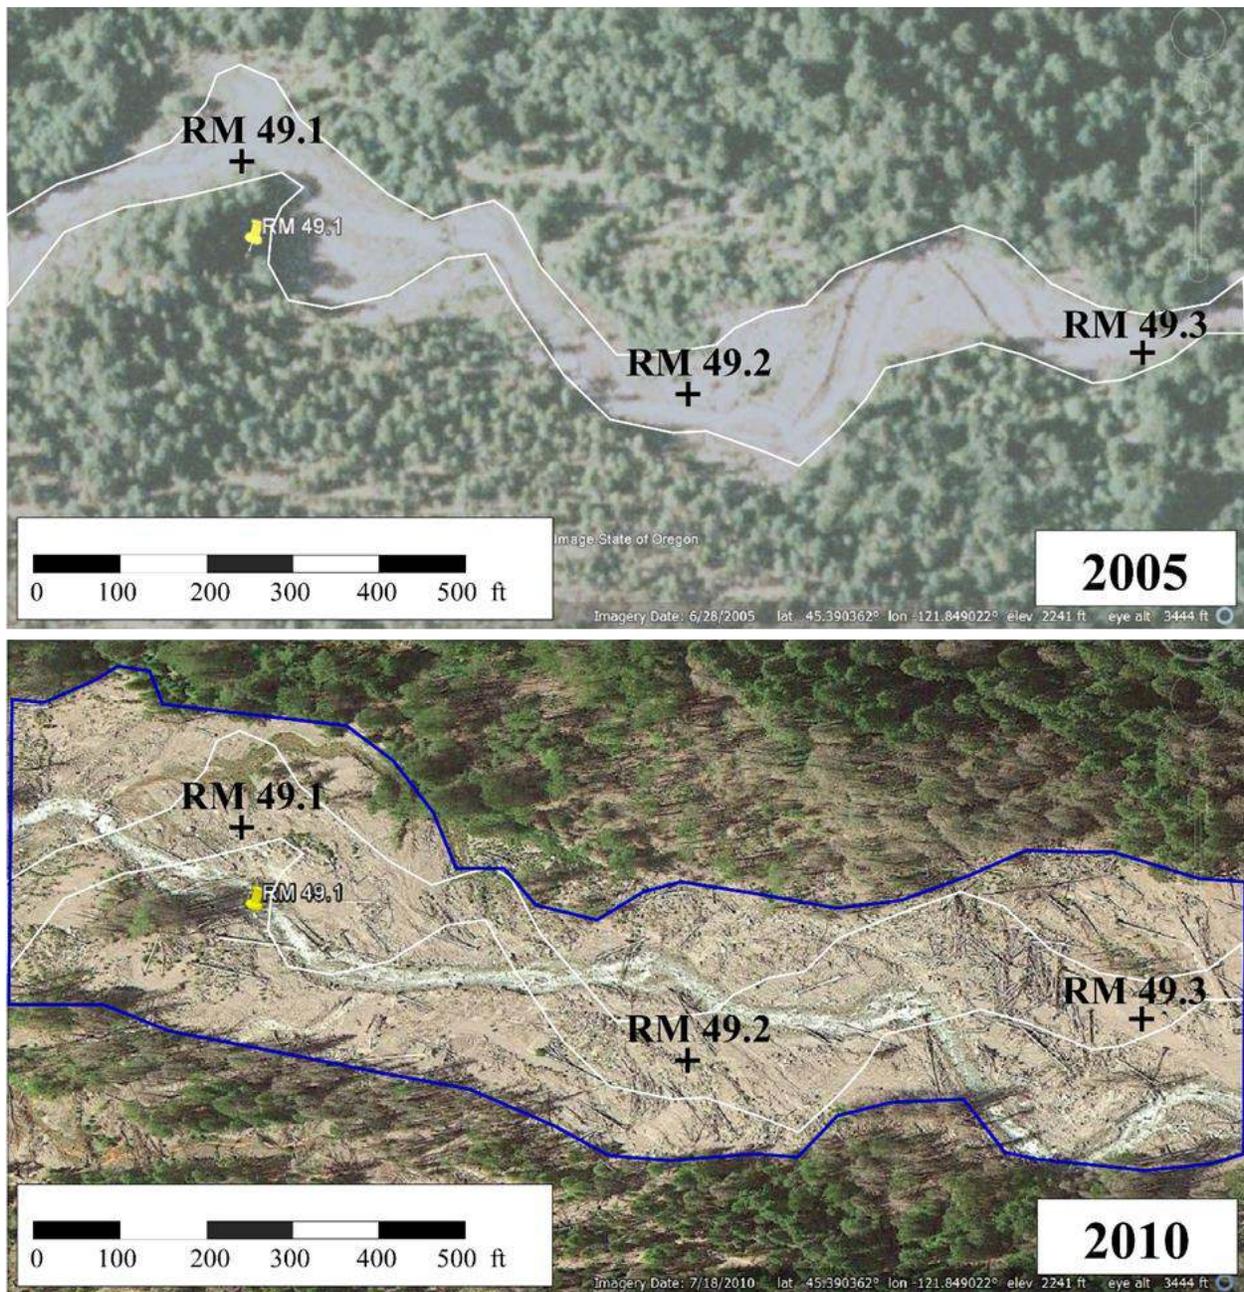
**Figure 24. Channel expansion in Upper Sandy around RM 49 (about 1.2 miles upstream of Muddy Fork Bridge, above the project area). This dramatic response probably occurred in the flood of 2006. Boulder deposits in the channel and the severity of the changes indicate it may have been run out of a large debris flow**

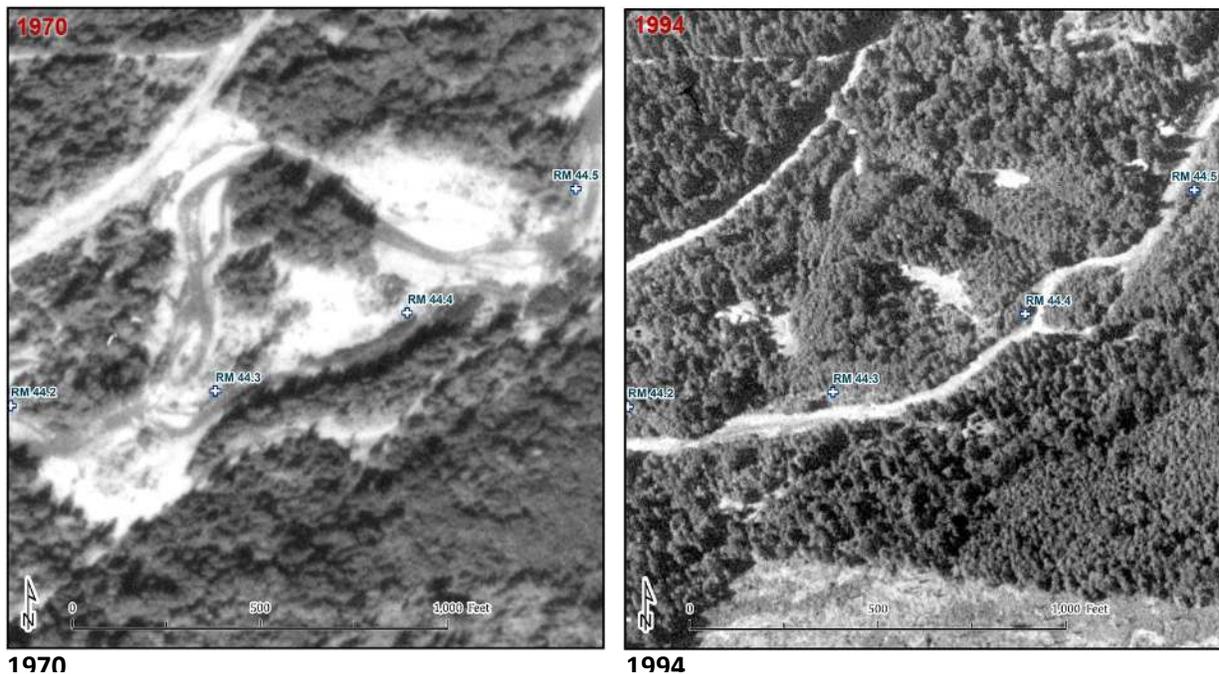
**Figure 25. 1970 / 1994 Avulsion.** An avulsion took place sometime between 1970 and 1994 in the Old Maid Flats area between RM 44.2 and RM 44.4. The large bend, active in 1970, was cut off and abandoned by 1994. Although avulsions like this can occur in the course of a single storm event, this one probably occurred over several years. Data sources: University of Oregon Libraries.

Channel avulsion is a form of migration where the river abandons its current channel to occupy a newly formed, or older abandoned channel (Figure 25).

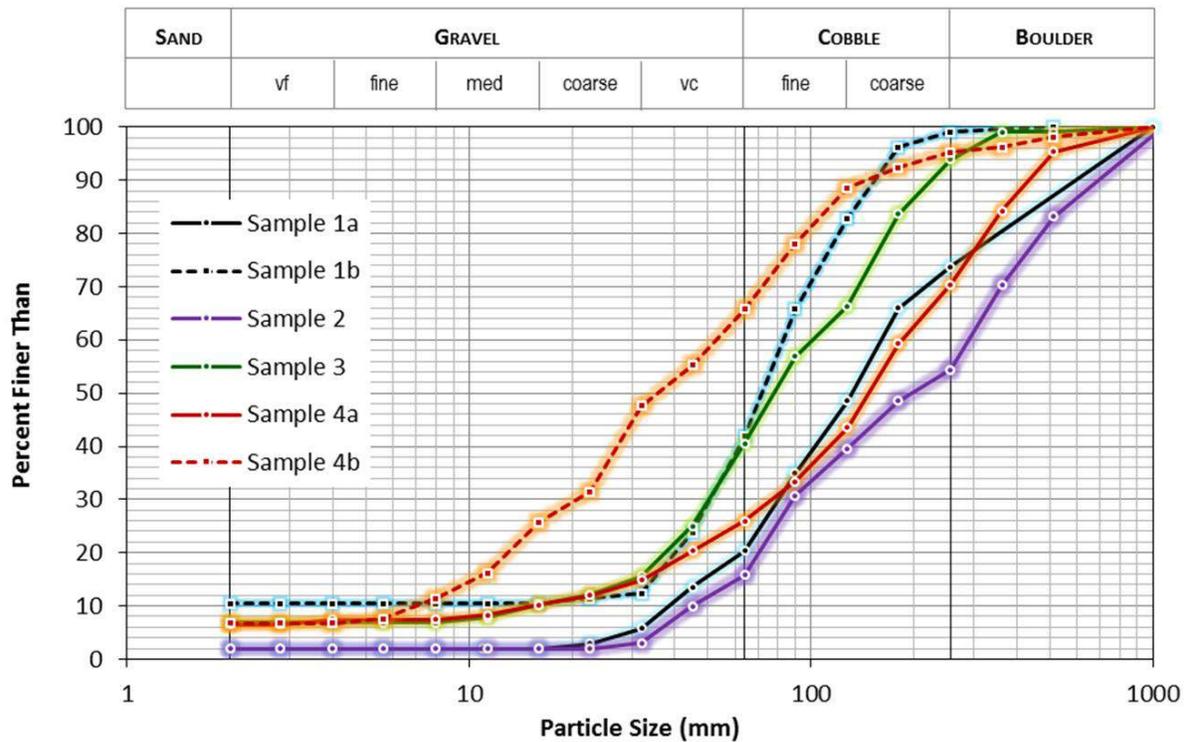
**Figure 26. Sediment Grain Size Distributions.** All samples were collected as point counts. Point count samples 1a and 1b were conducted at RM 39.65; Sample 2 at RM 41.3; Sample 3 at RM 40.3, and Samples 4a and 4b at RM 44.9.

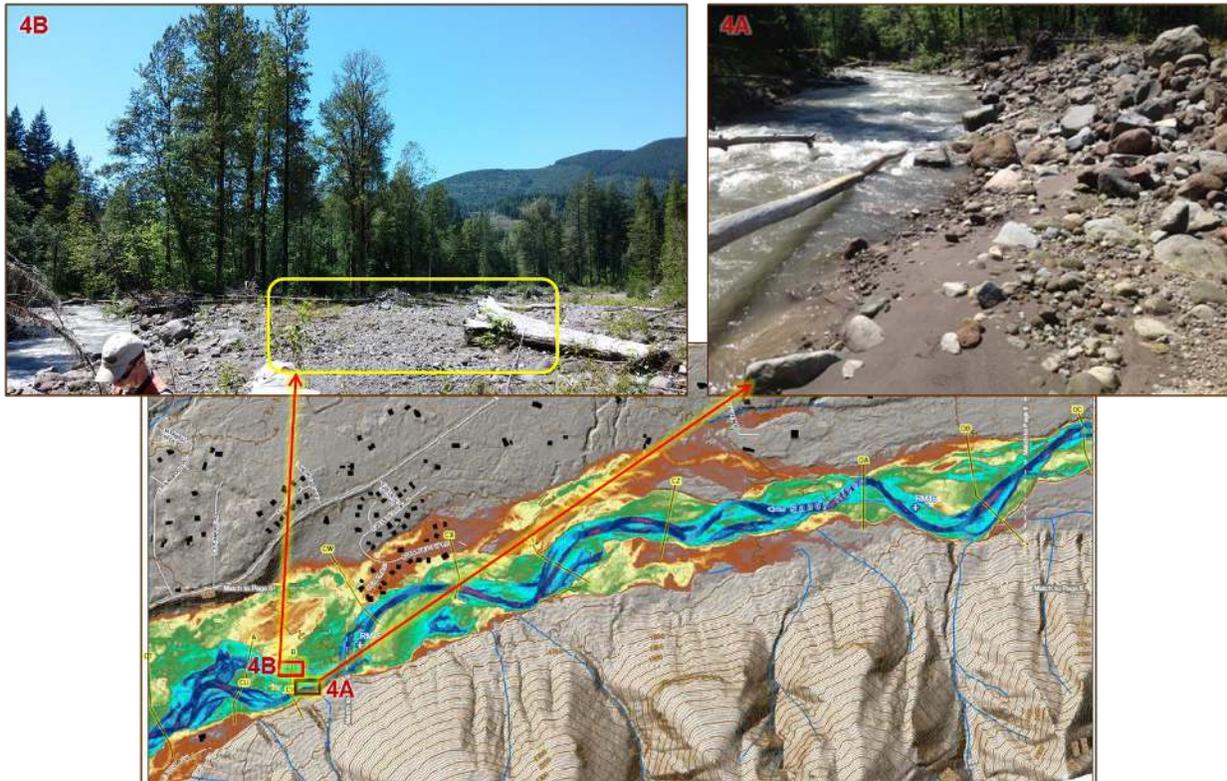
**Figure 27A. Grain Size Sample Locations 4A and 4B. Point counts comprising these samples were conducted at RM 44.9 from the edge of the active channel (Sample 4A) and the surface of an abandoned channel (Sample 4B). Note the finer grained composition of Sample 4B, which is more characteristic of sediment transported via debris flows.**

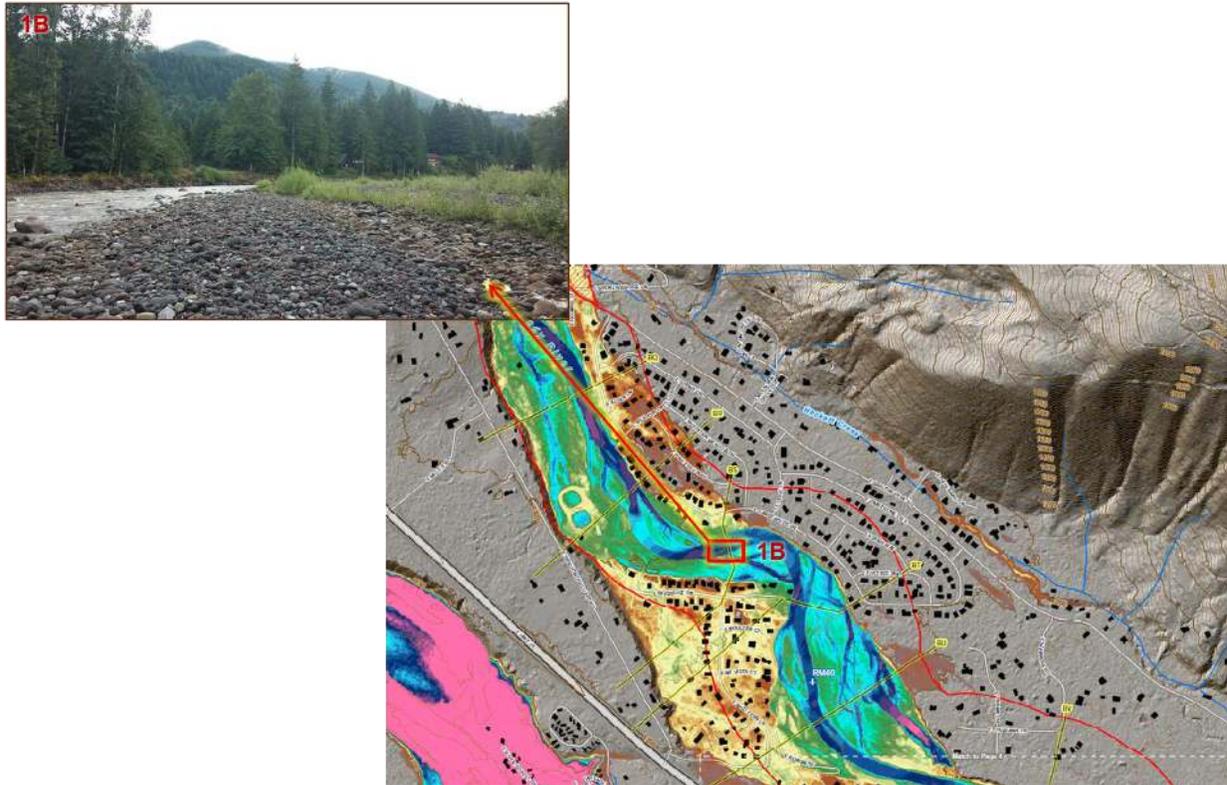
**Figure 27B. Sample 1B was collected from the surface of a gravel bar located just downstream of the Timberline Rim tennis court. Sampling from the surface of the bar is typically representative of bedload in transport at flows overtopping the bar surface.**

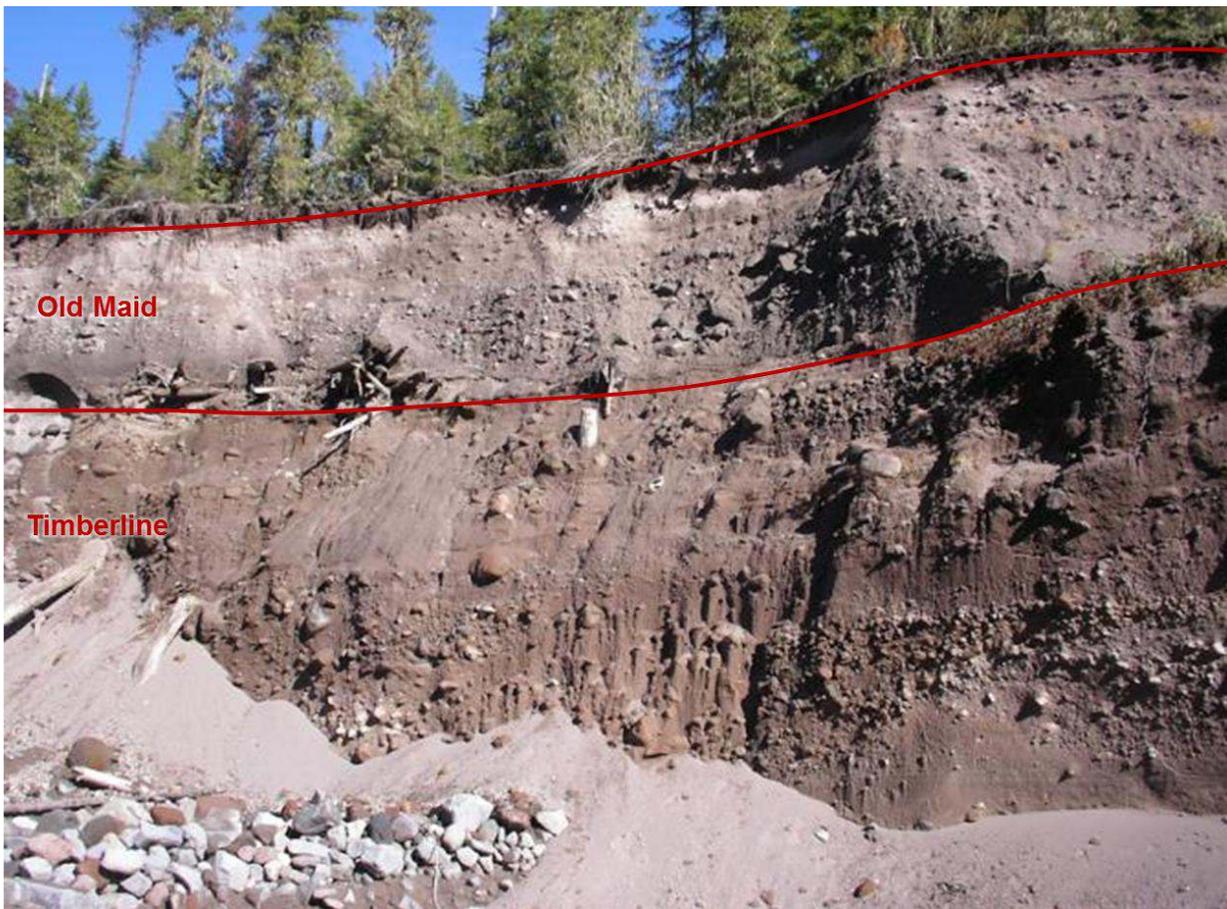
**Figure 28. Old Maid and Timberline Lahar Deposits. A slope face composed of a thick Timberline lahar deposit overlain by the Old Maid lahar deposit. The slope face is set well back from the river. The lahar unit have been exposed by hillslope weathering processes. Note the collection of woody debris at the top of the Timberline lahar, buried by the Old Maid unit, suggesting the former presence of running water.**

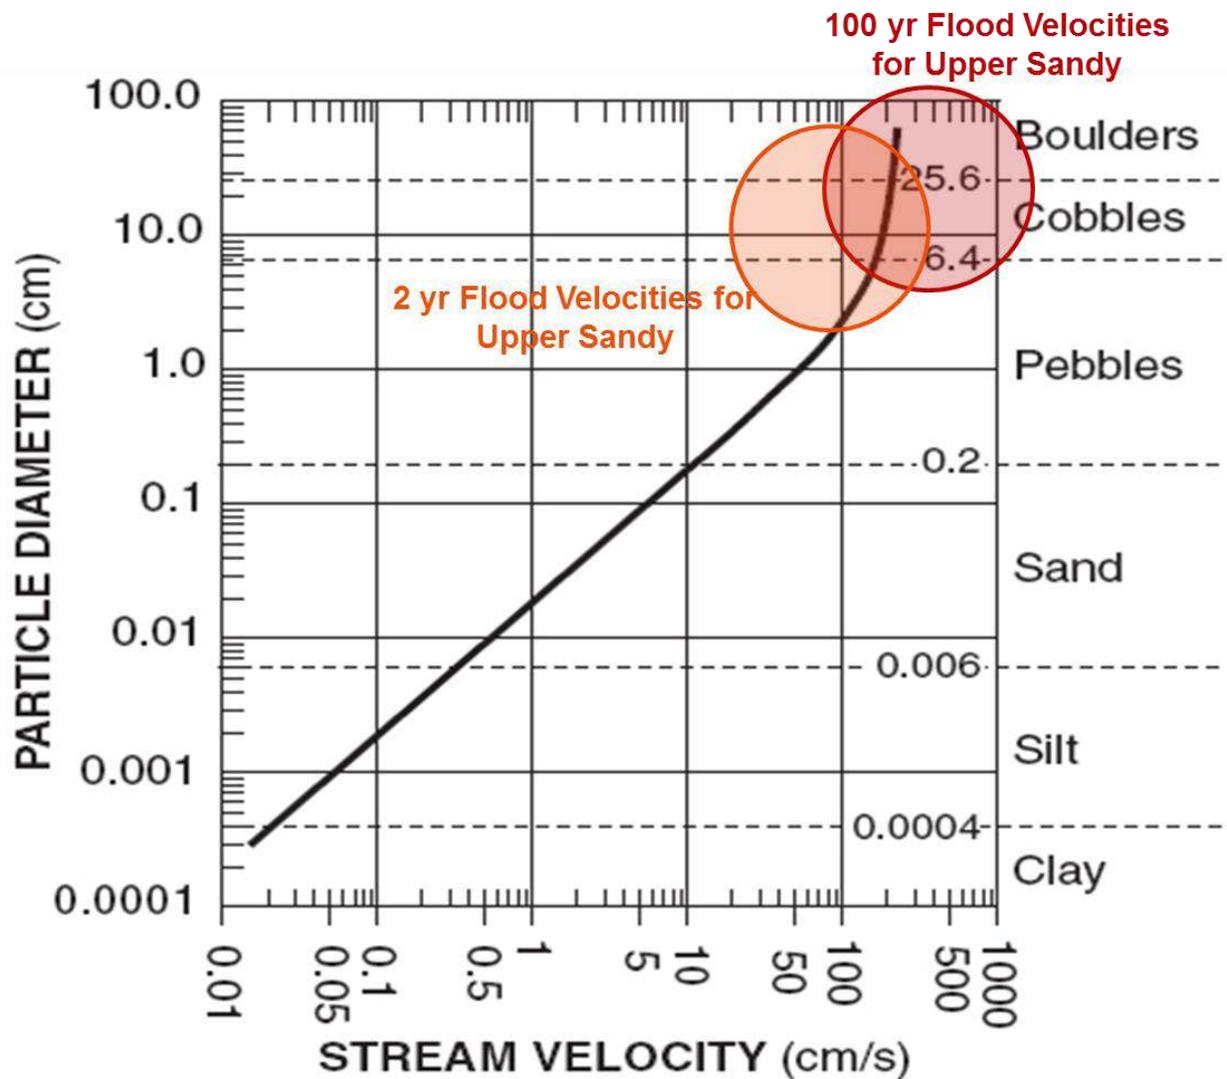
Figure 29. Relationship between flow velocity and average (D50) minimum stable particle size. This graph displays the median grain diameters stream flow can transport during the 2-year (large cobbles) and 100-year (cobble to boulders) recurrence interval storm flows. After Peter Mulroy 2012.

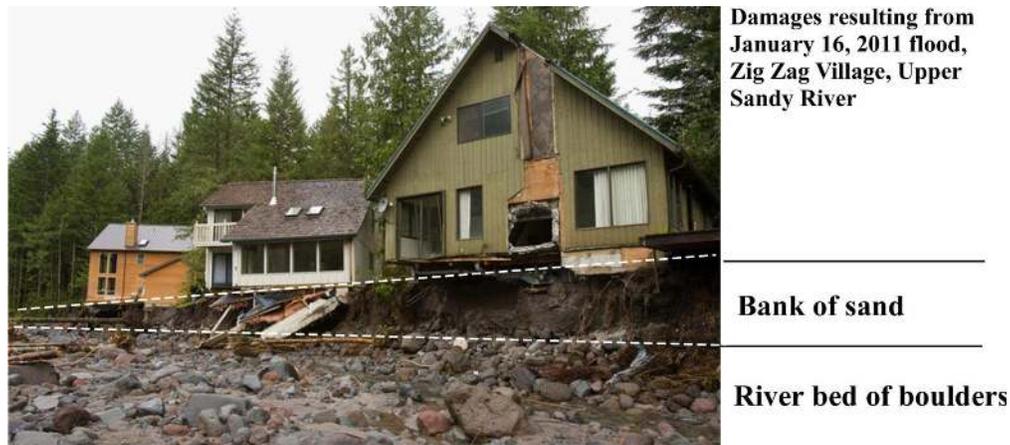
**Figure 30. Home damage along the Upper Sandy River due to erosion in 2011 along right bank at Zigzag Village development, RM 45.1. Like much of Upper Sandy, the bank is composed of fine sediment that is more easily eroded than the coarse material of the river bed. Photo credit: *The Oregonian* newspaper.**

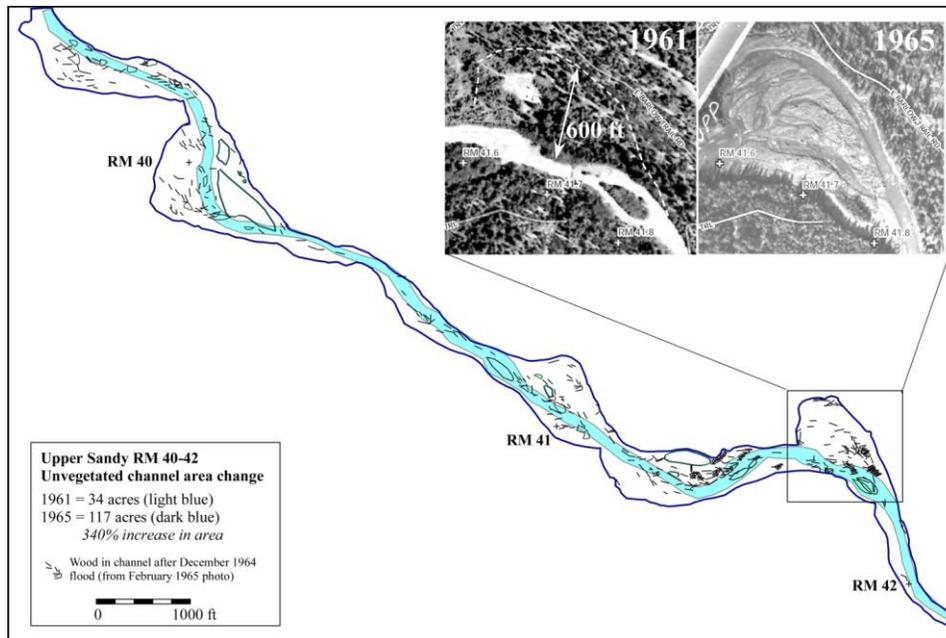
**Figure 31. Upper Sandy RM 39.8 to 42.0 showing the 340% expansion of the channel area after the December 1964 flood. The channel enlargement left behind a much more complex multi-thread morphology, a finer substrate and lots of wood. Inset photos show river at RM 41.7 where river moved over 600 ft to the north. After the flood the U.S. Army Corps of Engineers removed all the wood, constructed levees and re-established the river to an excavated channel in the 1961 alignment.**

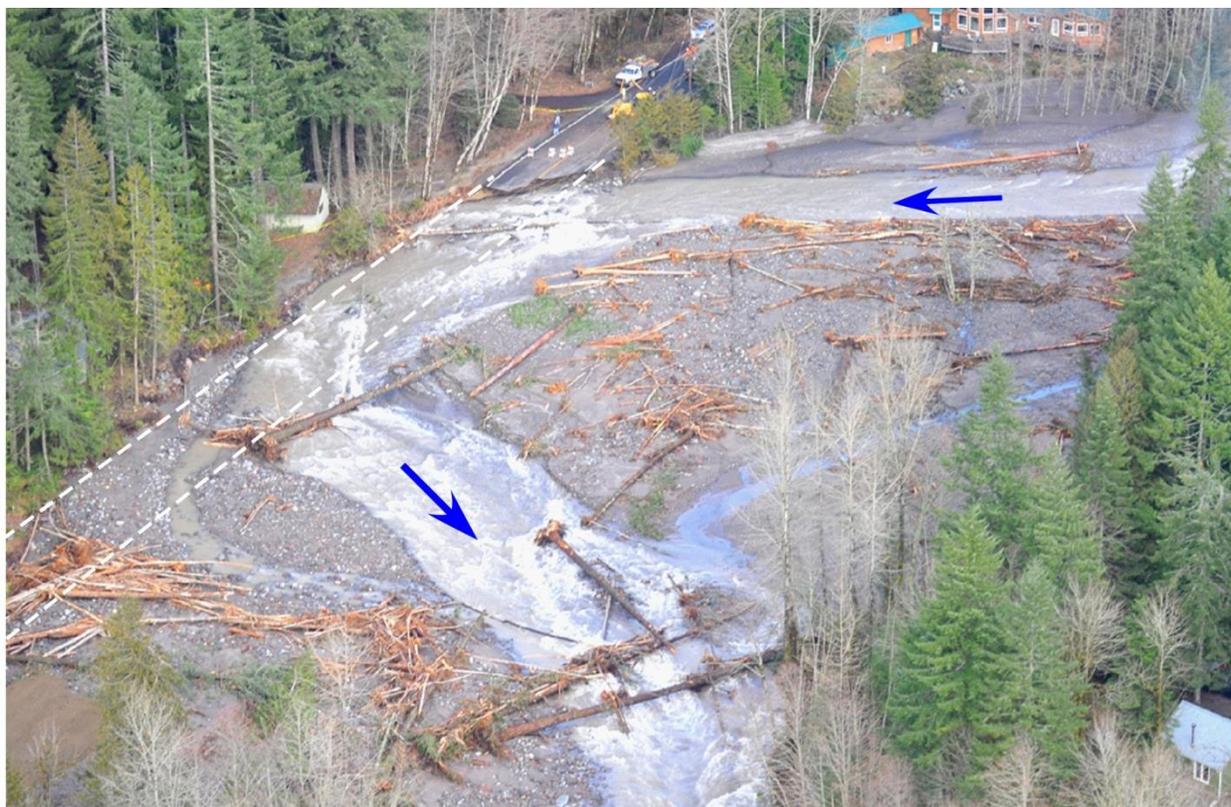
**Figure 32. Upper Sandy RM 44.1 Lolo Pass Road washout in 2011. The channel moved through the road adding over 60 ft to its migration zone. The flood left a net increase in the quantity of wood in the channel which added additional flow resistance and enhanced fish habitat. Historic confinement and wood clearing has concentrated the river's energy and severely limited the formation of beneficial salmon habitat. Providing the river with more room to move and implementing flood protection measures that focus on energy dissipation will not only improve habitat but reduce long-term flood protection costs. In this case the road was rebuilt in its pre-existing location.**

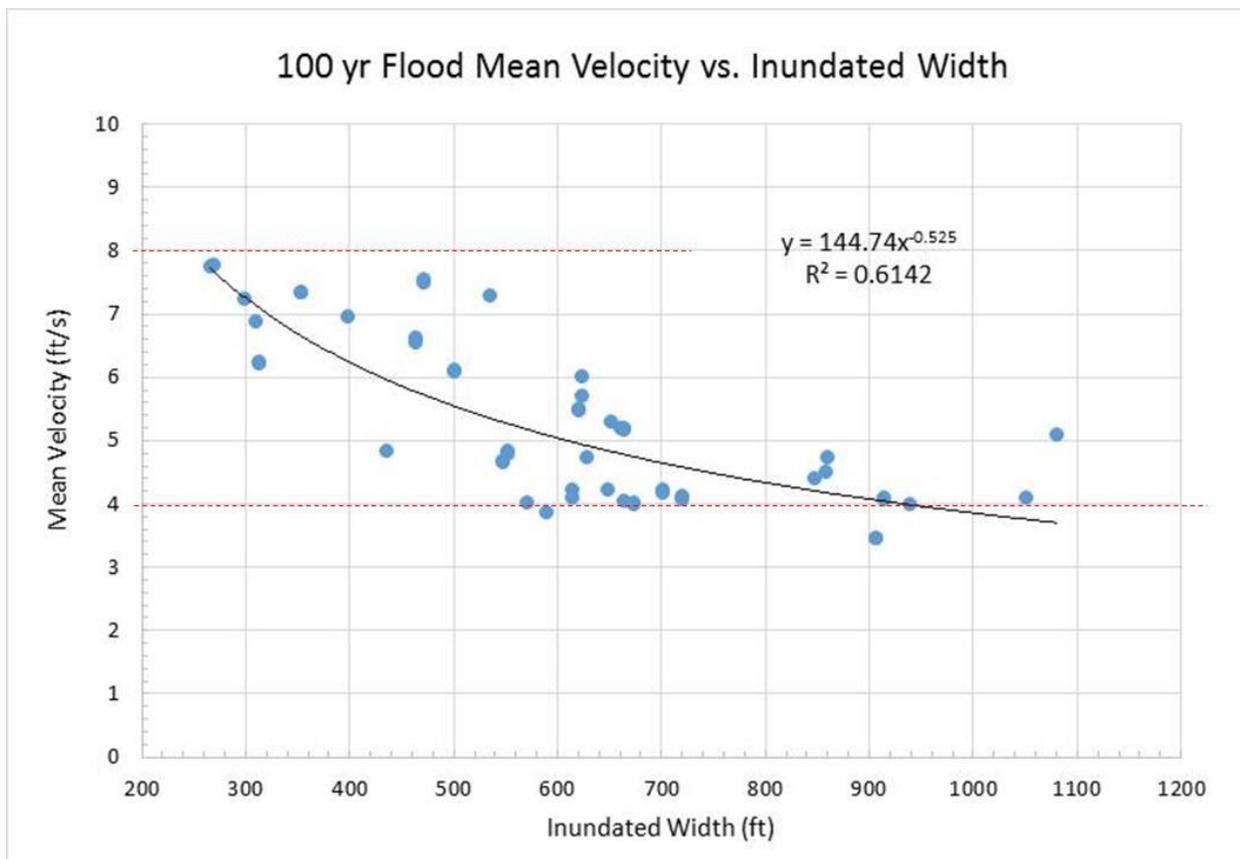
**Figure 33. Output from HEC-RAS hydraulic model showing how mean velocities during the 100 yr flood decrease as a function of the inundated (floodplain) width, showing an approximately 2-fold drop when it reaches 900-1100 ft in width. This provides guidance for a minimum zone in which channel migration can be manage**

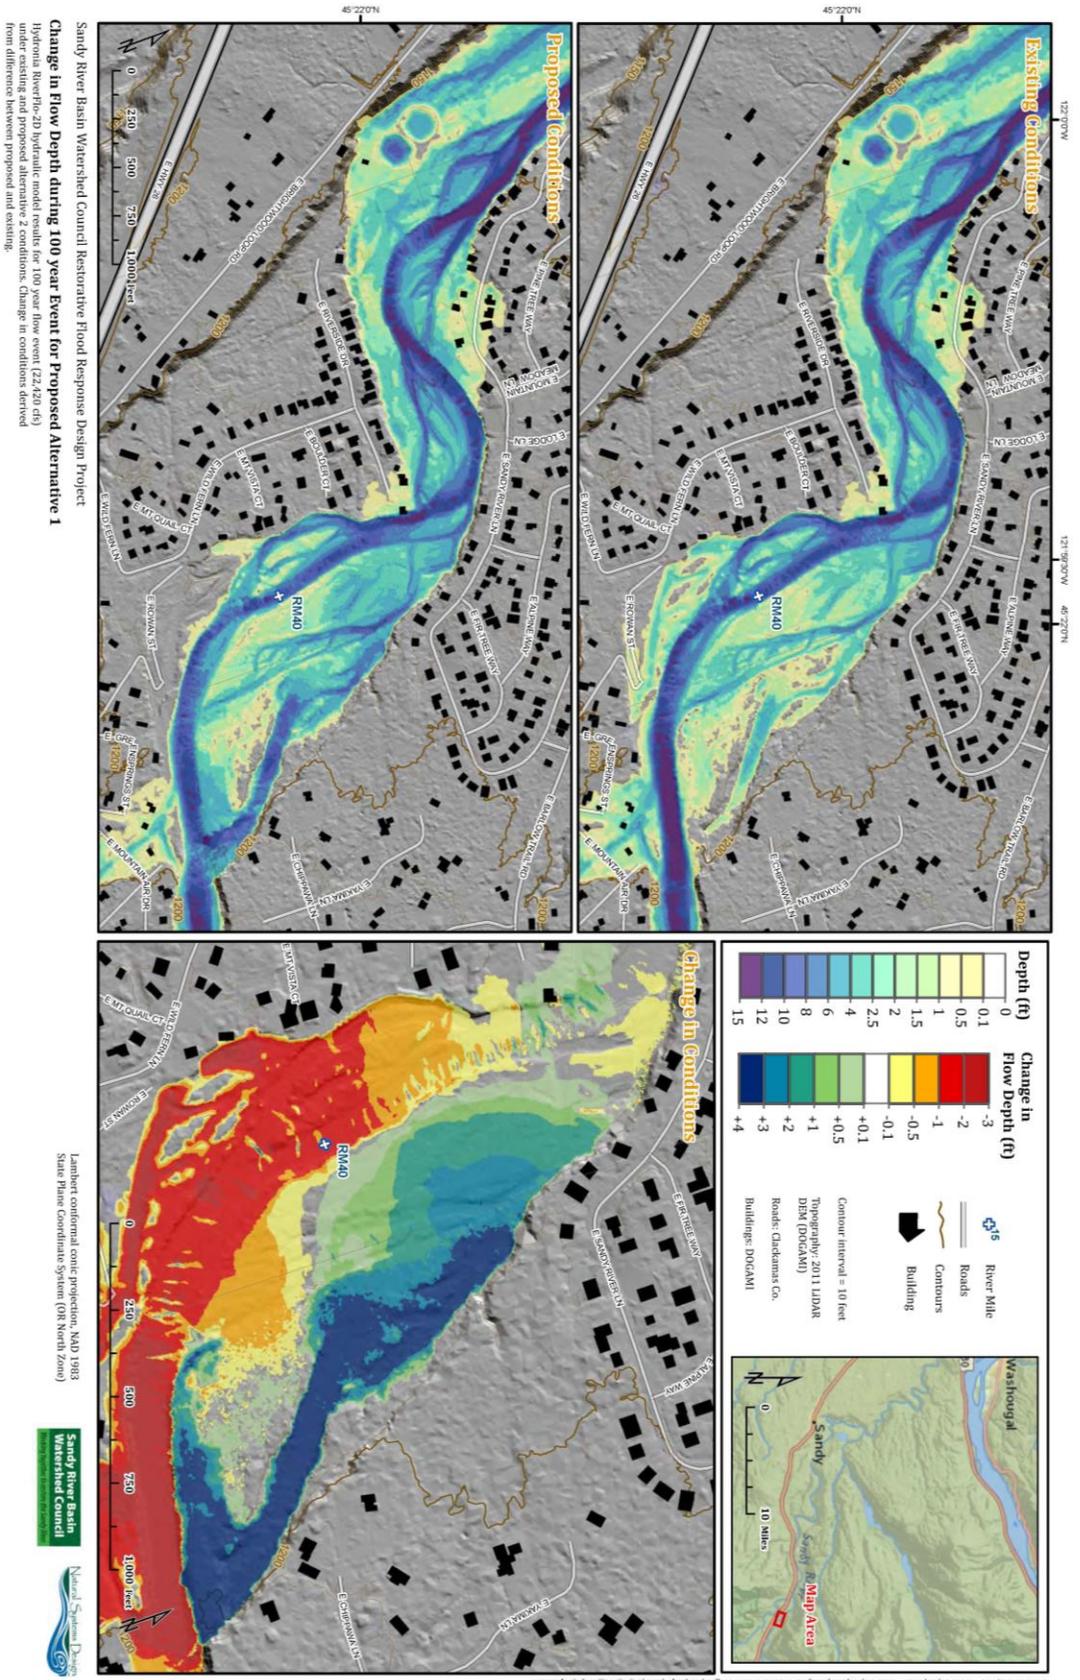
**Figure 34A.** Illustration of how widening the cross-sectional area available to flood flow will diminish flow depths. Timberline Rim community from RM 39.4 to 40.4, river flows from lower right to upper left. The upper left image is output from a two-dimensional hydraulic model showing the 100 year flood inundation depths under existing conditions. The lower left image is inundation depths if right bank levee was removed and the river re-engaged to a side channel it carved in the December 1964 flood. The lower right image shows the difference, illustrating a three foot reduction in depths in much of the river. Giving the river more space reduces the extent of inundation along the left bank.

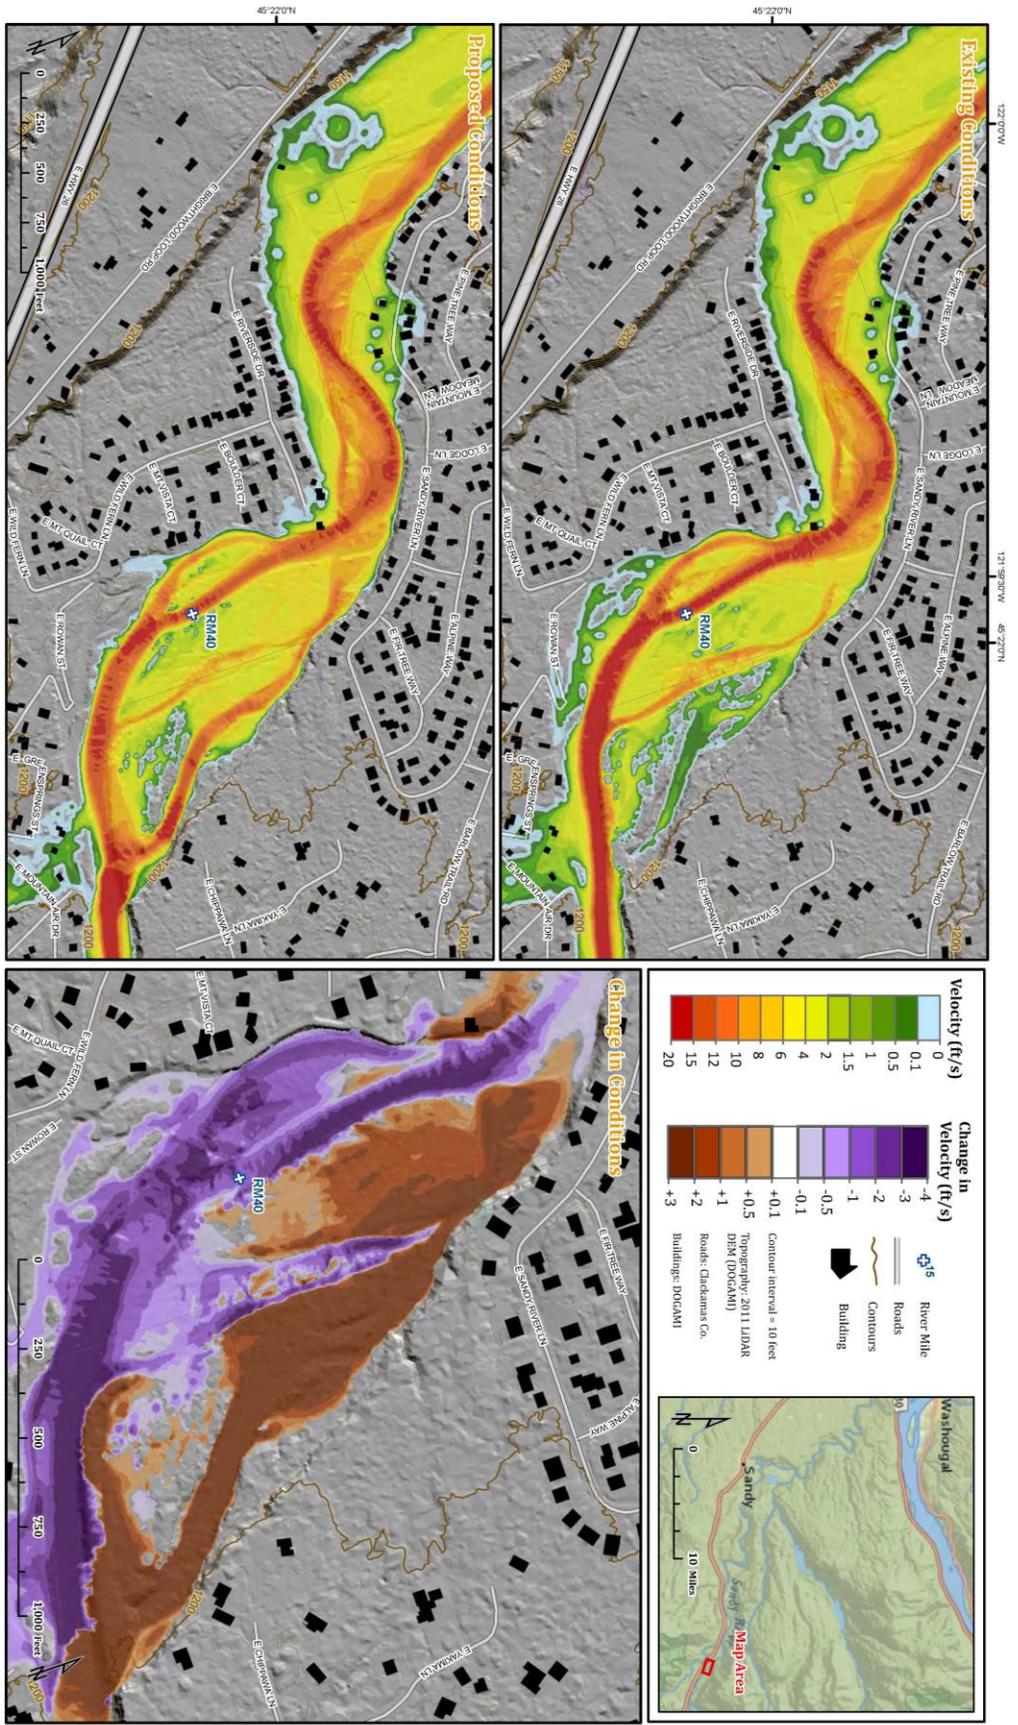
Sandy River Basin Watershed Council Restorative Flood Response Design Project  
 Change in Flow Velocity during 100 year Event for Proposed Alternative 1  
 Hydrogen River/Phi-2D hydrologic model results for 100 year flow event (22,420 cfs)  
 under existing and proposed alternative 1 conditions. Change in conditions derived  
 from difference between proposed and existing.

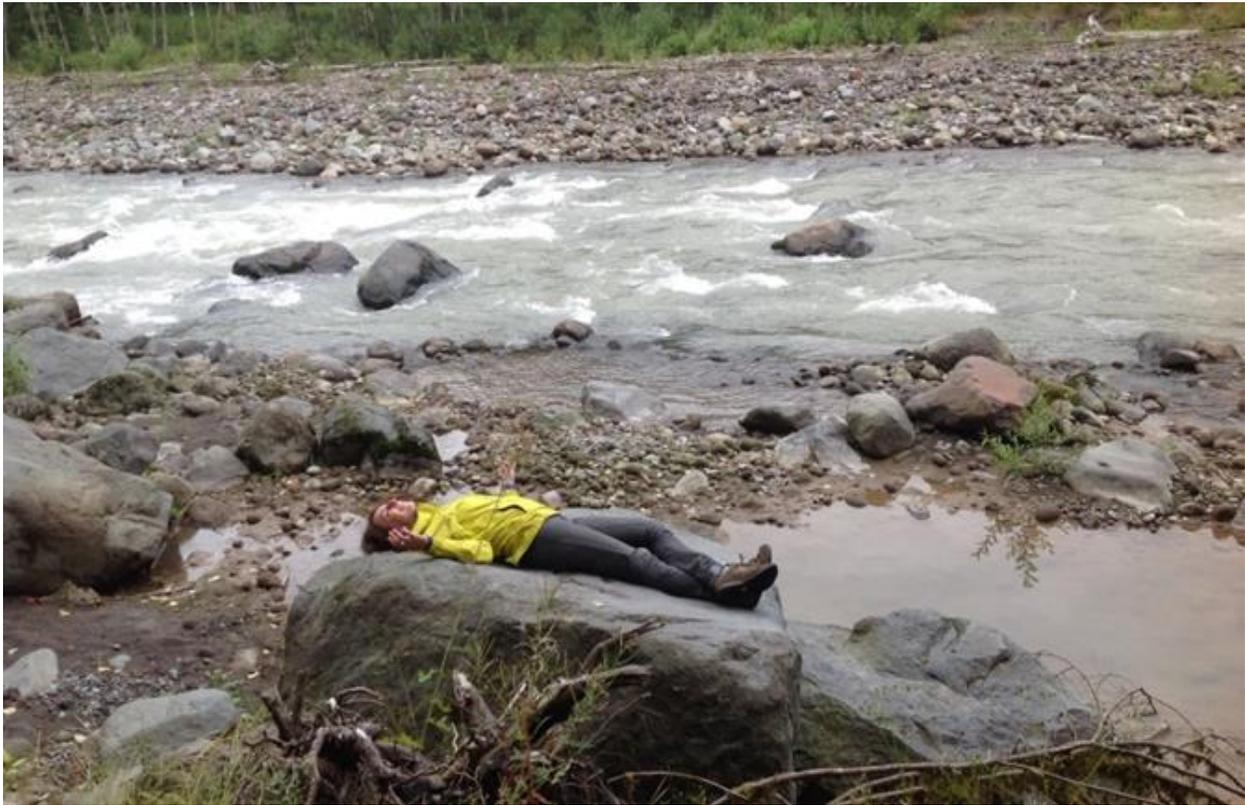
**Figure 35. The Upper Sandy has a very high sediment transport capacity, leaving a coarse river bed comprised of large cobbles and boulders. The larger boulders reflect the size of rock needed to be stable. View from left bank at RM 40.65, July 2014, flow is from right to left.**
