# Flood Erosion Hazard Mitigation Evaluation

## Upper Sandy River

Clackamas County, Oregon

March 24, 2015

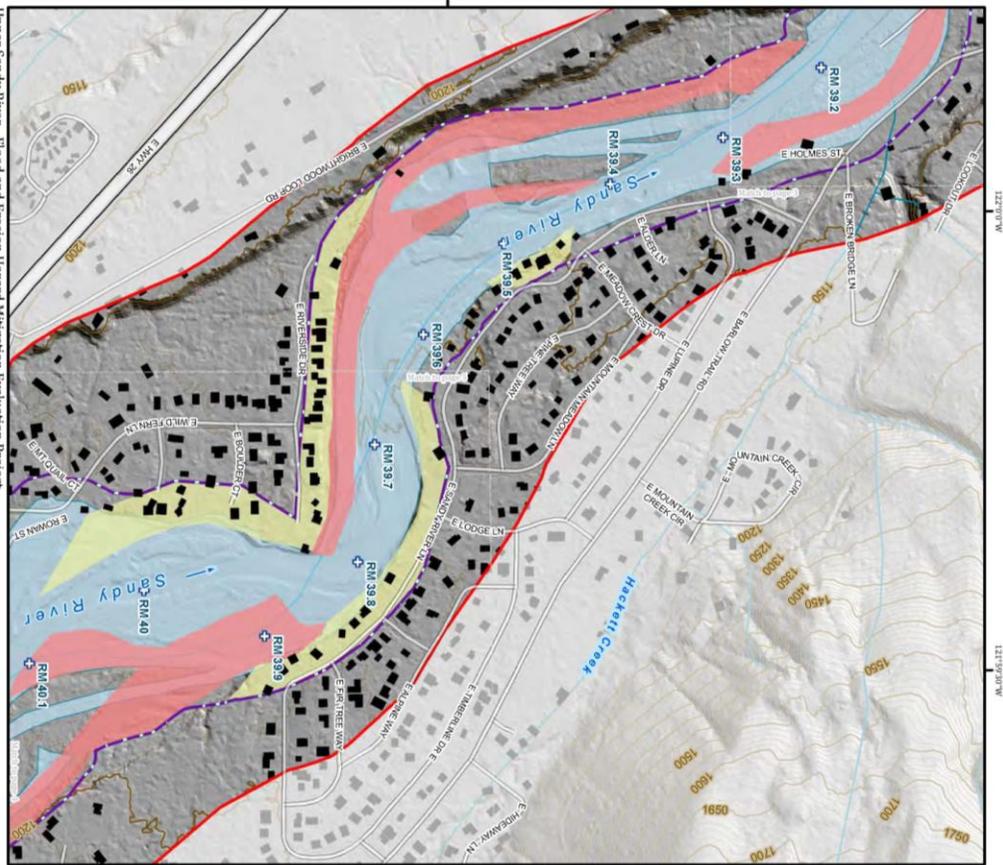
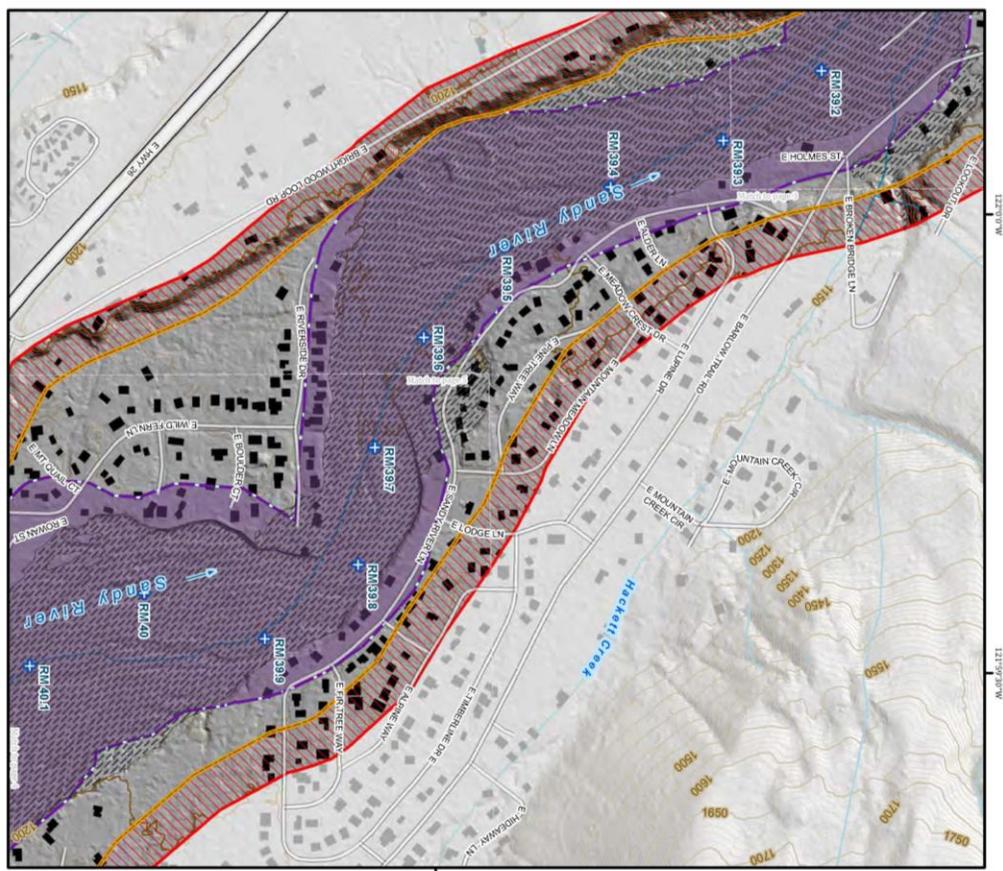
Figure 36. Maps from Risk and Hazard Mapbook prepared for Upper Sandy showing flow and erosion hazard areas, including channel migration zone (Appendix 19). The map on the right also presents an “emergency protection action line” (EPAL) that identifies boundaries of area in which channel migration can be managed.

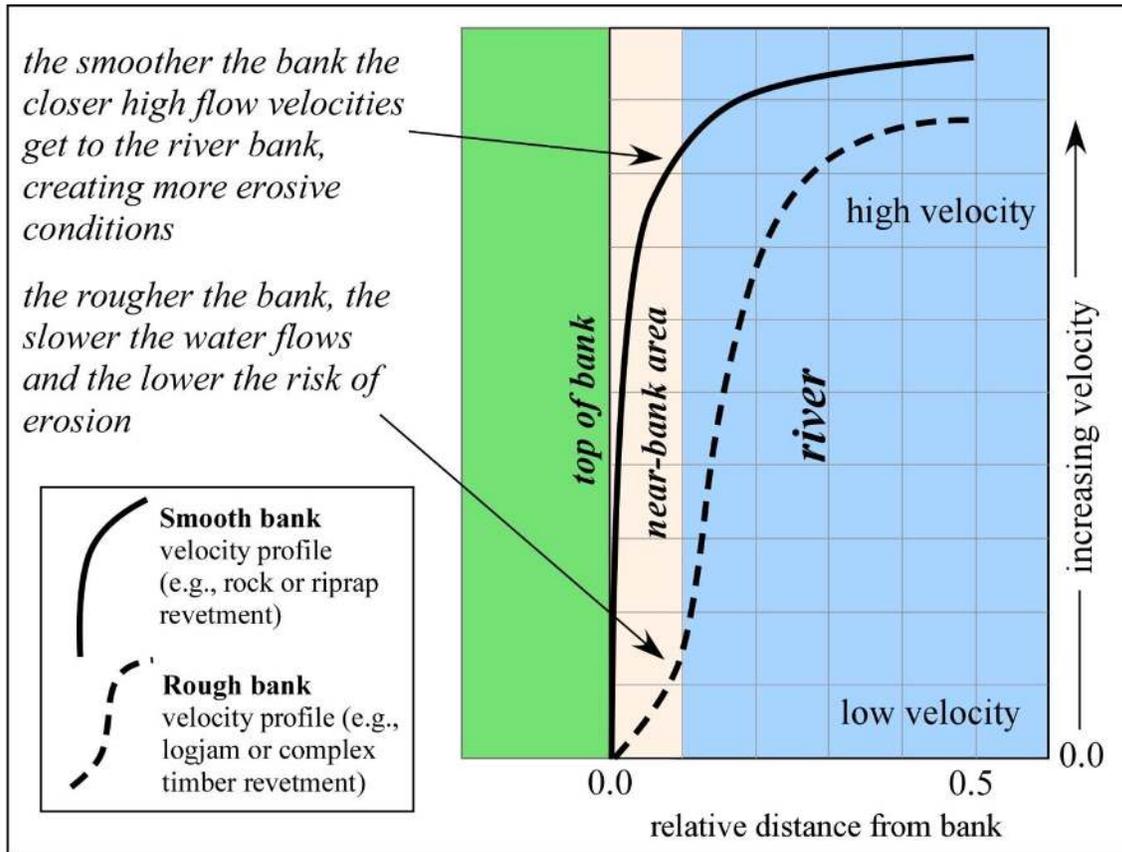
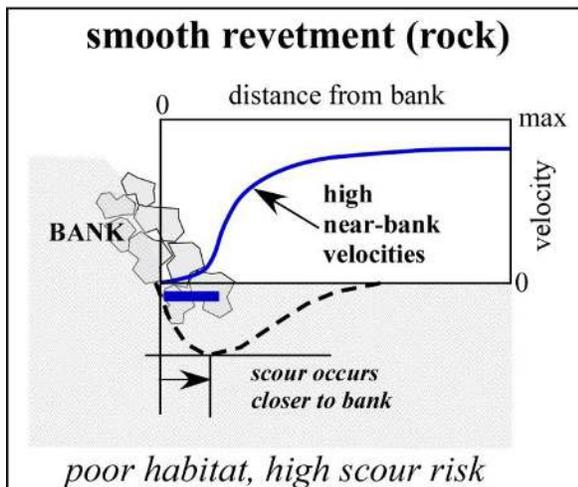
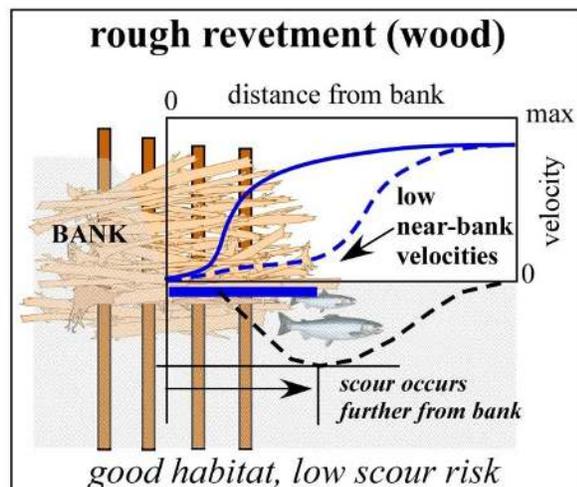
Figure 37. Illustration of how rougher banks reduce river velocities near the bank. Traditional bank protection tends to create a smooth bank where high flow velocities hug the bank (solid lines above). Where banks are roughened near-bank velocities are reduced (dashed lines), diminishing the risk of erosion and improving salmon habitat. T. Abbe.

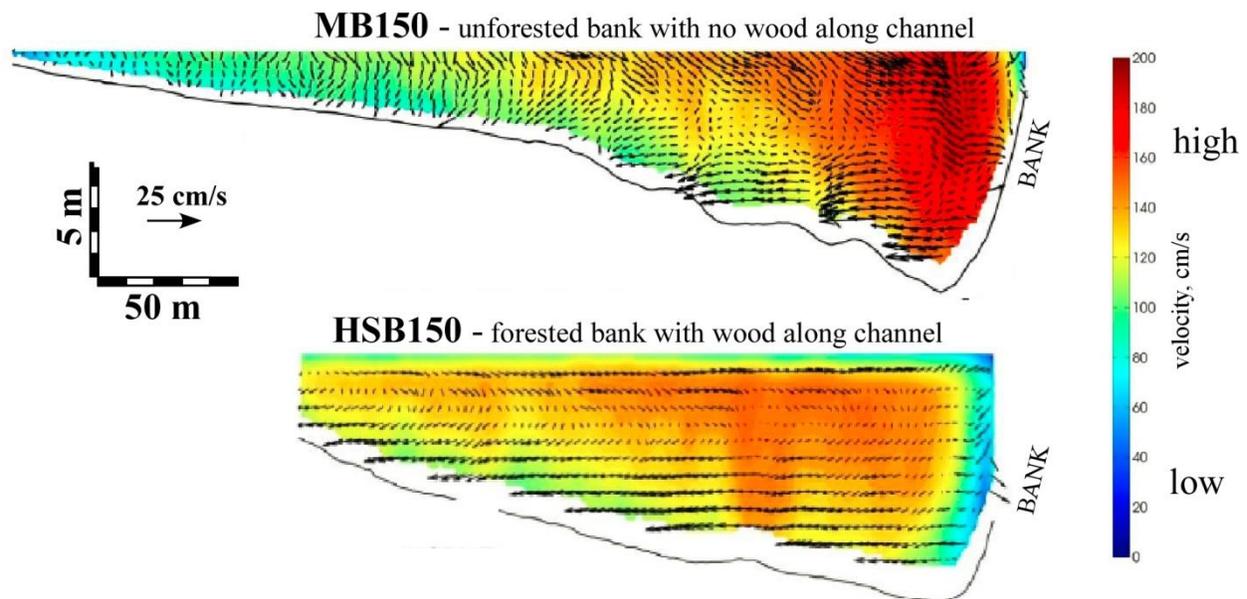
**Figure 38. Flow velocity fields around two bends of Lower Wabash River, Illinois. Cross-section MB 150 is downstream of meander apex with relatively smooth bank, HSB72 is cross-section in similar location of bend where there are snags along the bank. The roughness created by the snags along HSB72 slows down velocities near the bank. Erosion rates at HSB72 are 17 times less than MB 150 (Konsoer 2014).**

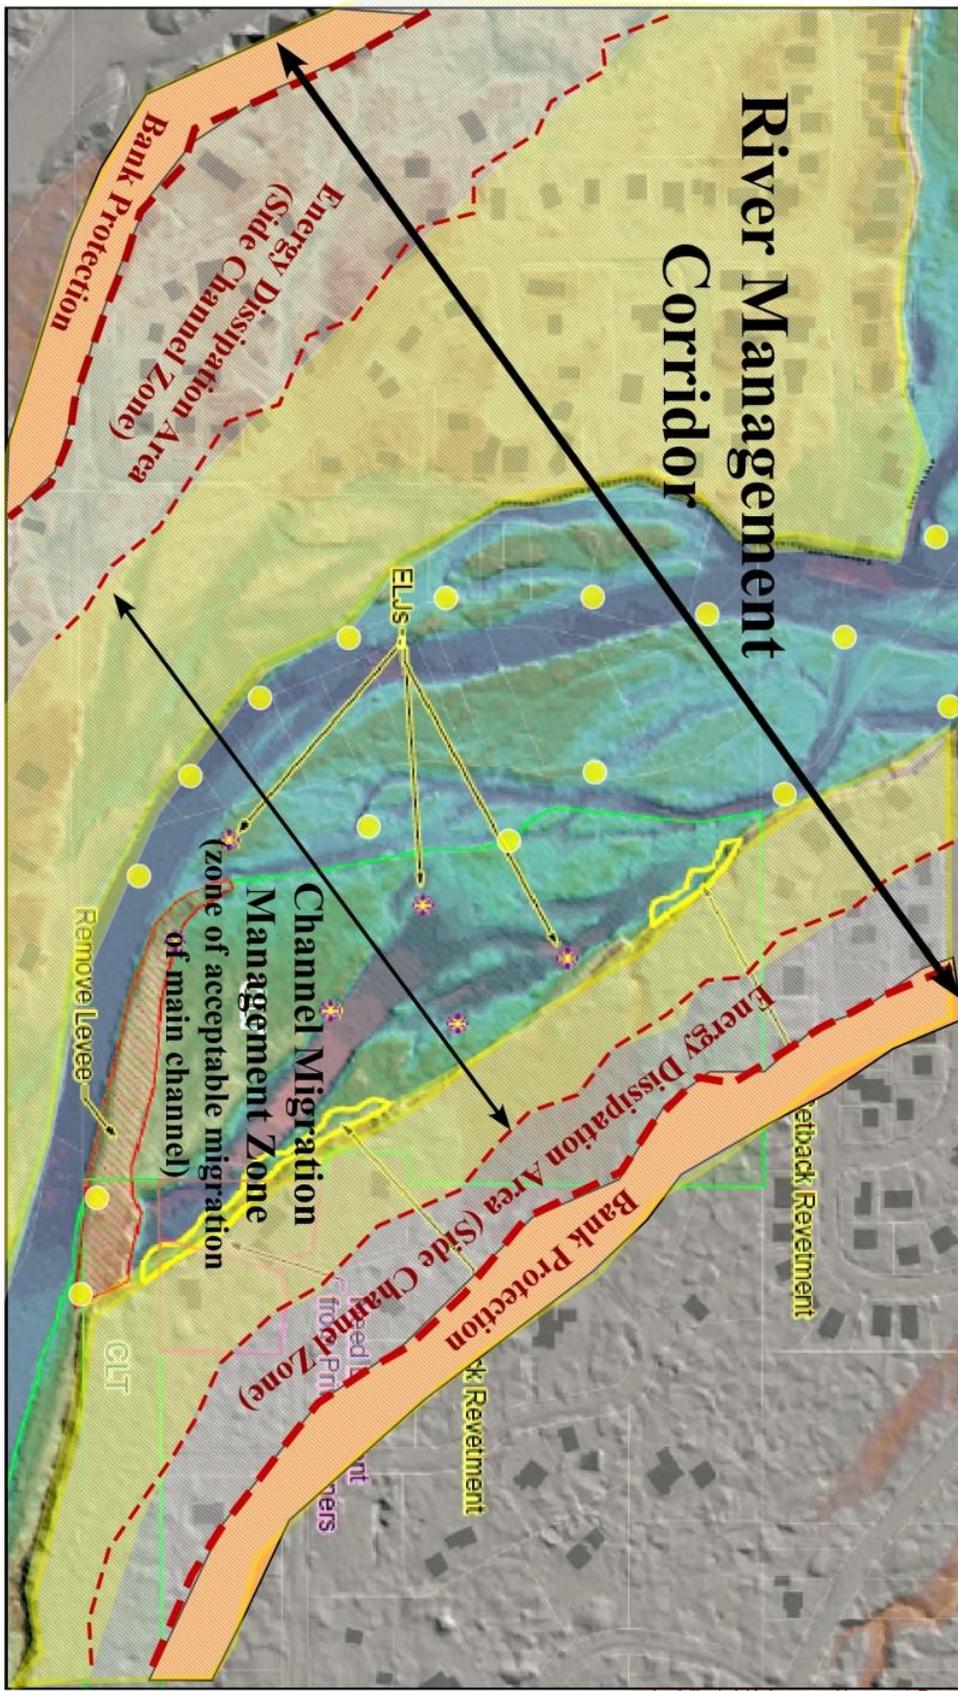
Figure 39. Spatial elements of long-term restorative flood protection strategy in the Upper Sandy River. Any land within the channel migration zone (CMZ) is at risk of erosion. Measures to limit channel migration will be most effective where the river has already established a wide floodplain or where land has been set aside to accommodate future erosion (~900-1200 ft in width). When bank protection is needed it should consist of methods that dissipate energy and create beneficial salmon habitat

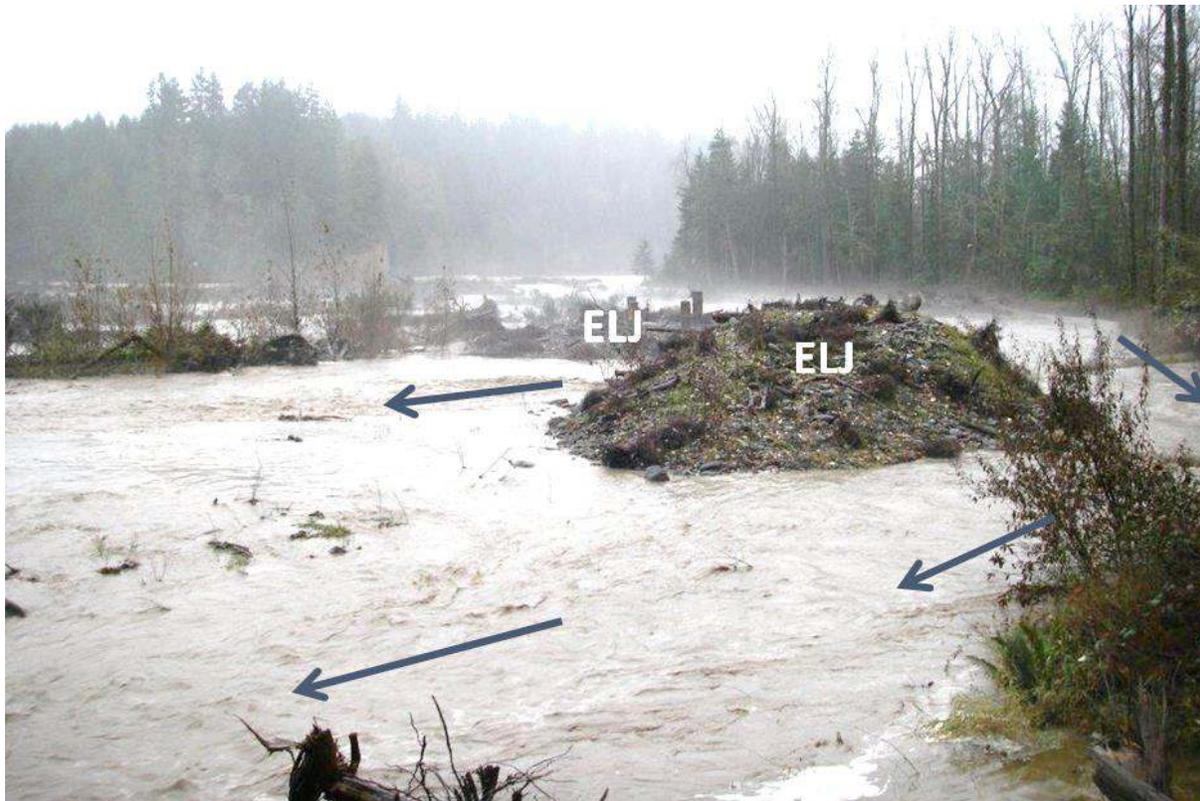
**Figure 42. The Upper Puyallup project during high flow in 2014 looking upstream at two of engineered logjams (ELJs) in the energy dissipation area (side channel zone). View is from complex timber revetment on Upper Puyallup River's left bank. The ELJs are splitting flow into smaller channels before the flow reaches the bank. The ELJ is one of six forming an array of structures to keep the main channel from approaching the bank. Photo by Tom Nelson.**

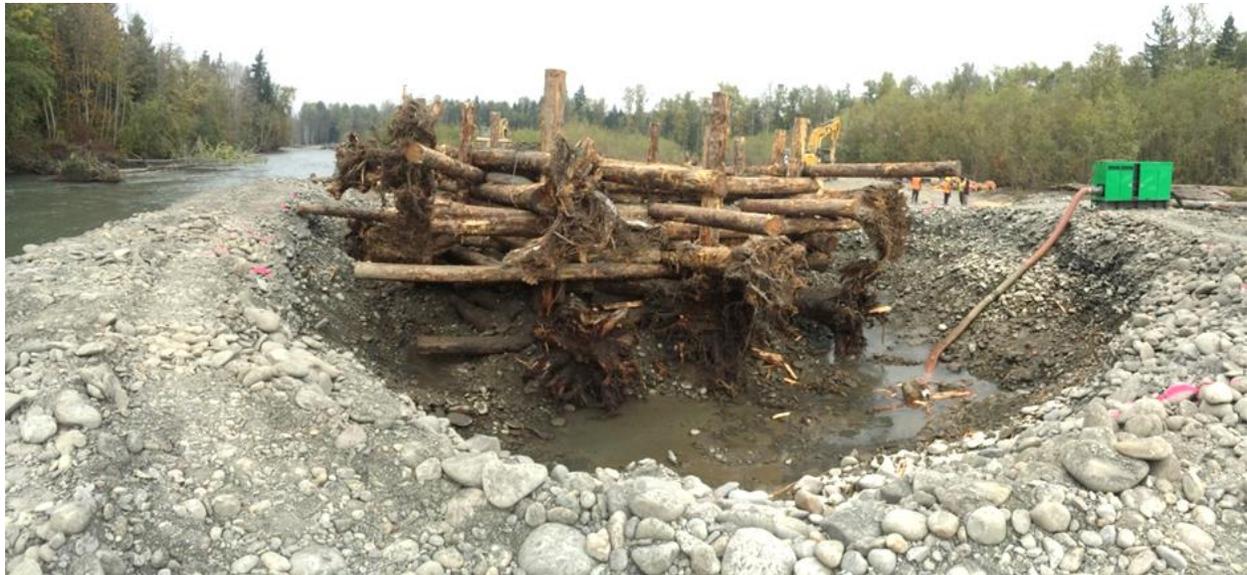
**Figure 43. Example of engineered logjam that doesn't have self-settling elements of previous examples. This structure is deeply embedded into the river so that it can withstand scour without being compromised. Note people on right side of the structure. Pit is 16 feet deep and timber posts extend deeper. Elwha River 2014.**

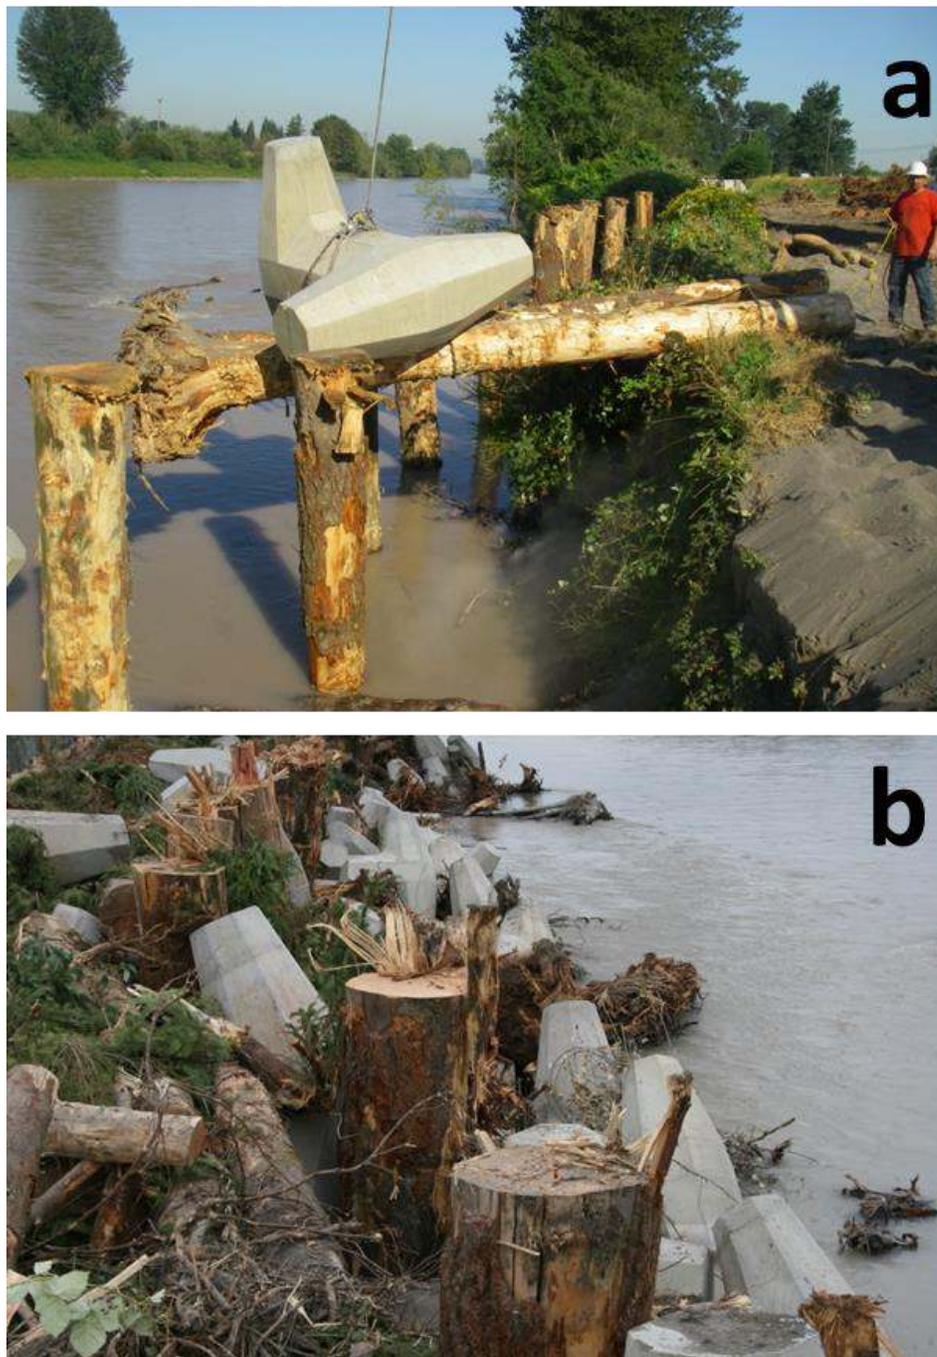
**Figure 44A/B.** Using a combination of timber and dolosse has been used in Washington State as a more restorative alternative to traditional measures to protect levees and roads. The dolosse are eight ton unreinforced concrete jacks that provide a complex interlocking shape emulating the function of natural snags. The top photo (a) shows how a dolo and attached log can be easily lowered into place and avoid expensive dewatering. Using the dolosse with logs creates a complex structure as shown in bottom photo (b) that can settle if undercut by scour, but without the need of rock or cable. The structures can be designed with lots of wood so the dolosse aren't even visible. Since they are self-settling, these structures don't need to be deeply excavated into the river bed as rock revetments or ELJs constructed only using timber (Figure 42, 43). Photos are of complex revetment built to protect a levee along the Lower Puyallup River in Fife, WA.

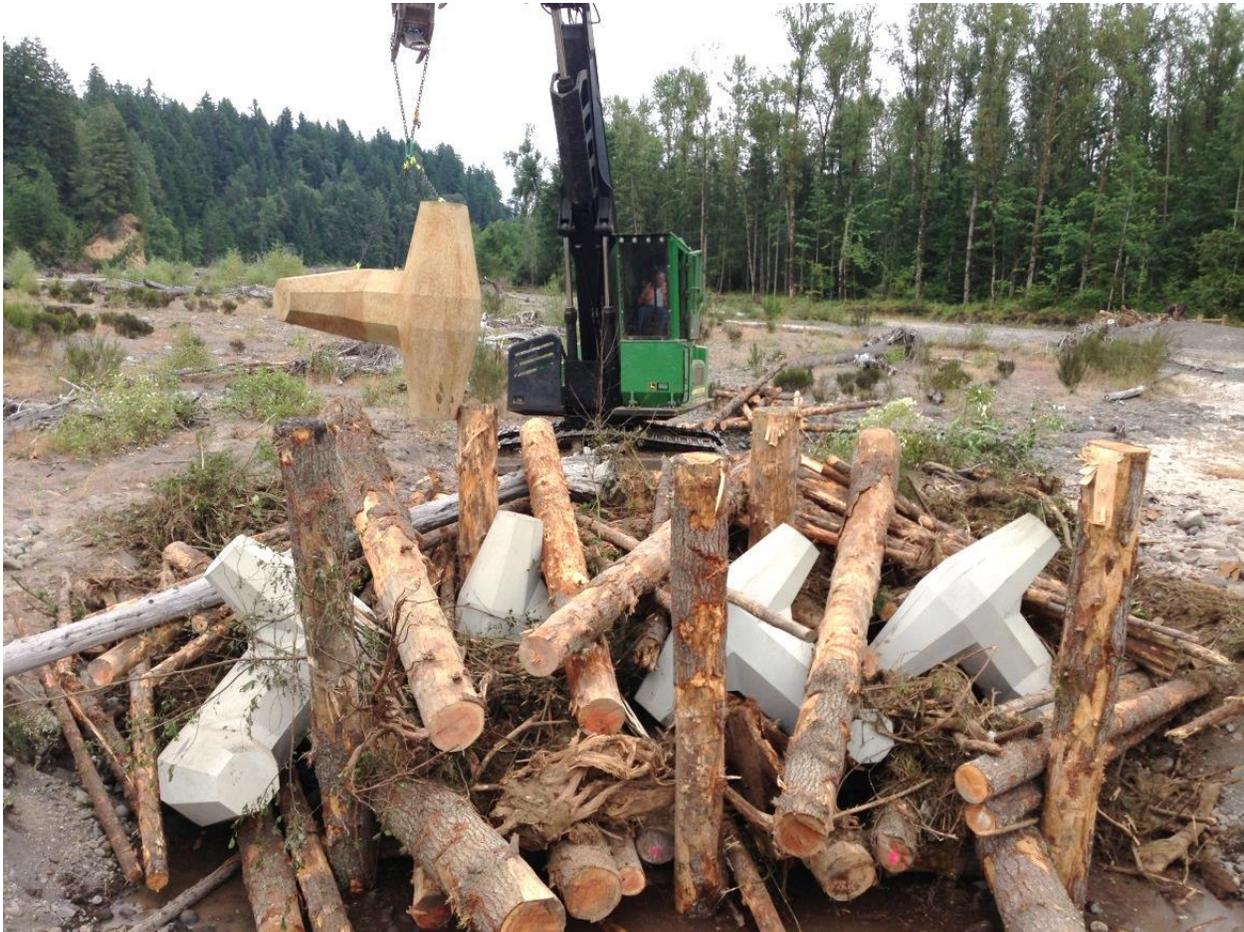
**Figure 45. Construction of ELJ using 8 ton dolosse in Upper Puyallup (same structures depicted in Figure 40). The dolosse offer an interlocking ballast the structure can settle into river bed if undermined without coming apart. This means the structures don't require as much excavation, lowering construction impacts and costs. Dolosse are covered with alluvium and wood so they are barely visible in completed structure. View is looking upstream into core of the structure.**

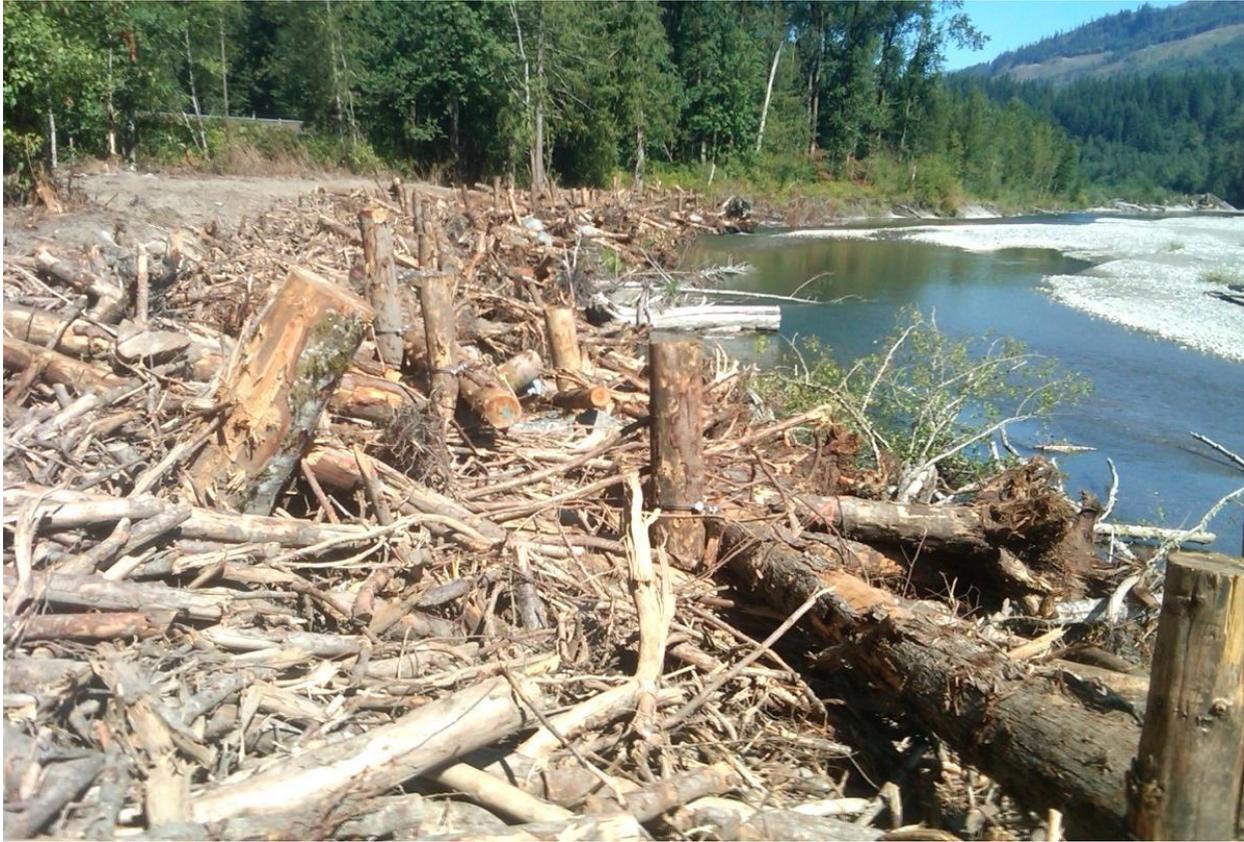
**Figure 46. Example of an engineered complex timber revetment bank protection creating a rough shoreline very different than traditional rock revetments found along Sandy River. The structure along the South Fork Nooksack River in northwest Washington is stabilized with timber piles and rock collars (no dolosse). Structure was built in 2011 by Lummi Indian Nation.**

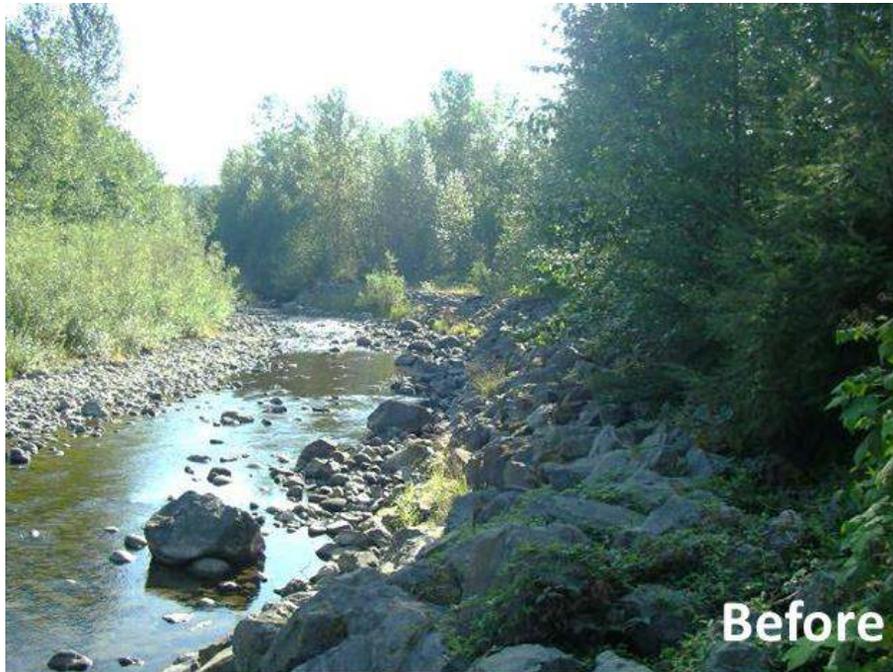
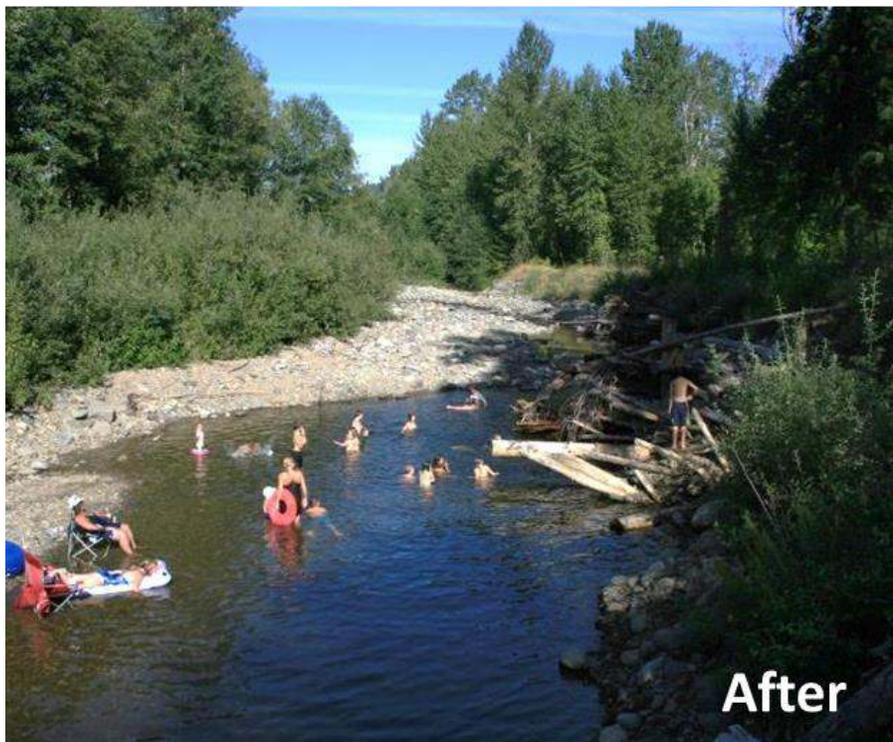
**Figure 47. Illustration of how river restoration doesn't just benefit salmon, but also people. The photos above are looking upstream at same site before and after restoration of the Mashel River in Eatonville, WA. In 2006 a rock revetment was replaced by a series of engineered logjams. The logjams formed deep pools where none had previously existed and created greater textural variance in the channel. Over 400 juvenile salmon were documented in each of the ELJ pools and during the summer the pools became popular swimming holes for Eatonville residents.**

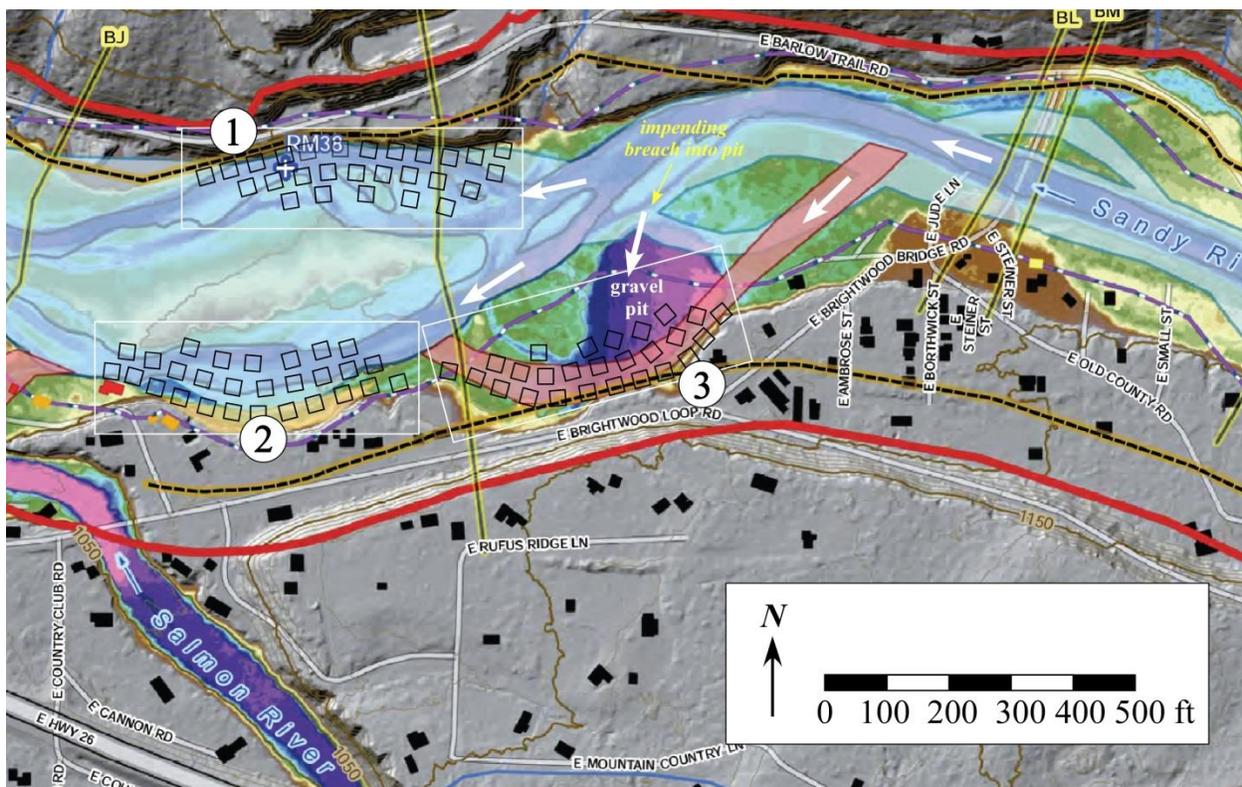
**Figure 49. Example of possible future bank protection layouts for recommended pilot project sites 1, 2 and 3. Sites 1 and 2 are segment of the river where it has established an active channel migration and floodplain width close to the minimum needed and thus are sites where actions could be taken immediately. Site 3 is located in segment of the river still constrained by a levee, but the levee has begun to fail and it is likely the river will break into the gravel pit and flow south toward E. Brightwood Loop Road. When the river occupies the gravel pit it will more than double its active migration zone.**
