Chico Creek Watershed Assessment for the Identification of Protection and Restoration Actions

Kitsap County, Washington

July 31, 2014

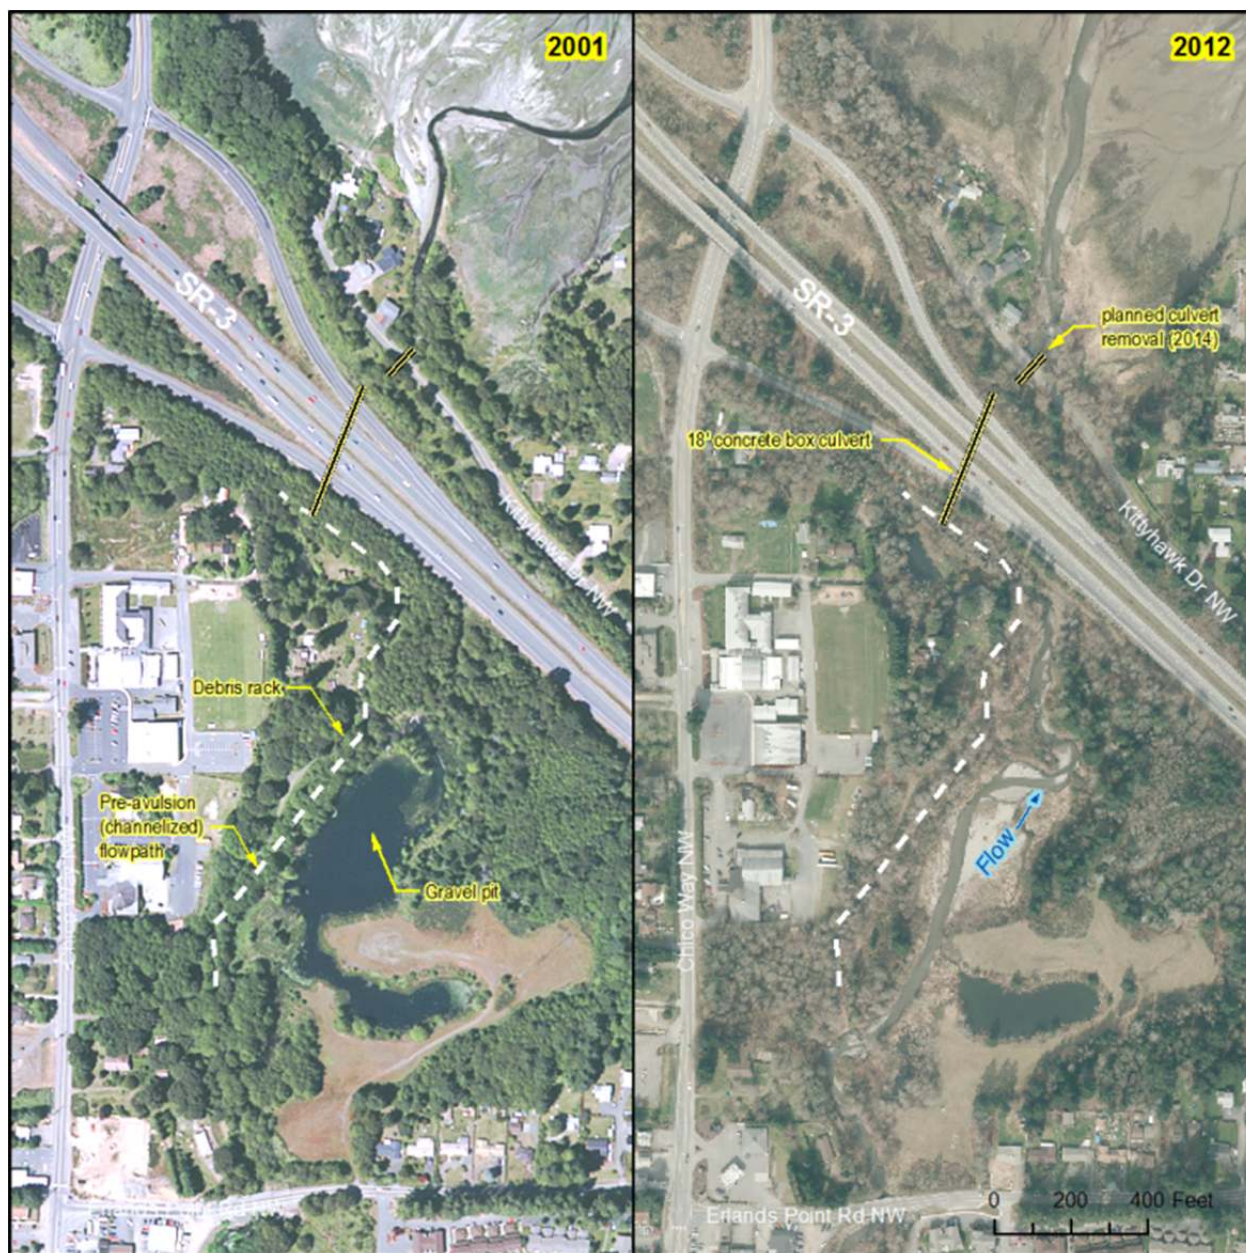
Problem: Upstream of the SR 3 culverts Chico Creek was historically channelized (probably in the early 1960s during construction of SR 3 crossing) into a straight alignment along the west side of the valley and confined by a 4-ft high levee that disconnected the channel from the floodplain. Gravel was extracted from the east half of the valley to fill an embankment as part of SR 3 construction. Gravel pits were left as ponded areas in the disconnected floodplain. A metal debris rack was installed in the channelized segment approximately 800 ft upstream of the culverts to prevent debris from blocking the double box culvert at SR 3. The debris rack was a barrier to fish passage when blocked with wood transported from upstream and required frequent maintenance by WSDOT to remove material accumulated during storm events. A channel avulsion in the early 2000s resulted in split flow with a majority of the streamflow being redirected into the gravel pit areas and bypassing the debris rack channel (Figure 47). Sediment has since accumulated in the pond area as the channel rebuilds a floodplain within the former gravel pit.

Figure 47. Aerial photo comparison showing recent channel changes in the reach between Erlands Point Road and SR 3.

Approach: This action will restore habitat-forming processes within a 2,100 ft channel segment owned and managed by Kitsap County (Erlands Point Park). Project components include removal of existing floodplain constraints (levee, metal debris rack), riparian forest restoration, and instream habitat enhancements. Wood placements should be incorporated to create stable hard points to establish an anabranching corridor characteristic of low gradient forested alluvial channels. Barnard (2009) prepared a conceptual design plan as part of the scoping report for planned replacement of the double box culvert at SR 3. This project should be coordinated with the planned culvert replacement downstream at SR 3.

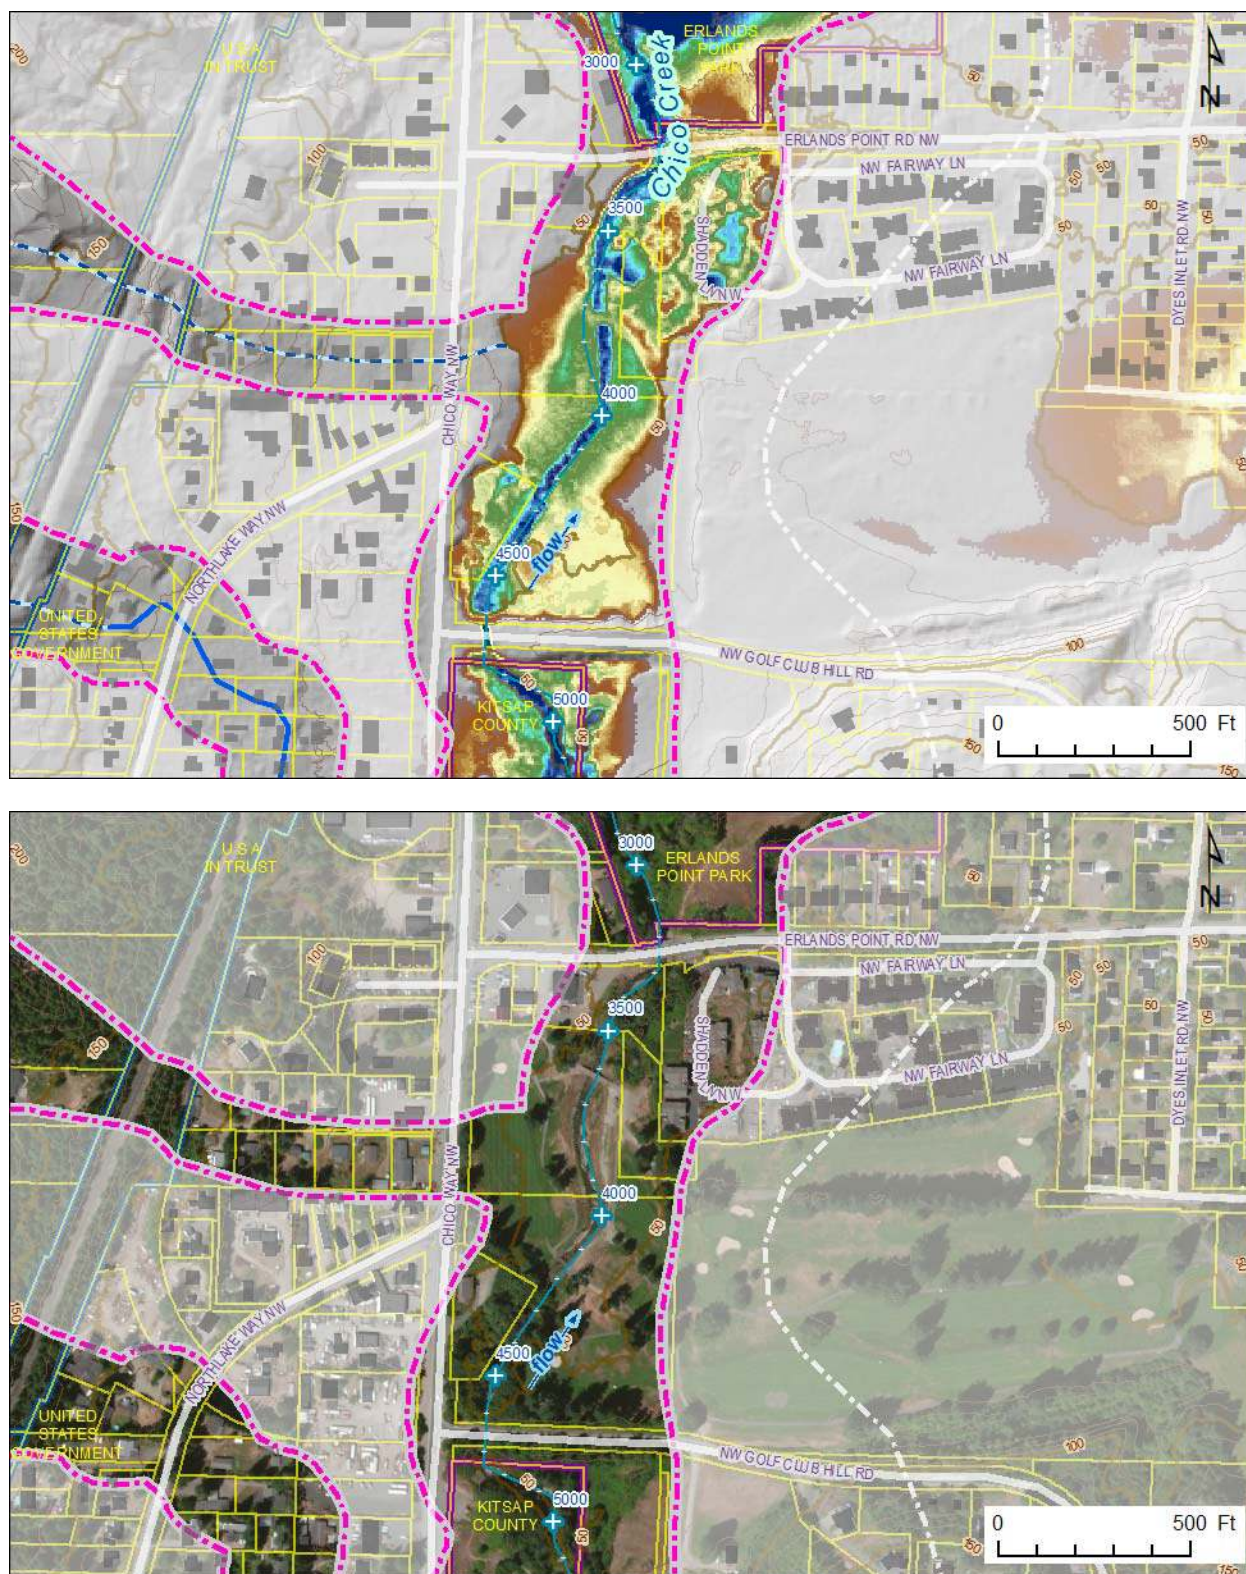
Problem: Artificial fill brought in to construct the road embankment encroaches into the floodplain on both sides of channel (Figure 48 and Figure 49). The bridge crossing confines the stream corridor and restricts habitat-forming processes.

Figure 49. Excerpt from geomorphic map (top panel, Appendix A) and aerial imagery (bottom panel, Appendix B) highlighting the stream corridor (dashed pink line) between Erlands Point Road NW and NW Golf Club Hill Road. Note artificial confinement by road fill at Erlands Point Rd NW and NW Golf Club Hill Road.

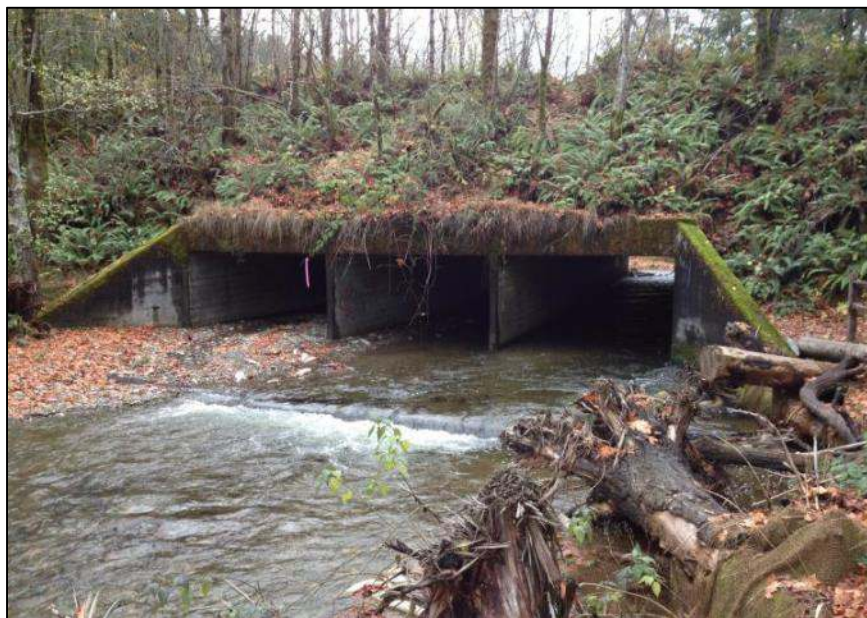
Problem: Past impacts to reach-scale processes in this channel segment have resulted in channel incision and disconnection of floodplain habitats. Key factors degrading habitat conditions include: floodplain constriction at the triple box culvert for NW Golf Club Hill Road, loss of roughness elements such as instream wood, and impairment of riparian processes such as wood recruitment and shade. Existing habitat conditions are characterized by a lack of channel complexity (few pools, limited refugia), low abundance of instream wood, loss of side-channel and off-channel habitats, and poor riparian conditions (Figure 51).

Figure 50. Photo of the triple box culvert at NW Golf Club Hill Road (view upstream). Photo taken November 2012 by Shawn Higgins, NSD.

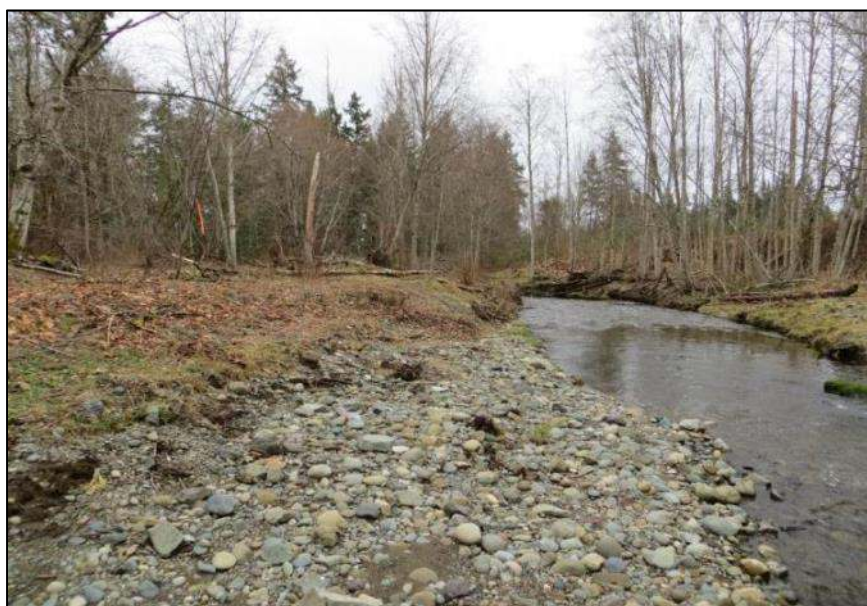
Figure 51. Photo of Chico Creek upstream of NW Golf Club Hill Road (view downstream). Photo taken February 2013 by Steve Todd, Suquamish Tribe.

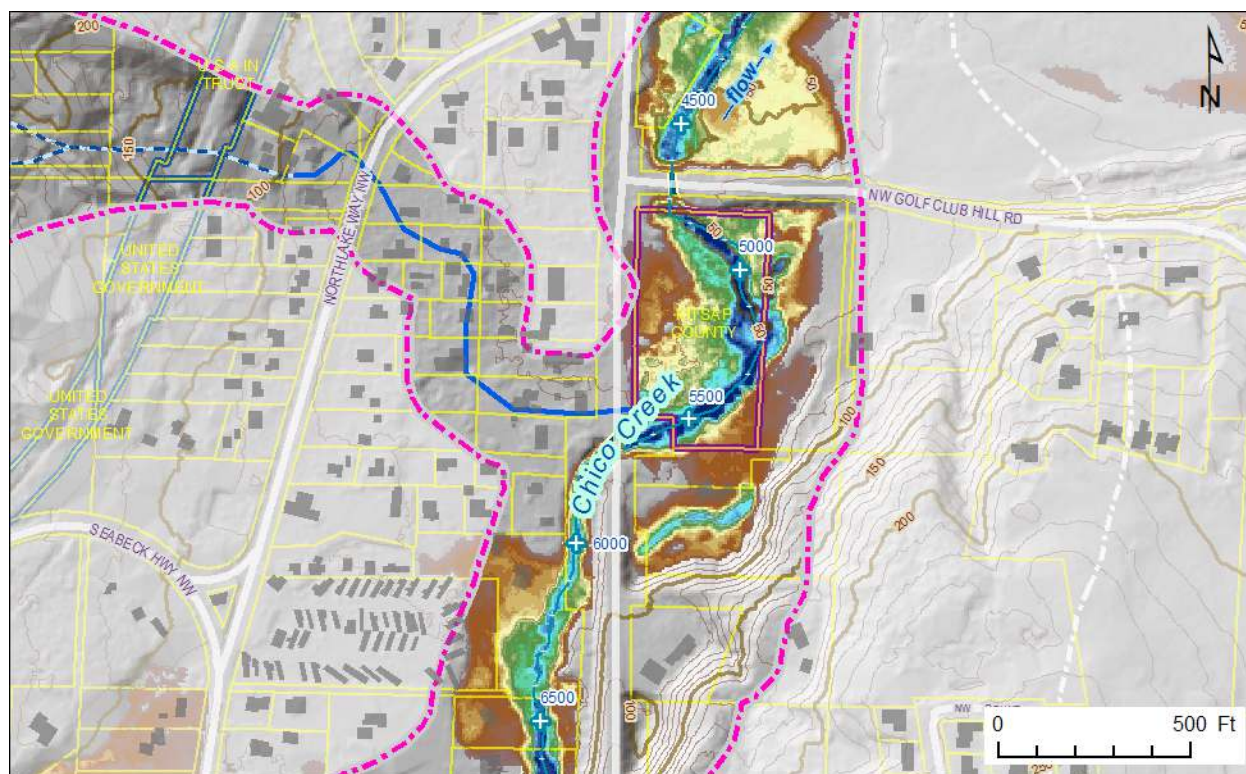
Problem: Artificial fill constricts the floodplain and restricts habitat-forming processes in the upstream and downstream reaches. The Chico Way bridge was damaged in the December 2007 flood and replaced with a new structure in 2009. The investment in this new structure likely limits opportunity to replace the bridge for several decades until the structure is nearing the end of its design expectancy or is damaged in future flood events. Unfortunately, the new bridge continues to confine the stream corridor. In addition, an isolated side channel feature in the floodplain, approximately 700 ft in length, is disconnected at the upstream end by fill placed for the Chico Way NW road embankment and is disconnected at the downstream end by past incision (Figure 52).

Figure 52. Excerpt from geomorphic map (Appendix A) highlighting the stream reach between NW Golf Club Hill Road and Chico Way NW.

Approach: This action will open up the floodplain to reduce constriction and aid in the restoration of habitat-forming processes in upstream and downstream reaches. The crossing should be constructed with a longer span and/or additional bridges to enable reconnection of floodplain habitats including potential to restore connectivity with approximately 700 ft of right bank side channel habitat. The two parcels are owned by the same landowner and have a combined value of approximately \$300,000 as assessed in the 2012 tax records. Acquisition of these properties for conservation of habitat forming processes was explored as part of an earlier feasibility assessment for realignment of NW Golf Club Hill Road. The landowner was not interested in selling property at the time (2012), however, we recommend that stakeholders continue engaging with landowners should future opportunities to acquire the parcels become feasible. Instream habitat enhancement will require strategic wood placements to increase channel complexity and restore natural stream grade through the incised segment. Floodplain areas will be graded at the upstream and downstream ends to reconnect the side channel.

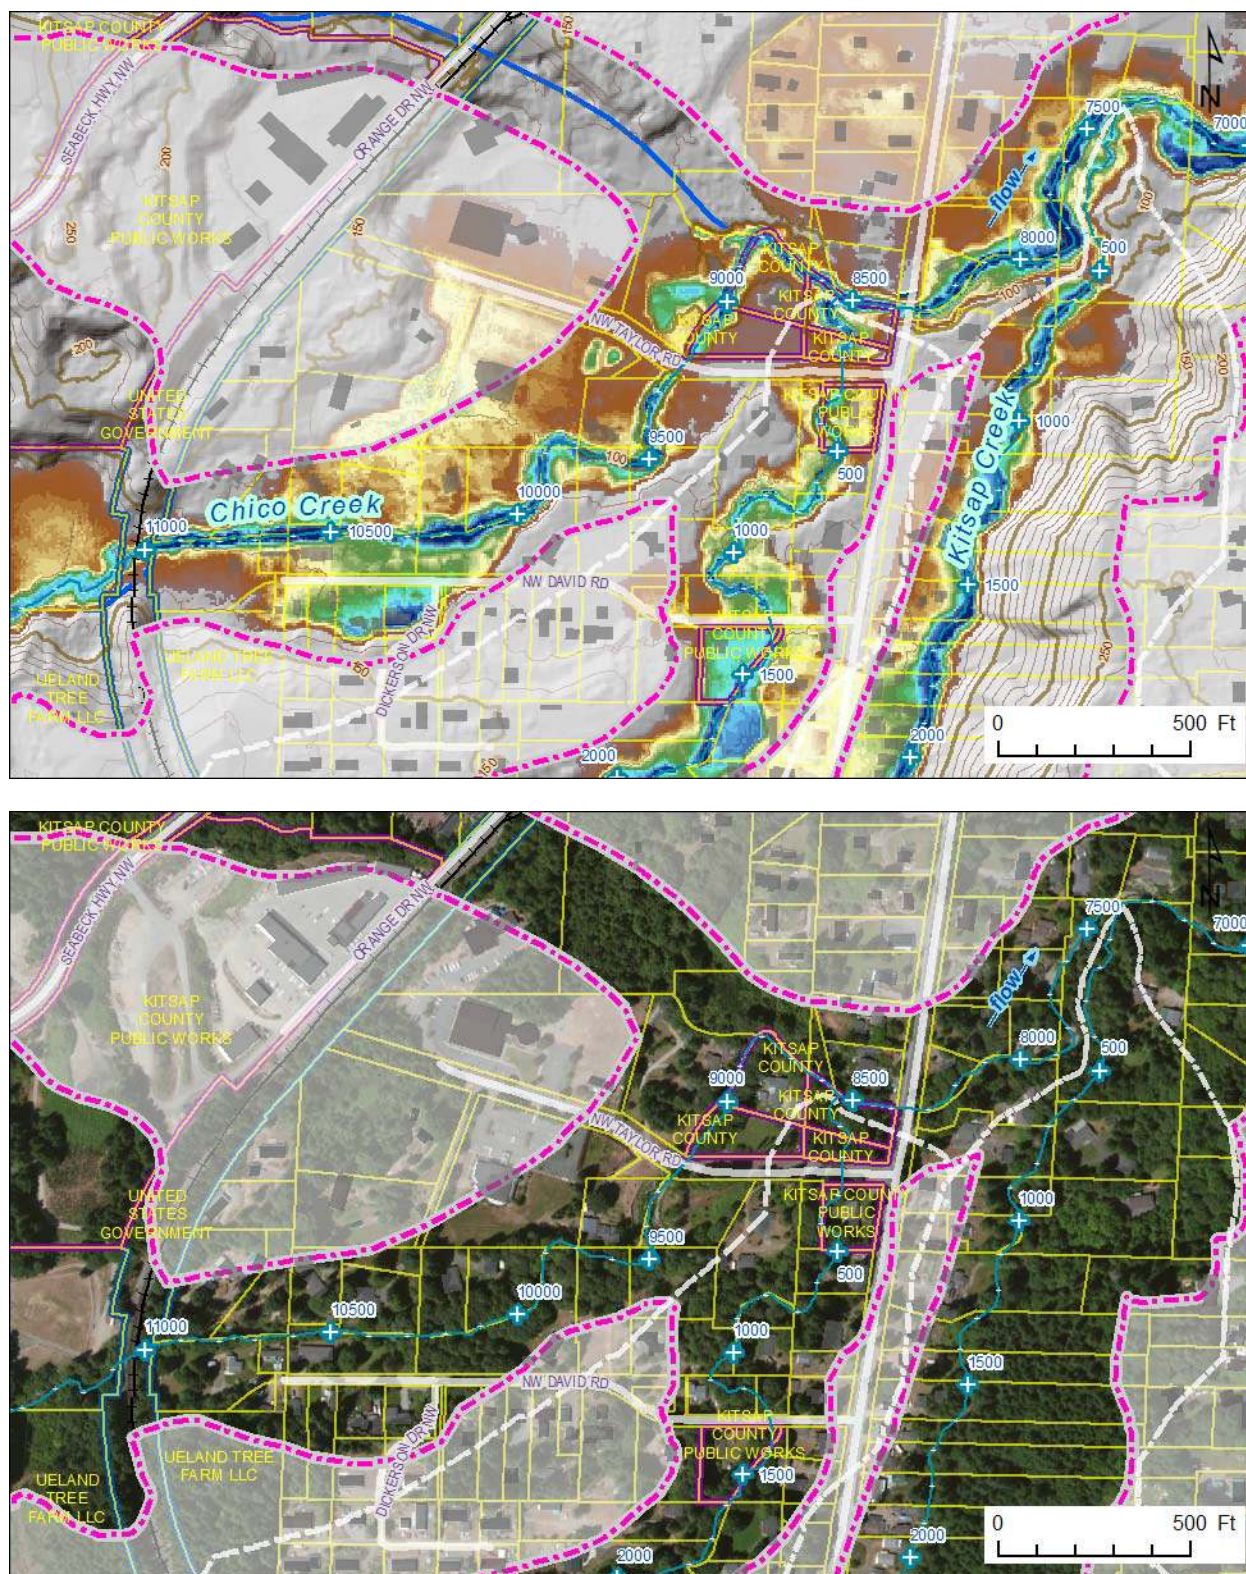
Problem: Habitat conditions are degraded from past impacts that have resulted in an incised channel (Figure 55) lacking in wood and characterized by low channel complexity with few pool habitats. The relatively flat surface on the inside of the 90 degree bend upstream of the Dickerson Creek confluence represents the pre-settlement floodplain surface prior to channel incision.

Figure 55. Excerpt from geomorphic map (top, Appendix A) and aerial imagery (bottom, Appendix B) highlighting the stream corridor (dashed pink line) between Chico Way NW and the Navy RR trestle as well as the lower reaches of Kitsap and Dickerson Creeks.

Approach: This action will aim to restore floodplain connectivity, riparian processes, and instream habitat conditions. The primary mechanism for past channel incision has been removal of instream roughness due to loss of instream wood and impairment of riparian processes. Restoration actions should include targeted wood placements to increase channel complexity and restore natural stream grade. Kitsap County acquired 4 parcels totaling 4.8 acres along the right bank of Chico Creek in 2010,

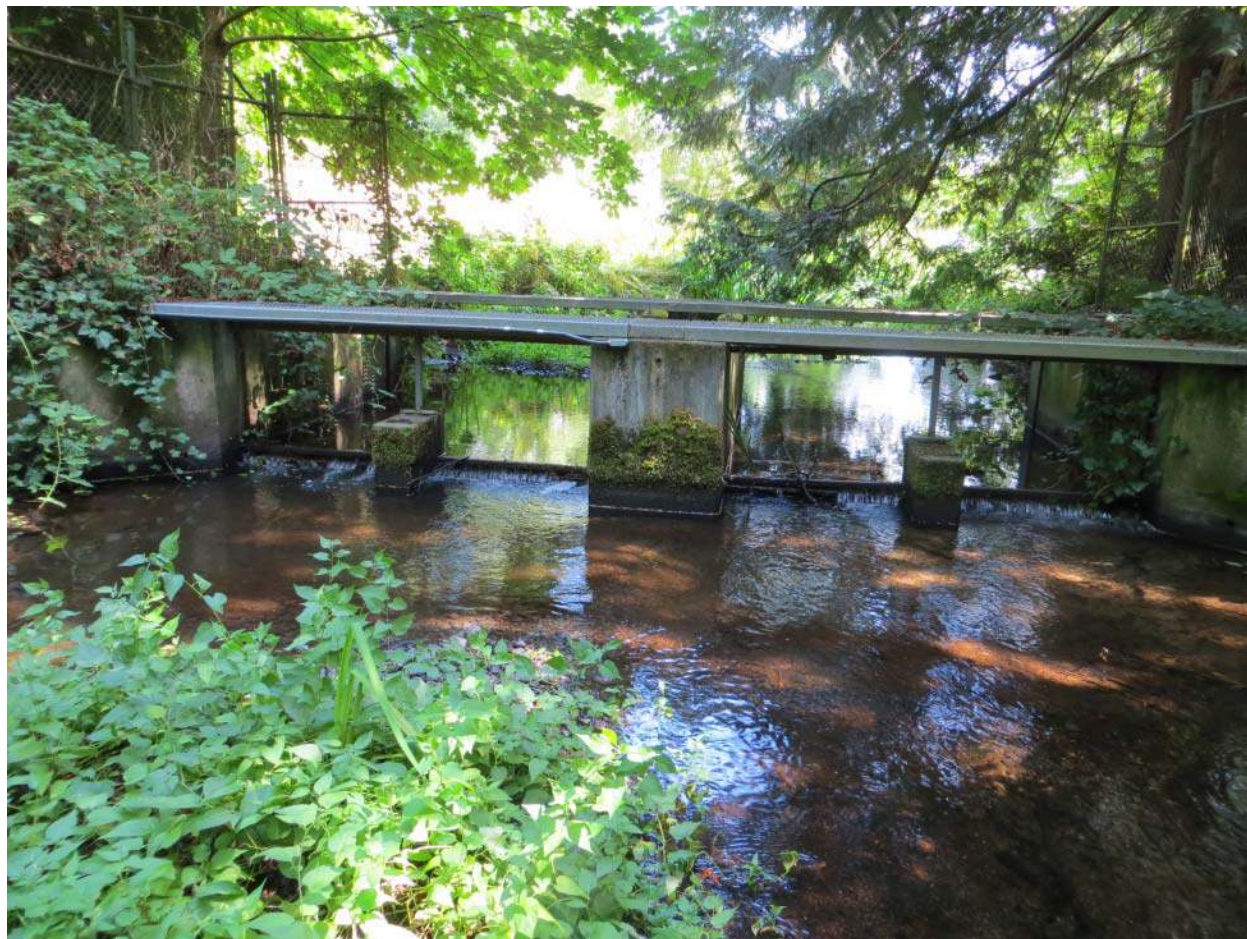
Problem: Fish screens at the outlet of Kitsap Lake previously restricted anadromous fish passage. The screens were removed in 1999; however, the concrete pieces that supported the screens remain in the channel (Figure 60). At times, this infrastructure has been altered by local residents to control the lake level without authorization. Such action results in rapid drawdown of streamflow in downstream segments of Kitsap Creek.

Figure 60. Existing infrastructure at outlet of Kitsap Lake (photo by S. Todd, August 2013).

Approach: Remove infrastructure from the channel at the lake outlet to prevent future manipulation of lake levels.

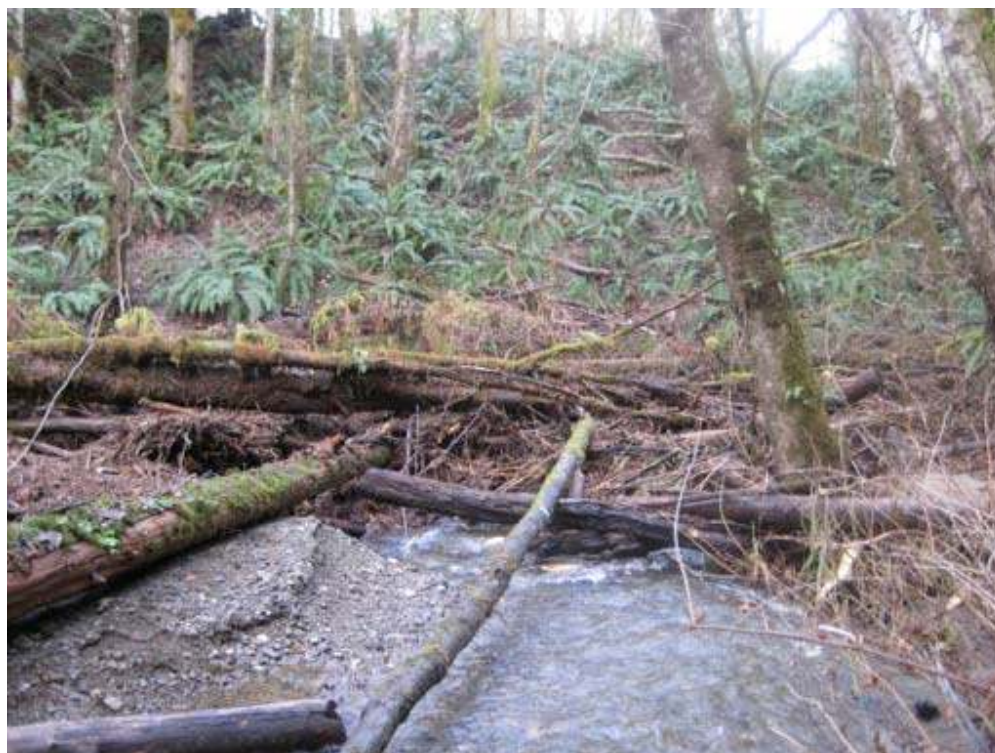
Problem: The U.S. Navy railroad crossing at Dickerson Creek is constructed on artificial fill that rises 40 ft above the valley floor. Two metal culverts pass through the railroad embankment. The culvert outlets are perched due channel incision downstream. A fish ladder maintains passage to one of the culverts (Figure 63); however, the culverts are assumed to be velocity barriers during high flows and also pose passage problems during low flows. The crossing restricts conveyance of sediment and wood from upstream reaches. Sediment and wood accumulate on the upstream side of the railroad grade during floods and are removed from the channel by the Navy's routine maintenance (Figure 64).

Figure 64. Photos of Dickerson Creek at the Navy railroad, view looking downstream. Upper photo from October, 2012 (photo by Tim Abbe, NSD). Lower photo from December 2010 shows blockage of the 48" diameter culverts (photo by Jon Oleyar, Suquamish Tribe).

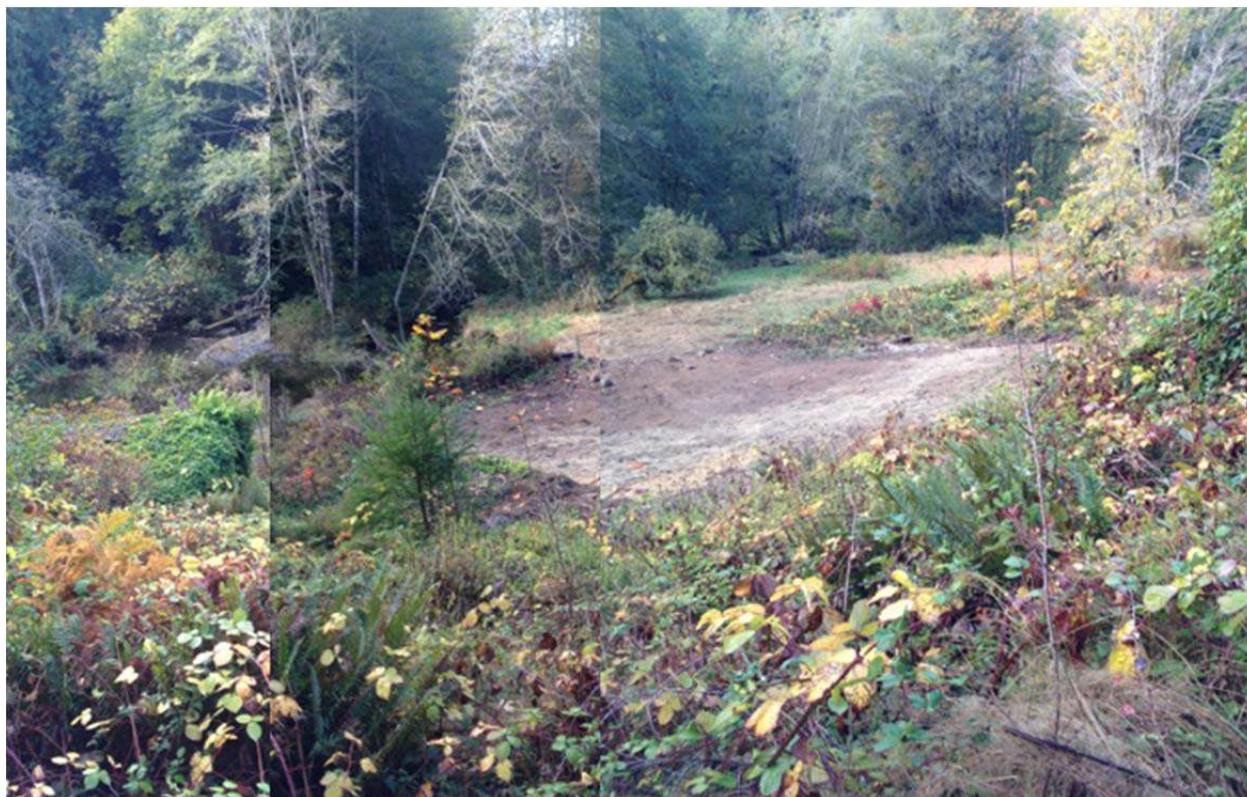
Problem: The riparian forest has been cleared along the lower 500 ft of Wildcat Creek (at the confluence with Lost Creek) as part of an abandoned homestead that is now part of the Rhododendron Preserve (Figure 66). The channel is slightly incised, has unvegetated banks, and is lacking in channel complexity due to impairments to natural wood recruitment.

Figure 66. Photo of the homestead area along Wildcat Creek at the confluence with Chico and Lost Creeks (photo taken Oct. 2013 by Tim Abbe, NSD).

Approach: Re-establishing native forest is crucial to the long term restoration of the stream corridor. Recent efforts to remove abandoned buildings from the property create opportunity to re-plant riparian vegetation. The addition of large wood to the stream will not only increase the number of pools and

cover, but raise water elevations and improve floodplain connectivity. Minor excavation work can restore ephemeral side channels and wetlands along the left bank floodplain that were filled when the site was farmed. Beavers have been very active in the area and restoration designs at this site (as well as some other locations in the watershed) will need to consider how beavers utilize the area and alter the channel, floodplain, and riparian characteristics of the stream corridor. The site may be ideal for public access where visitors can see a very rare Puget Lowland stream in near-pristine condition (upstream of homestead) and see a locally impacted area in the process of being restored.
