Abbe Tim, Hrachovec Mike and Winter Steve, Engineered Log Jams: Recent Developments in Their Design and Placement, with examples from the Pacific Northwest, U.S.A., Reference Module in Earth Systems and Environmental Sciences, Elsevier, 2018. 30-Oct-18 doi: 10.1016/B978-0-12-409548-9.11031-0.

Engineered Log Jams: Recent Developments in Their Design and Placement, with examples from the Pacific Northwest, U.S.A.

Tim Abbe, Mike Hrachovec, and Steve Winter, Natural Systems Design, Seattle, WA, United States

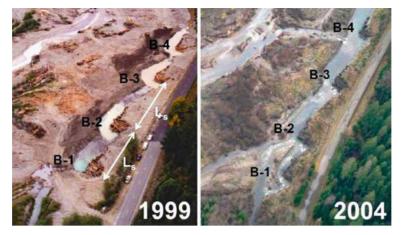
Fig. 1 Postconstruction conditions for ELJs installed along the Cispus River, Lewis County, WA.

In 1999, the first road protection project using ELJs was done for Gifford Pinchot Natinoal Forest in southwest Washington State. The project is located on the Cispus River (fifth order channel Q100 = 27,100 cfs) with goal to to protect a major highway after a rock revetment had failed. The ELJs were built as a series of discrete structures spaced along the edge of the highways road fill and acted to deflect flow away from the highway. The ELJs were constructed of a log crib design and backfilled with alluvium, topped with soil and planted with native trees (Abbe et al., 1997). The structures have acted as an analog to rock groins for their bank protection function, but with significantly greater in-stream habitat value by creating deep pools with complex overhead cover which support rearing and refuge for fish. The structures have remained stable and allowed a riparian buffer to become established between the roadway edge and the river, providing overhanging vegetation for shade and food production (Fig. 1).

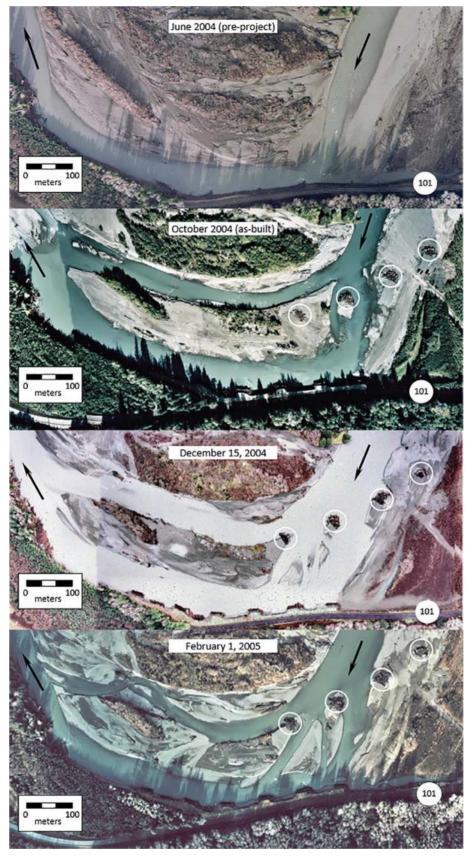
Fig. 2 Time sequence photos of pre-and post-project conditions for ELJs re-directing flows on the Hoh River, Jefferson County, WA.

Building on the success of this initial work, pile-stabilized ELJs were installed to protect State Route 101 along the Hoh River in 2004, including a series of 4 ELJs upstream from the erosion site to re-direct some of the river's flow prior to reaching the road embankment (sixth order channel, Q100 = 73,600 cfs) away from Highway 101. This flow re-direction successfully restored a single-thread channel into its historic anabranching morphology, resulting in several deep, narrow channel threads and a much more complex pool-riffle sequence, which also resulted in significantly reduced shear stress along the river's edge at the road fill (Abbe and Brooks, 2011) (Fig. 2).

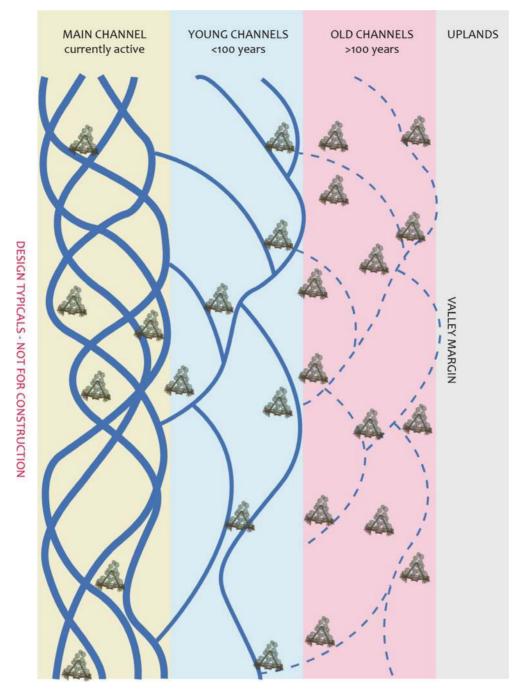
Fig. 3 Conceptual approach to development of anabranching morphology with ELJs in large rivers.

This approach to installing ELJs upstream and out from the river bank was advanced further in the Quinault River (sixth order channel Q100 = 55,800 cfs) beginning in 2008, with the development of a tiered conceptual model to ELJ spacing (QIN, 2008) as shown below in Fig. 3. Closest to the edge of the historic valley margin, ELJs are tightly spaced, preferably within a zone of historic

channel migration and located to re-engage relict channels. This tight spacing functions to disperse incoming flows and reducing shear stress at the valley margins, thereby allowing for re-establishment of a riparian corridor interspersed with side channels, and creating extremely complex habitat conditions and slow, shaded water for salmonid rearing. Stepping out from this edge habitat, ELJs are spaced more widely apart to encourage anabranch conditions and establishment of perennial side channels separated by forested islands. In the center of the river corridor, ELJs are spaced more broadly apart, allowing development of wider central channels. In this zone, the spacing is dictated by accommodating the valley trends in directions and ELJs are located wherever possible at historic island heads. In zones of broad open gravel plains caused by human actions, locations are determined by a geomorphologist, primarily by reviewing historic channel locations as determined by air photos and/or relative elevation mapping.

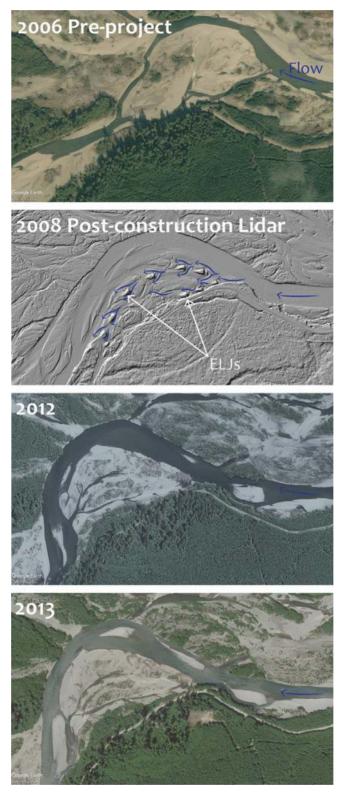
Fig. 4 Development of anabranching channel morphology using ELJs on the Upper Quinault River, Jefferson County, WA.

This approach to restoring anabranching morphology in large rivers was first put into practice in 2008 on the Quinault River as shown in Fig. 4 (Shields et al., 2016). These log pile-stabilized ELJs were installed to provide perennial flow to the inlet of the Alder Creek side channel inlet and prevent the mainstem channel from eroding its connection with the mainstem. The general design layout of the ELJs is illustrated in Fig. 4. This side channel is particularly important as a fisheries resource by providing critical refugia and rearing habitat for juvenile blueback sockeye salmon. The sequence of images first represents a LIDAR image of the post-construction condition, showing the relative height of the ELJs above the surrounding surface. Array of ELJs constructed on large point bar in 2008. (depicted in LiDAR DEM at top). Main channel is in upper right and flowing to right to left (west). The 2009 image shows the initial collection of incoming LWM on the upstream faces of the ELJs and the flow splits occurring around each of the structures on the otherwise-planar gravel bar. By 2012 the river migrated into ELJ 08-10, forming a new pool, added more than 100 ft. of racked wood, initiated new side channels, two new logjams formed, the side channels are more pronounced and ELJs had begun forming forested islands. The final 2013 image illustrates a perennial side-channel which has established to provide steady flows to the head of the Alder Creek side channel; this side-channel has continued to receive a stable inflow due to the riverine response initiated and sustained by the ELJs.

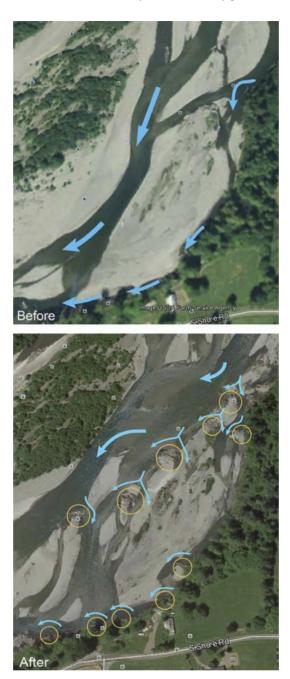
Fig. 5 Preproject (before) and postproject (after) conditions at south shore road Upper Quinault River, Grays Harbor County, WA (this site is downstream of site in Figure 4 and in different county).

This approach was advanced further in 2012 on the Upper Quinault River with the need to protect the South Shore Road and riverfront residential properties from continuing erosion down-valley of the original 2008 installation. Fig. 5 shows the conditions at and upstream from the South Shore road, with the mainstem channel impinging on the road and private residences. Local efforts had obtained little success in stabilizing the bank with logs tethered to the bank with steel cables. The river continued to erode laterally and down-valley, threatening the continued function of the South Shore road.

The After image (Fig. 5) shows the ELJs having successfully restored anabranch morphology to this reach, with tightly-clustered ELJs along the edge of the valley margins and resulting multiple small channels. These channels have high habitat benefit as they provide a wide range of hydraulic conditions (fast/shallow riffles as well as slow/deep pools) and resulting benefits of gravel sorting to provide stable spawning areas which are critical to the local blueback salmon.

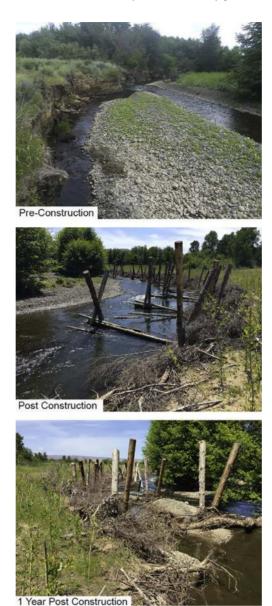
Fig. 8 ELJs installed in Toppenish Creek in 2016 to raise bed level, water levels and stabilize high banks lacking riparian trees. Yakima County, WA.

In 2016, this approach of reversing channel incision with the use of channel spanning ELJs was advanced for Toppenish Creek in Yakima County, Washington (fourth order channel, Q100–4600 cfs). In this case, the design called for using pile-supported collections of partially channel-spanning log structures alternating from different banks and designed to collect and retain incoming fine sediment and gravels. This project was intended to not only reverse recent human-caused incision and reconnect relict channels, but also to increase water storage both instream and within the adjacent soils. This was done with the intent to raise groundwater levels and allow restoration of the historical riparian corridors which had died to due to loss of groundwater associated with incision. Fig. 8 below illustrates before and after conditions, where the groundwater has been elevated approximately three feet and satisfying project goals for arresting bank erosion. Fig. 8 shows pre-project conditions of an entrenched channel and failing stream banks which result in significant sediment inputs as the channel attempts to re-create and inset floodplain. The post-project image illustrates the ELJs shortly after construction, and the 1-year post project photo illustrates the ability of the ELJs to collect and retain incoming sediment, thereby elevating adjacent surface water and groundwater elevations.

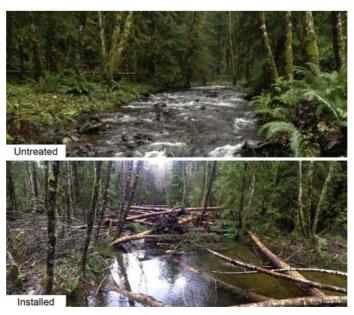
Fig. 9 Ellsworth Creek with and without ELJs during storm. Pacific County, WA.

Not all project sites can be accessed using ground-based excavators as were used for the examples above. The Ellsworth Creek (second order channel, Q100=340 cfs) restoration project was accomplished concurrent with logging using structures installed using cable logging equipment operating from adjacent ridgetops. The project intent was to reverse historic human-caused incision by installing whole trees in a self-ballasting matrix design that was intended to sufficiently slow incoming flows to trigger deposition of sediments and re-engage flows with adjacent relict floodplains and wetlands. This project advanced the science of ELJ design by incorporating large amounts of slash and racking into a valley-spanning ELJ. As shown in Fig. 9 the segment of channel without ELJs is fast and shallow during winter base flows, with velocities exceeding seven ft/s, a wetted width of approximately 30 ft. and a bedrock channel. The segment of channel with an ELJ has instream velocities less than one ft/s, a wetted width over 15 ft. and a channel of fine sediments.

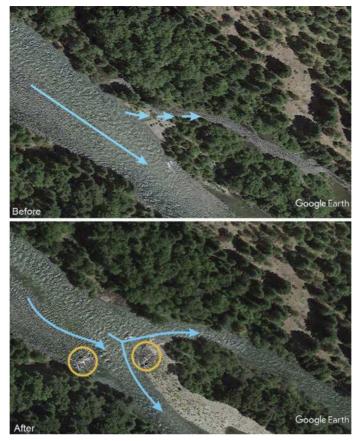
Fig. 10 Two ELJs directing flows into the upper side channel on the Cle Elum River, before and after conditions. Kittitas County, WA.

Fig. 10 shows before and after conditions at Side Channel B, where two ELJs working in concert to steer flows towards river left and split out a portion of the mainstem flow into the side channel inlet. Structure locations and flow splits were determined with

2-dimensional hydraulic modeling and iterative solutions to attain the desired hydraulic outcome, with predictions for velocity and shear stress on the bed.

The second image is of a ballast-stabilized Apex ELJ that was installed via helicopter, then backfilled with local material using an excavator. The flow split into a side channel on river left is clearly visible and is made possible due to locally elevated hydraulics caused by two ELJs placed in conjunction as shown in Fig. 10.

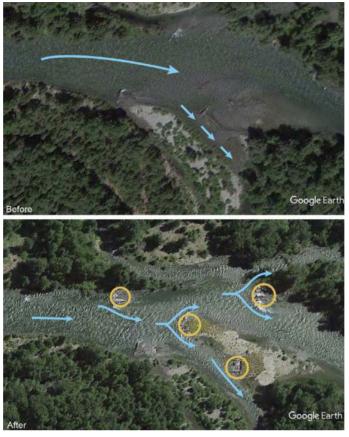
Fig. 11 Four ELJs directing flows into a side channel on the Cle Elum River, before and after conditions.

In this second example, 2-dimensional hydraulic modeling of this reach identified the need for installation of four ELJs to work together to raise local water surface elevations, direct some portion of the flow river right to restore perennial flow into a historic side channel (Fig. 11).

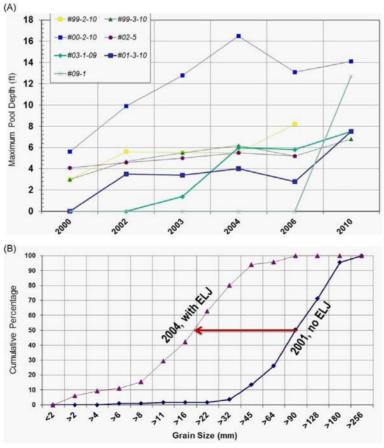
Fig. 12 Increasing pool depth (A) and decreasing grain size (B) following ELJ installation on Elwha River.

For over 100 years prior to recent dam removal, the lower Elwha River (forth order, Q100–42,000 cfs) suffered from a lack of incoming sediment, as the natural sediment transport regime was interrupted by the upstream dams. That, coupled with human removal of large native wood resulted in a simplified channel with large aggregate and few deep pools, providing little rearing habitat for juvenile salmonids. To create additional pool habitat, ELJs were installed in 2000, 2002, and 2006; pool depth was found to consistently increase on an annual basis as shown in Fig. 12A, (data from Mike McHenry, Elwha Tribe, in Abbe et al. 2016). Median grain size (D50) (Fig. 12B) was found to decrease from 90 to 19 mm (3.5 to 0.8 in.) over the same time period. This represents a 79% decrease in grain size, which is a result of the stress partitioning caused by the ELJs.

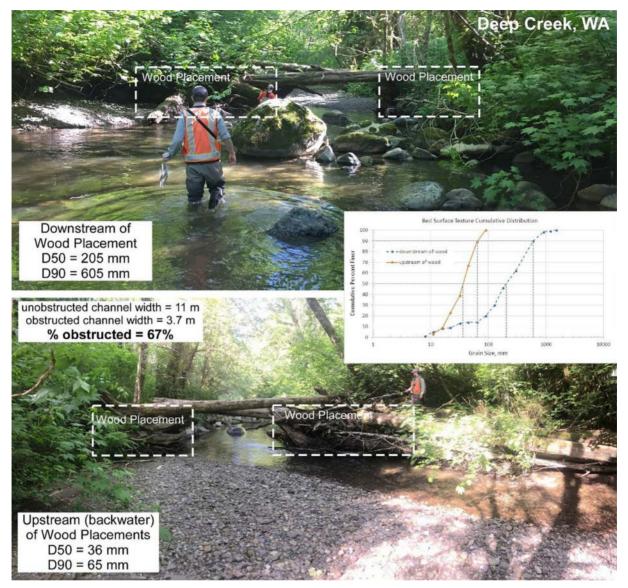
Fig. 13 Decreased upstream channel grain size resulting from ELJ placements on Deep Creek, Clallam County, WA.

ELJs can be placed to constrict the channel cross-section, causing a backwater condition with decreased average channel velocity. This lowers shear stress at bed level and can cause deposition of smaller-grained materials on the upstream side of the structures. In the case of paired ELJs on Deep Creek (third order channel, Q100 = 2900 cfs), 67% of the channel cross-section was obstructed by ELJs. Fig. 13 shows images of conditions upstream and downstream of the ELJs. Downstream, the bed grain size is in the cobble/boulder size range and unsuitable for spawning. Following ELJ installation, aggradation has occurred and the upstream bed grain size has reduced to a gravel substrate which is suitable for spawning.

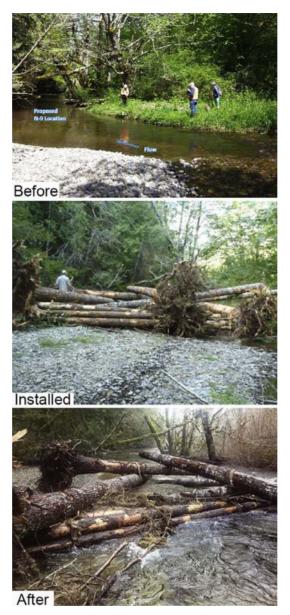
Fig. 14 Pre- and postproject conditions and 1-year post project conditions for ELJ retaining sediment in Big Beef Creek, Kitsap County, WA. View looking downstream.

Fig. 14 shows conditions prior to the project, immediately postproject and one year postproject for a helicopter-installed ELJ on Big Beef Creek (third order channel, Q100 = 2300 cfs). Twenty ELJS were installed in a single day and were intended to slow flows and increase channel sinuosity sufficiently to transform the reach from a degrading condition to an aggrading condition. One year after construction approximately three feet of gravel have been deposited within and around the ELJ, which not only creates stable spawning for salmonids, but has improved floodplain connectivity. These structures are collecting and retaining incoming small woody material, increasing bed texture and hydraulic diversity and storing excess sediment within the reach. The larger gravel bars, coupled with embedded logs and hydraulic gradient from upstream to downstream ends of the ELJs, have been found to improve hyporheic exchange and result in decreasing instream temperatures.

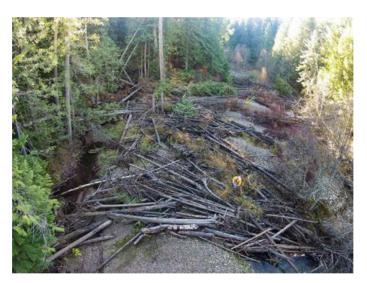
Fig. 18 Naturally-occurring valley log jam, Sullivan Creek, Pend Oreille County, WA.

In many cases existing channels have degraded extensively and have become disconnected from their historic floodplain. The natural analog of a valley-spanning log jam has been found to have successfully restored incised channels by reducing velocities and transforming degraded reaches into aggrading reaches. Fig. 18 shows a naturally-occurring valley log jam composed of a broad

collection of whole trees and smaller wood, which has achieved a vertical bed rise of over 6 ft. along the 200 ft. structure length. Downstream, the channel is predominantly cobble/boulder while upstream the bed is dominated by small to medium gravels. This structure is located on Sullivan Creek (third order stream, Q100 = 2200 cfs).

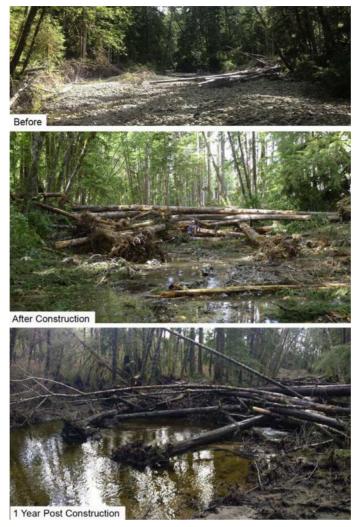
Fig. 19 Valley scale ELJ, pre-construction, post construction and 1 year afterwards. Hurst Creek, Jefferson County, WA.

Design and installation of a valley-spanning ELJ is an emerging application with initial pilot installations installed beginning in 2015. Fig. 19 shows pre- and postproject conditions at the site where a valley-scale ELJ installed in Hurst Creek (second order stream, Q100 = 2300 cfs) intended to promote aggradation of the channel bed through retaining incoming sediment. This reach had entrenched approximately 4 ft. to bedrock, as a result of logging activities and changing hydrology as well as human removal of the historically-extensive collections of large wood from the channel. This structure was constructed of whole trees using trackhoes, and stabilized by entangling many of the trees into the surrounding riparian corridor.

Ongoing monitoring of the six valley-scale ELJs installed in series has found that sediment is beginning to accumulate in the channel, transitioning the bed from bedrock to small gravels. The 2-year storm is now re-engaged with the historic floodplain, which prior to structure installation had been elevated above the 100-year flow.

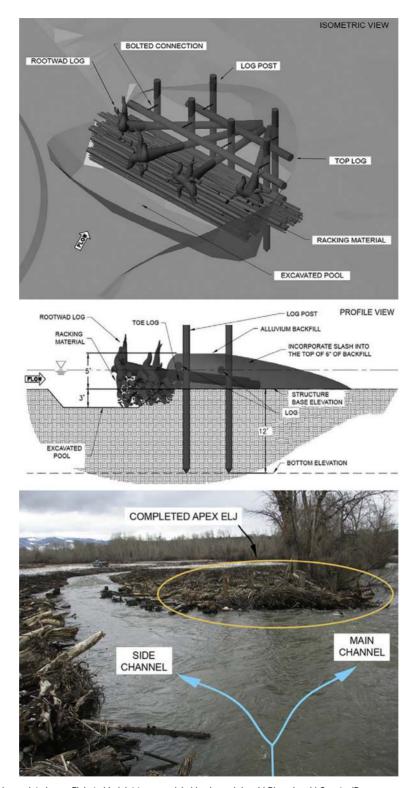
Fig. 20 Design layout and completed apex ELJ at side inlet to perennial side channel, Lemhi River, Lemhi County, ID.

The primary elements of a simple mid-sized ELJ are illustrated in Fig. 20 in isometric and profile views as well as a photo of the installed structure. This ELJ was designed and successfully installed in the Lemhi River (fifth order river, Q100–3200 cfs) to activate a relict side channel and create local pool habitat. Structure stability is provided by six vertical posts driven a minimum of 12 ft. below thalweg. Structural members include four rootwad logs and three cross logs to secure the rootwad logs within the pile array via

bolted connections. Backfill of native aggregate is placed on the downstream end of the structure for additional ballast and to provide a higher floodplain surface for trees to be planted and create a forested island head (Abbe and Montgomery, 1996). Slash can be installed within the alluvium backfill to provide some structural stability to the fill as well as retain moisture to promote plant growth.

A key element of successful structure function is to install significant amounts of racking material in the upstream face of the structure. In this instance this racking material is held in place by the overhead trapping rootwads. The racking creates diverse refuge habitat, particularly for juvenile salmonids.
